CONDITIONS ASSESSMENT REPORT

Shawnee Indian Manual Labor Boarding School

Shawnee Tribe Cultural and Historical Preservation Committee | December 6, 2021

Architectural
Resources Group

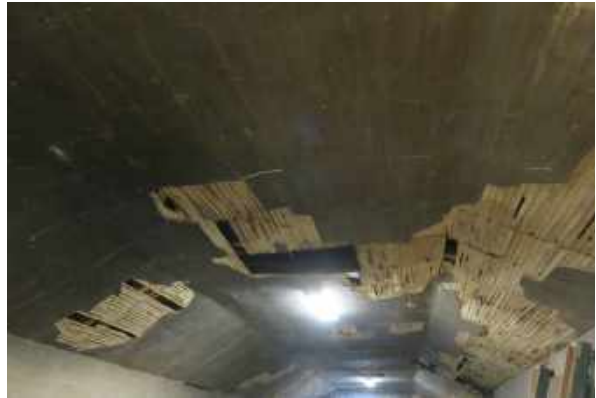
East Building. Plaster ceiling at the attic. Note staining and large areas of missing plaster and missing lath.

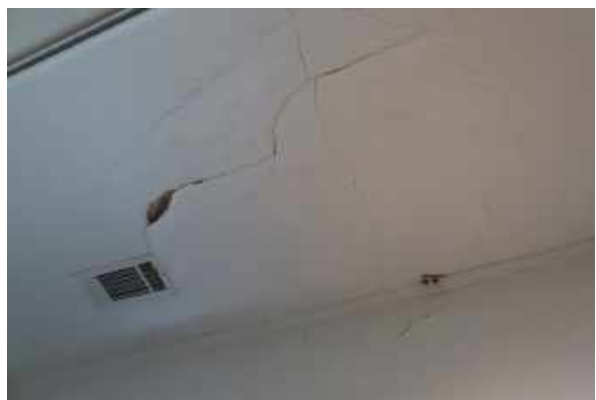
East Building. Water damaged ceiling and wall in southeast room at the second floor.

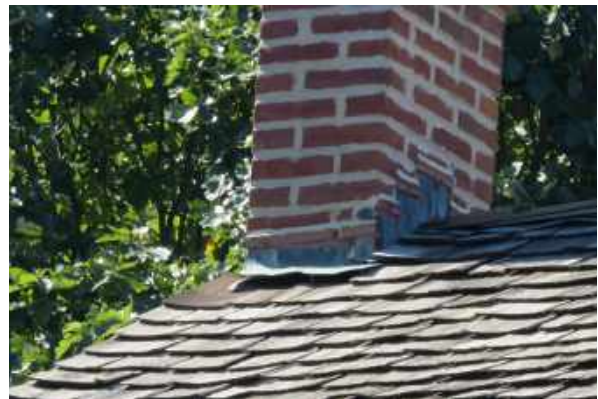
Lifting flashing at south chimney. Note the deteriorated sealant.

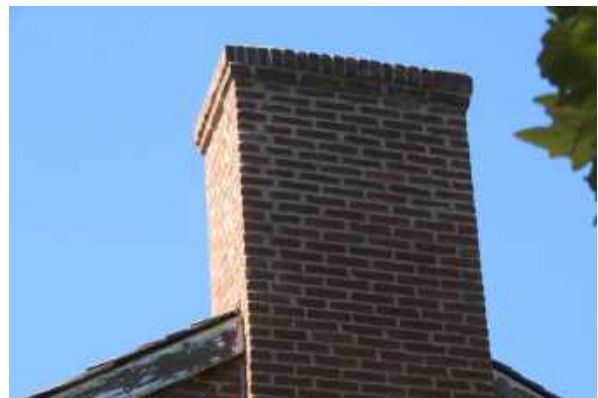
Open joints at east chimney. Note deteriorated paint at fascia panels.

- The crack in the masonry should be repaired and the brick should be repointed. A mortar analysis should be completed to identify the original mortar. A new repointing mix should match the original in color and should be compatible with the historic masonry.

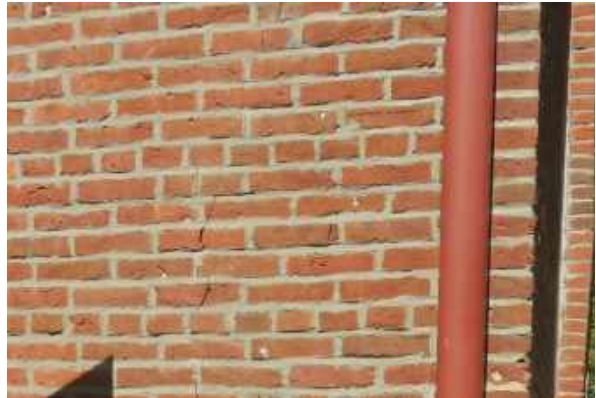
Masonry crack at southeast corner.

- The foundation and masonry should be inspected annually for open joints.
- The cracked corner of the original structure should be repaired and monitored for future cracking, which may indicate a structural issue.

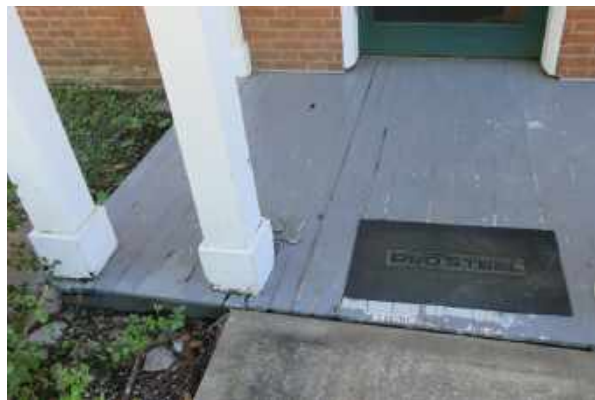
Paint and wood deterioration at north porch. Note the open seams in the column bases. These conditions are typical of both porches.

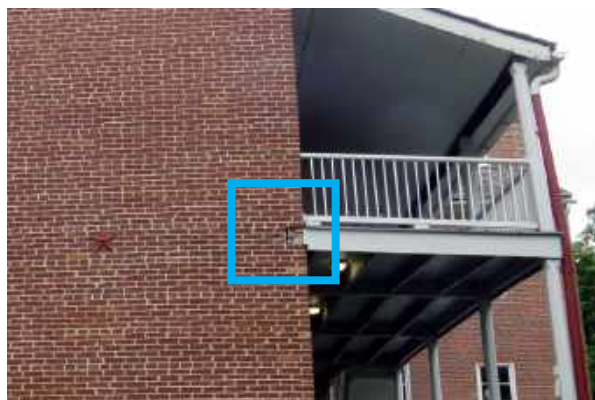
Exposed joist pocket, outlined in blue.

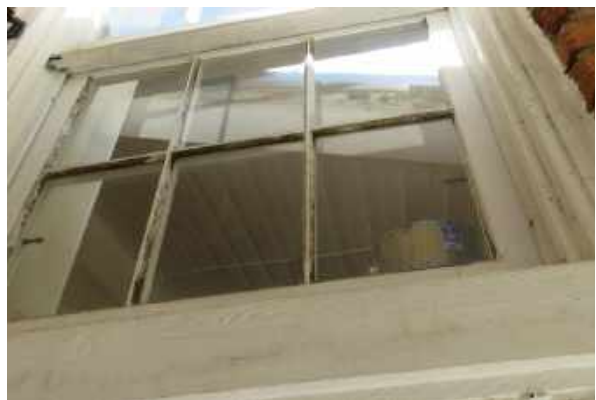
Deteriorated paint and glazing material at a window on the south elevation.

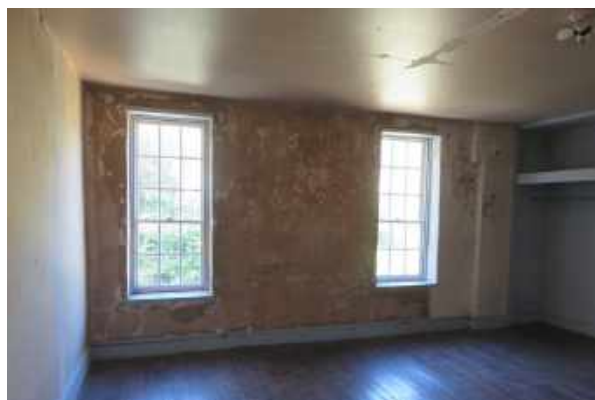
Plaster wall at second floor room in the rear addition. Note the ceiling damage and unfinished drywall on the left.

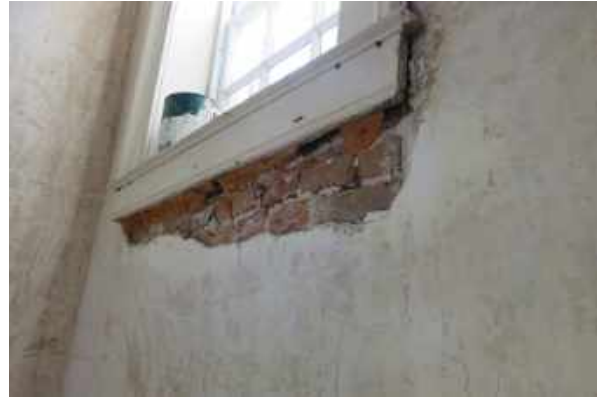
Plaster damage and exposed masonry below stairwell window.

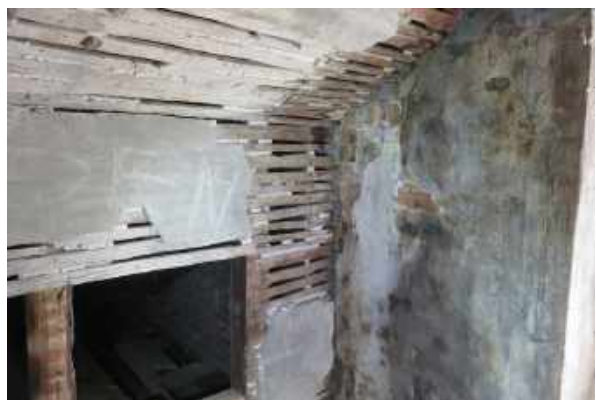
Plaster and lath in the attic at the south end. Note the graffiti scratched into the plaster on the left.

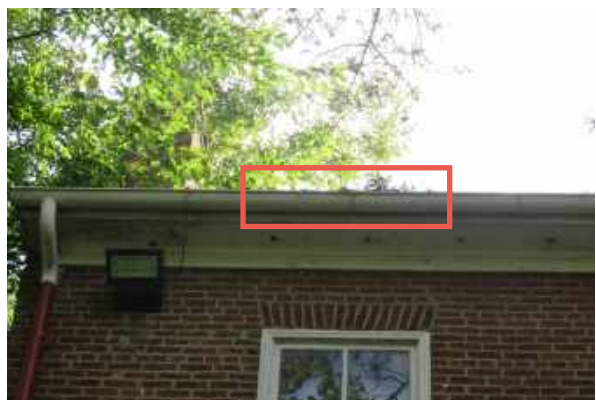
Pine needle and plant buildup in gutter visible from ground level, outlined in red.

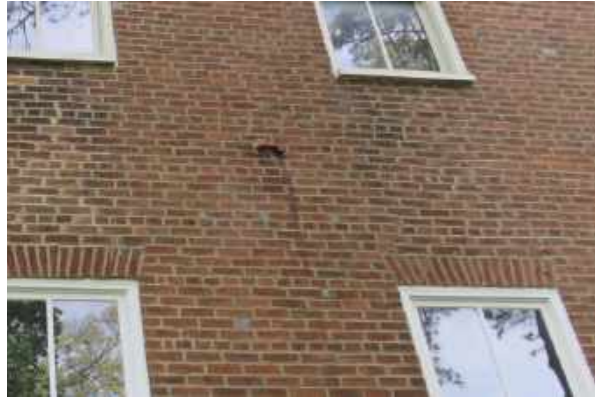
Pipe at the north end of the west elevation leaking an unknown substance down the brick.

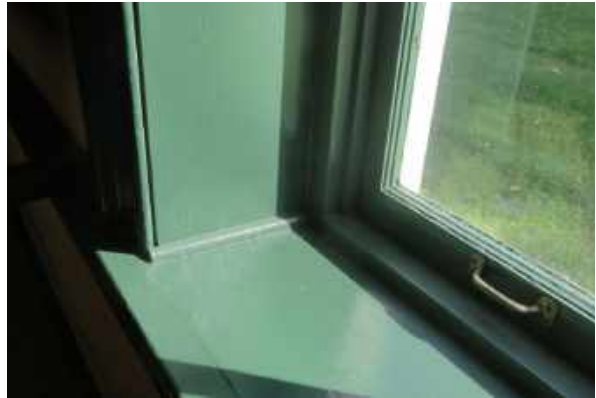
Windows on the first floor did not open and appear to be painted shut. It is unclear if this was intentional or due to high temps and humidity during the site visit.

- Monitor windows at the interior after high wind or rain events for leaks.
- Survey the windows annually for signs of glazing, sealant, and paint deterioration. Depending on exposure, some windows may require intervention sooner than others.

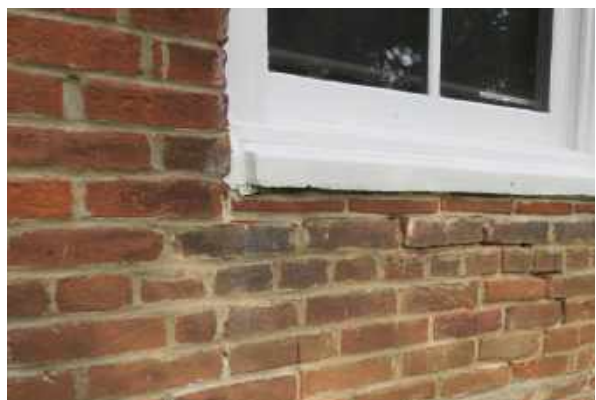
Sealant at window frame.

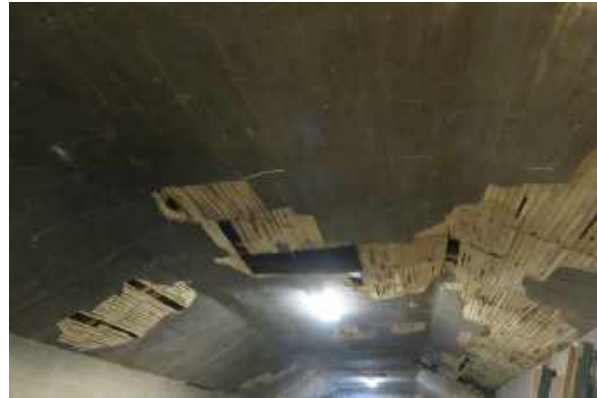
- The attic is in very poor condition. The floor is uneven and there are large sections of damaged and missing plaster. The attic is not currently interpreted by the museum,

Plaster ceiling at the attic. Note staining and large areas of missing plaster and missing lath.

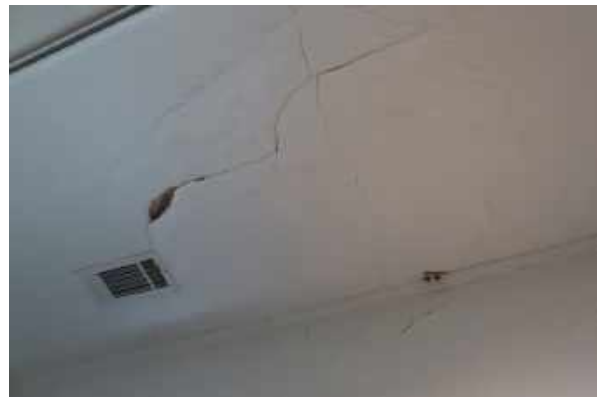
Water damaged ceiling and wall in southeast room.

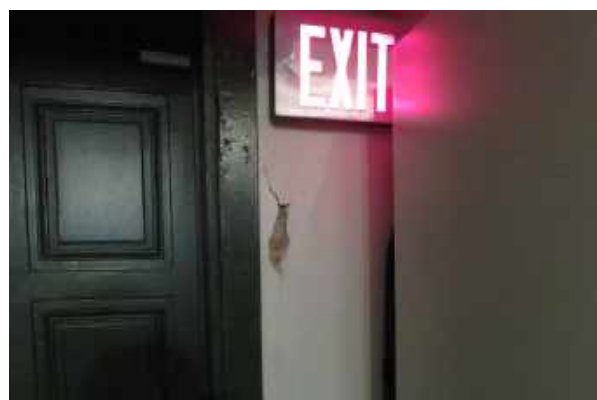
Plaster cracking at northwest door. The masonry is exposed in this area, and multiple previous finishes are visible.

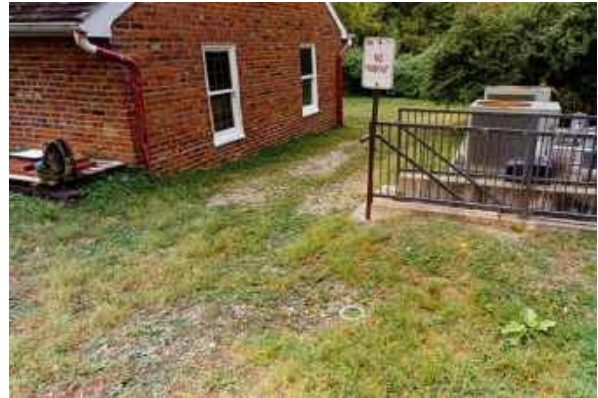
Area with thin gravel cover. Piping from the downspout in this corner can be seen through gravel in some areas.

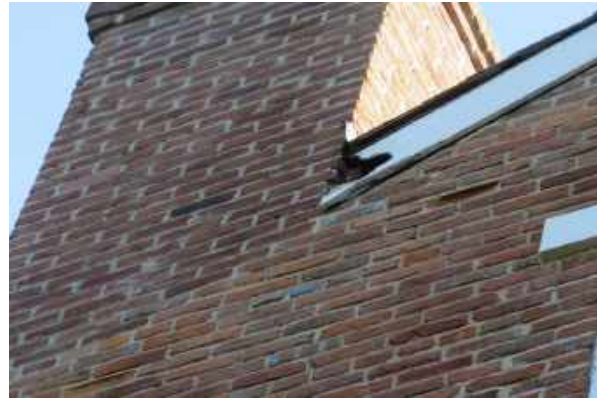
Hole in fascia panel on west elevation.

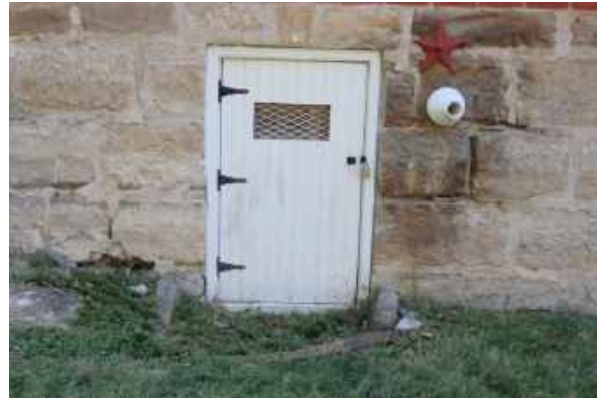
Open joint around cellar door.

- The foundation should be repointed. A mortar analysis should be completed to identify the original mortar. A new repointing mix should match the original in color and should be compatible with the historic masonry.

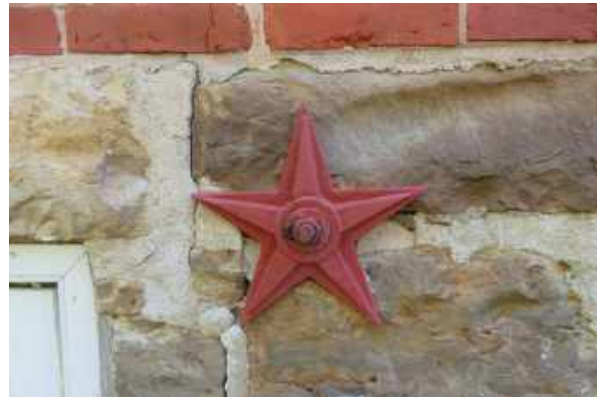
Paint deterioration and rust at building tie.

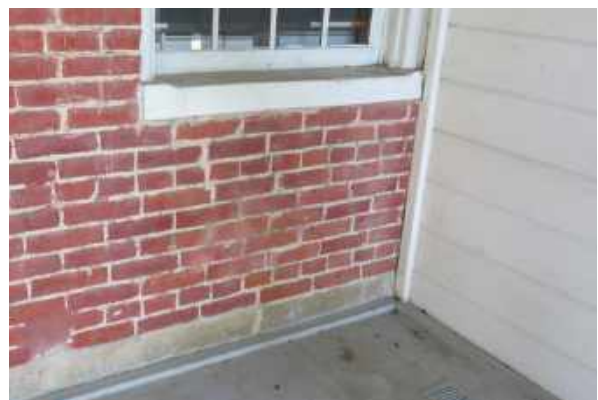
Open joints below window at the porch.

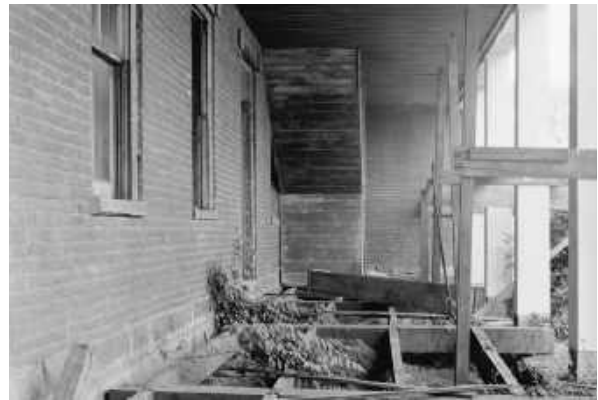
1940s HABS photo showing missing porch floor at the first floor. Note that the staircases is still intact and may be original.

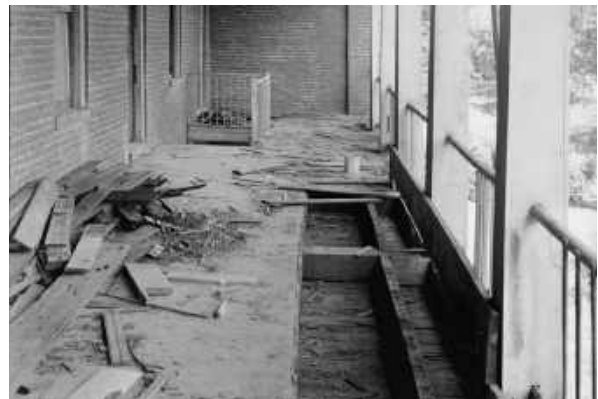
1940s HABS photo showing missing porch floor at the second floor.

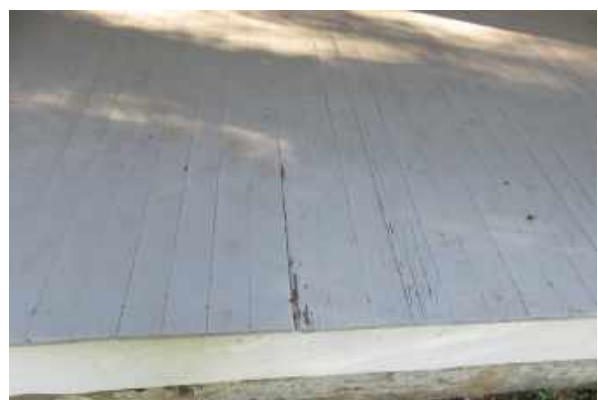
Damage and deterioration at tongue and groove floor at the first floor.

- The porch floors should be inspected annually for paint deterioration. As paint is the first line of defense for wood, areas of bubbling, cracking, or peeling should be removed and repainted.
- Depending on the amount of foot traffic it may be necessary to repaint areas of the floors every 2-3 years.
- Areas of standing water should be cleared with a broom after rains.
- Wood trim elements should fit snugly together to minimize gaps and seams.

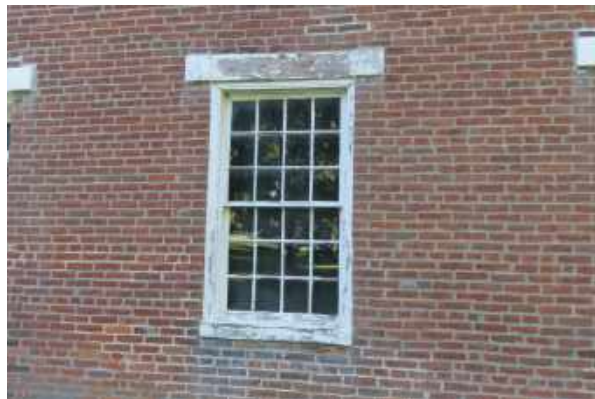
Window with heavy paint and glazing putty deterioration. This window does not appear to have been included in the 2016 scope.

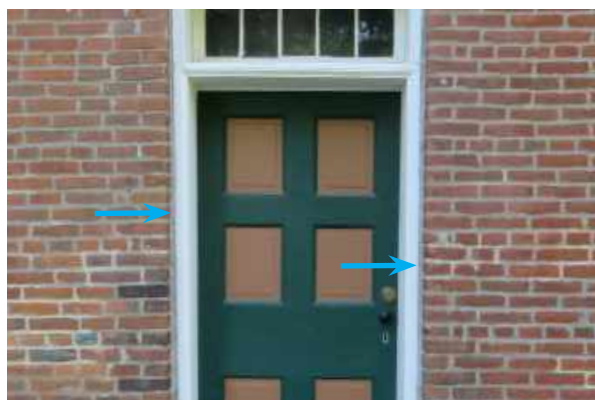
Unpainted grey sealant added at the door surround.

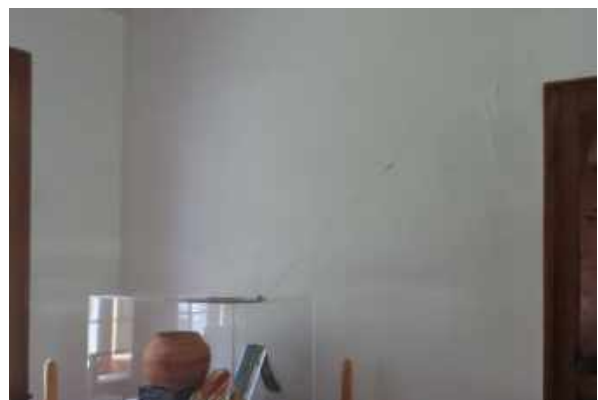
Plaster cracks in the exhibit room to the west of the main entry room.

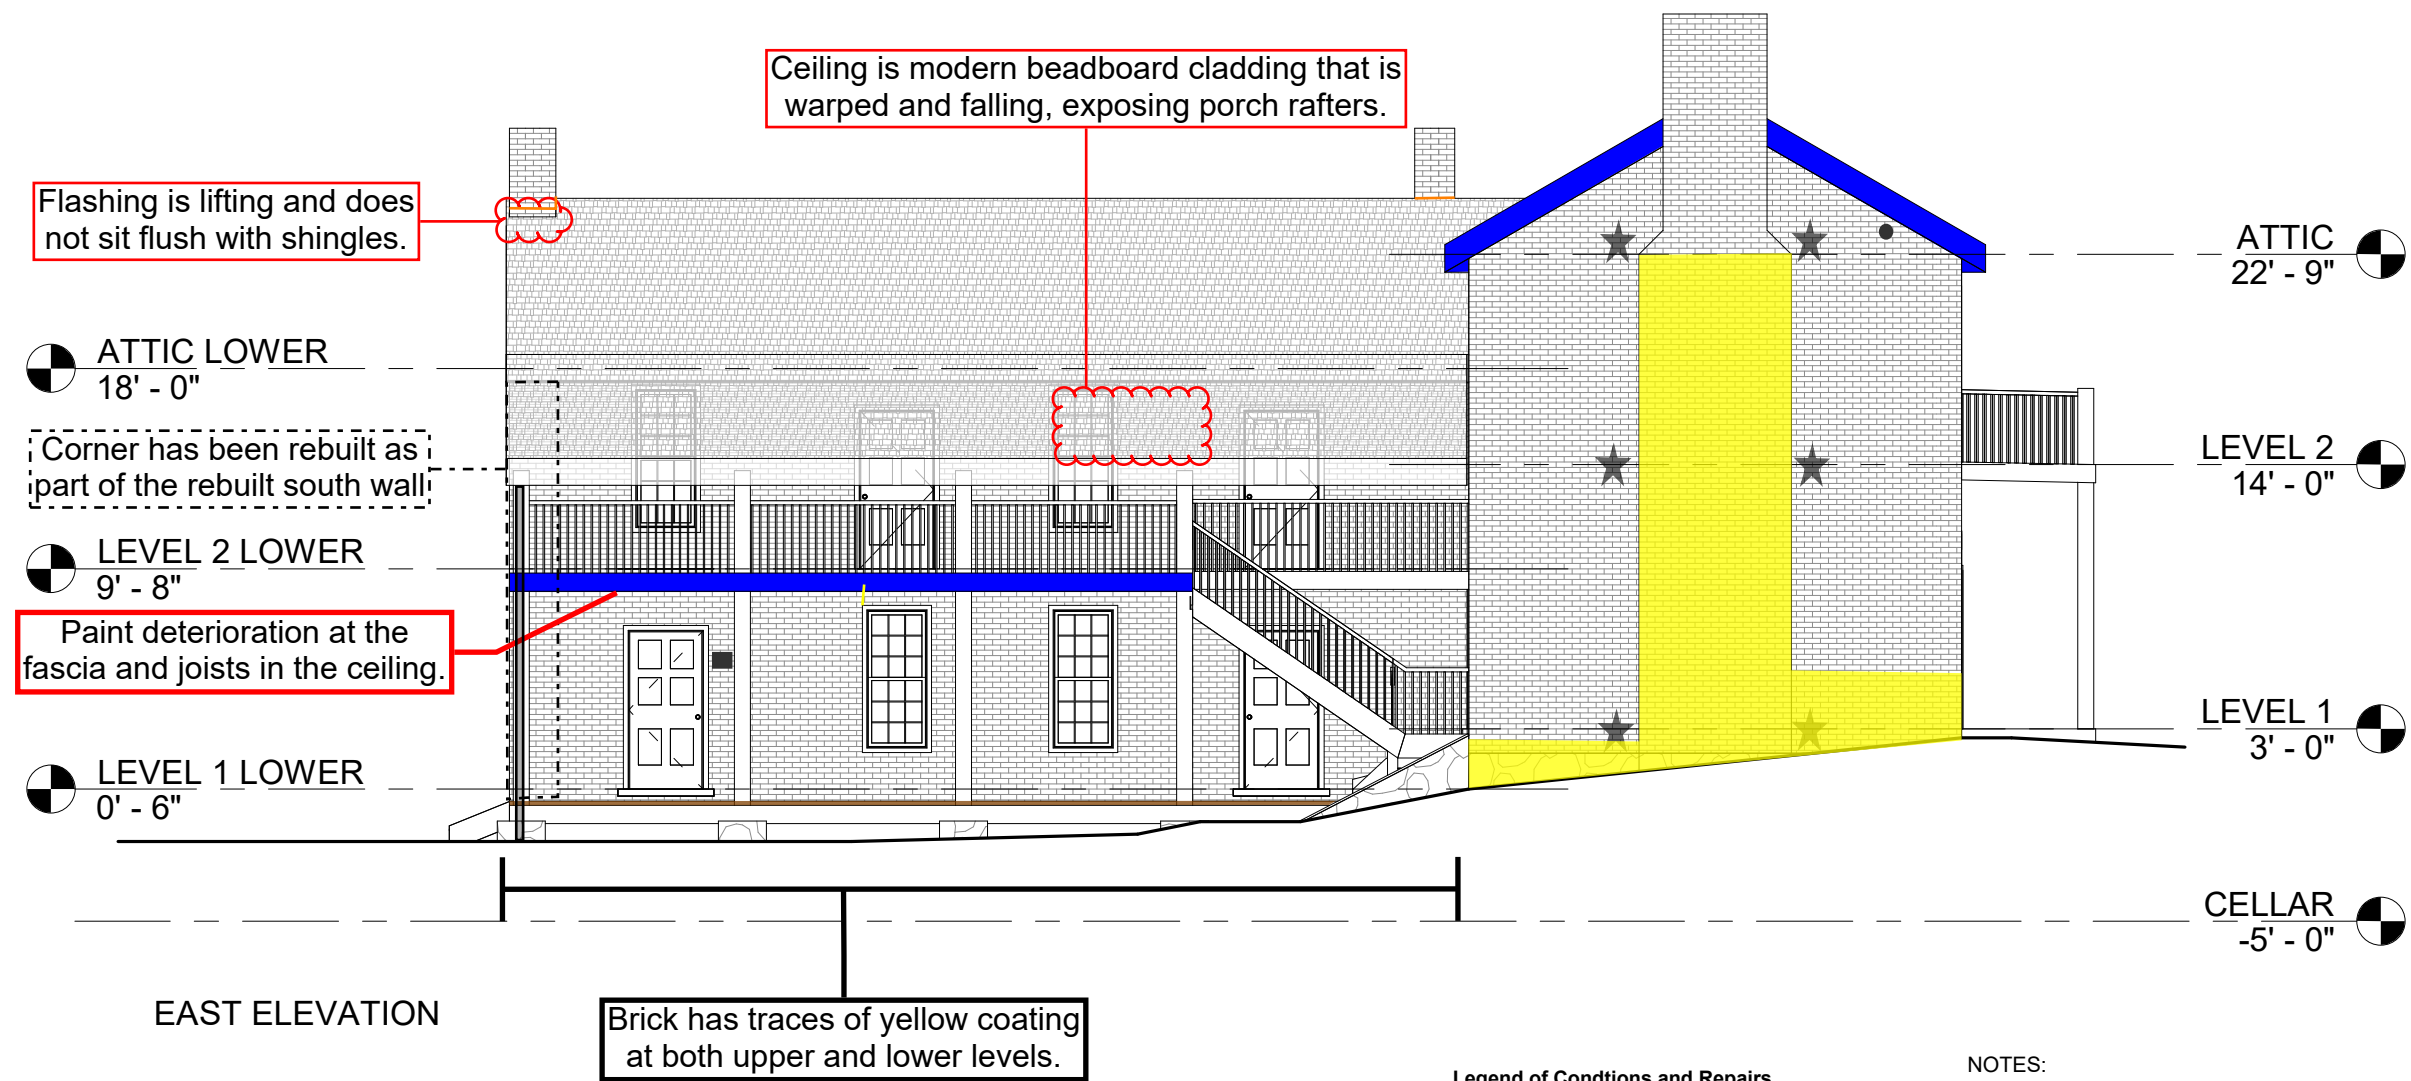
NOTES:
--Paint on soffit is very deteriorated.
--Foundation is rough-hewn rectangular limestone.
--Open joints in the limestone foundation vary and can be very large in size.
--There are multiple areas of brick infill that vary in size from single bricks to larger sections of walls and corners. The brick is a fair match for the existing brick, that is slightly darker in color and with more color variation than the original.
--Wood and paint deterioration at edges of floorboards at the first level of the porch.
--General paint deterioration and wear on porch floor.
--Second floor porch plate is rough hewn timber. The rafters are concealed by modern bead board cladding.
--Mortar caps on chimneys are in poor condition and should be replaced during repointing.
--Porch roof has isolated areas of lifting shingles

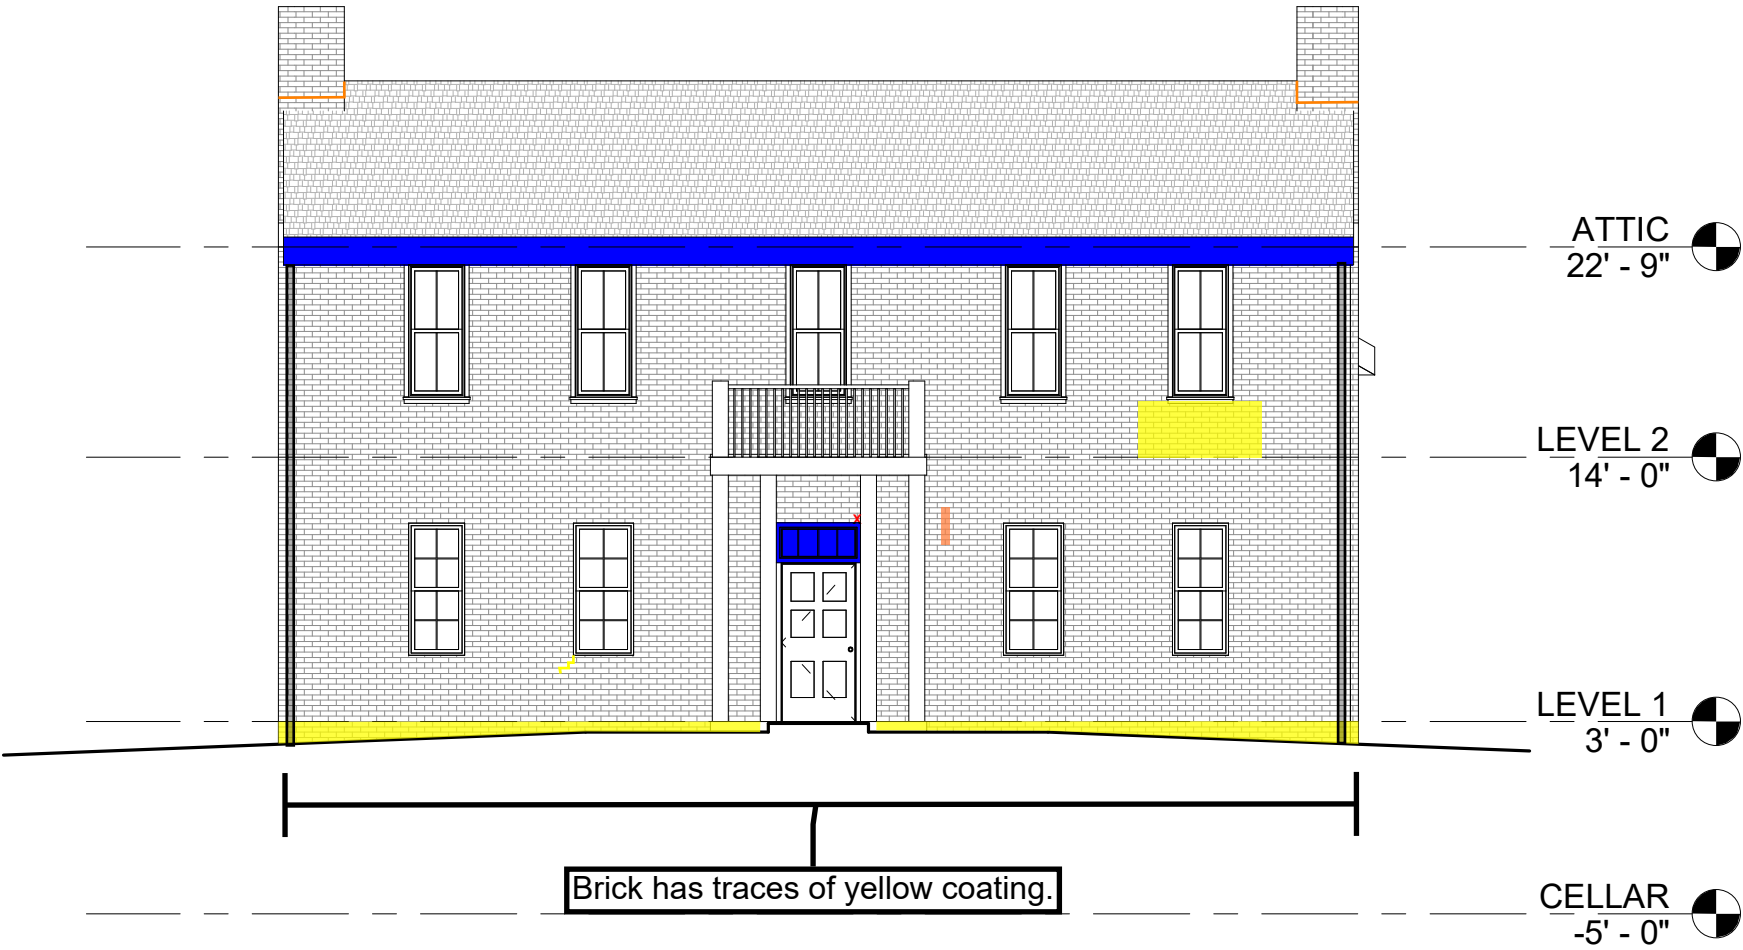
NORTH ELEVATION

- There are multiple areas of brick infill that vary in size from single bricks to larger sections of walls and corners. The brick is a fair match for the existing brick, that is slightly darker in color and with more color variation than the original.
- Wood and paint deterioration at porch, especially at floor and column bases.
- The brick bond on this portion of the building is not consistent with the rear addition or with the other buildings at the site.
- Sealant around windows and doors appears to be in serviceable condition, date of previous repair or replacement is unknown.
- The roof shingles shows early signs of curling but is overall in good to fair condition. Sealant at chimney flashing shows signs of cracking and should be replaced.
- Mortar caps on chimneys are in poor condition and should be replaced during repointing.

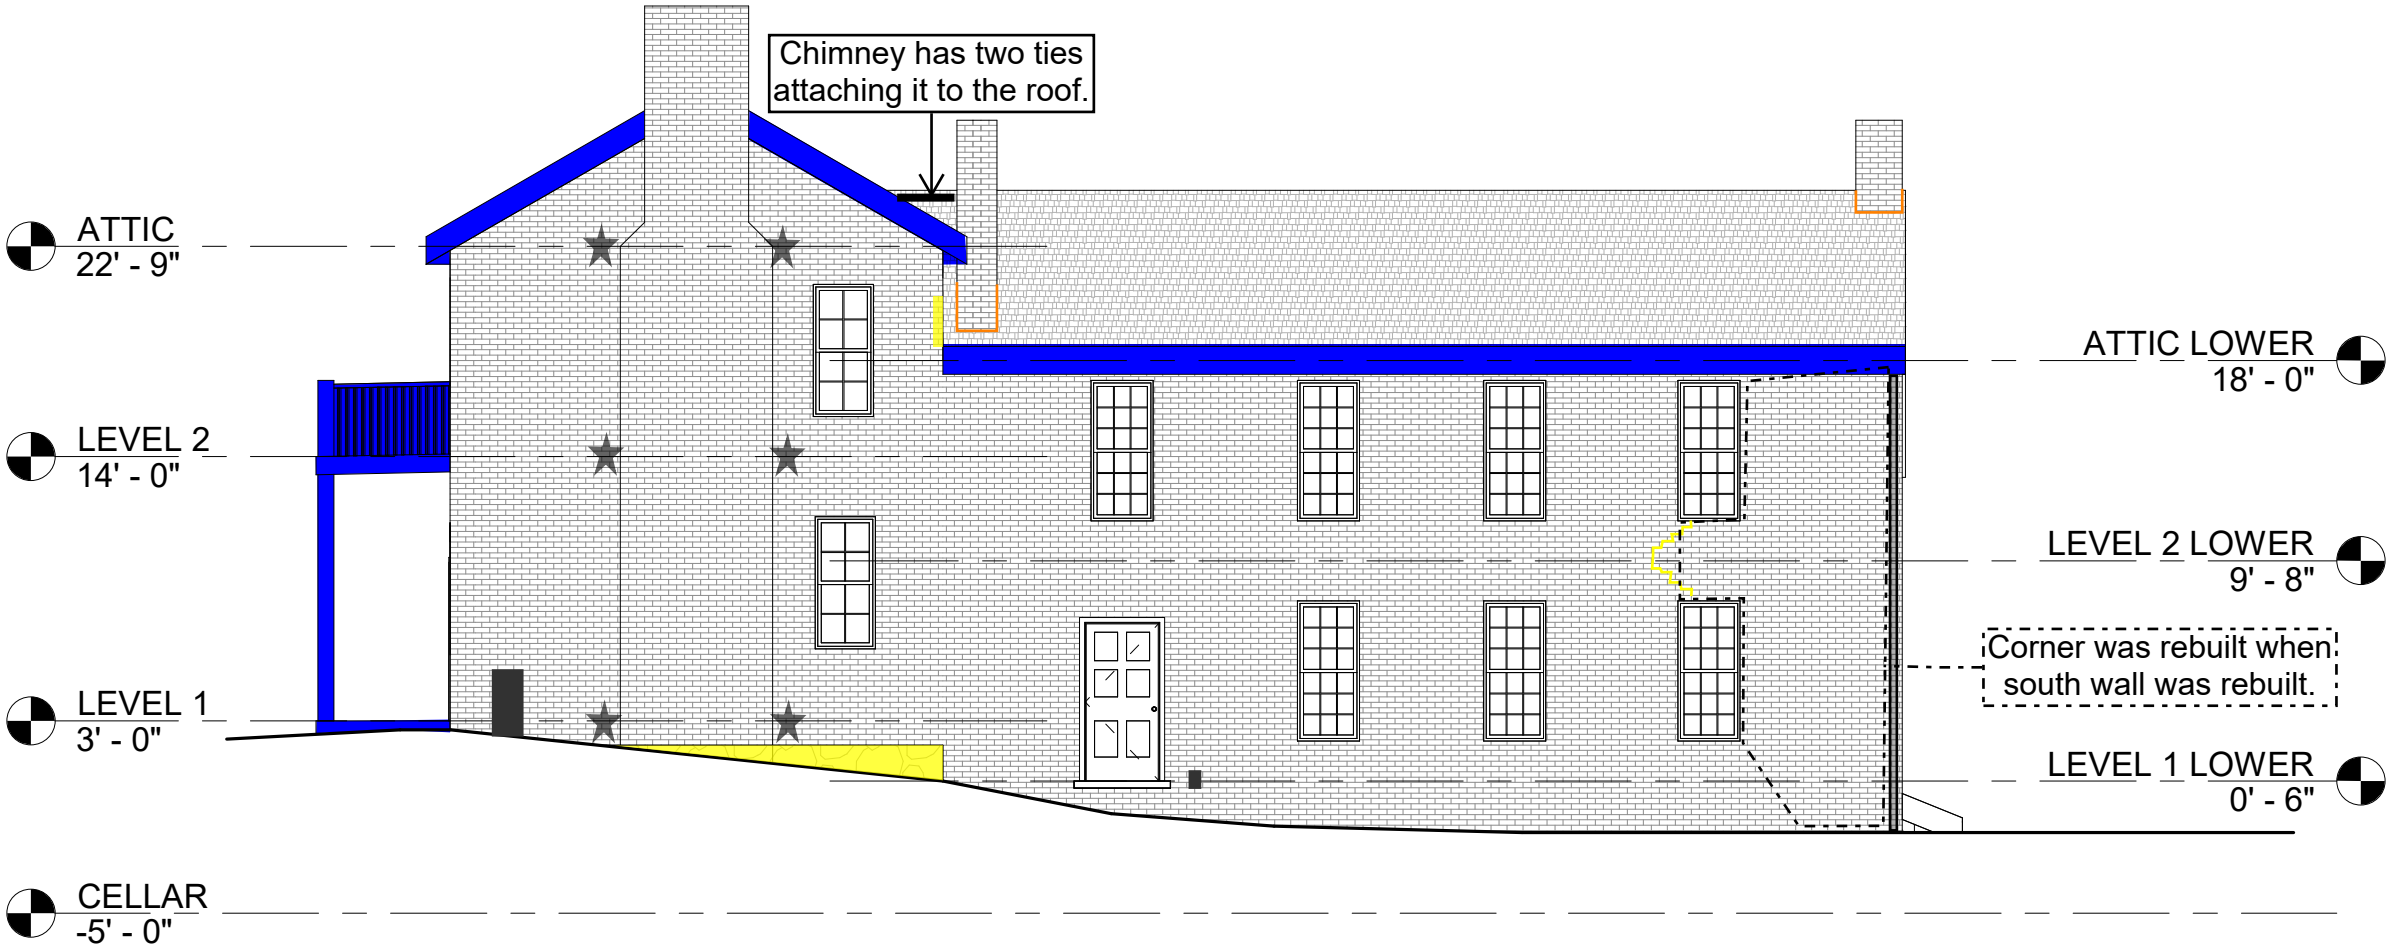
WEST ELEVATION

- Paint on soffit is very deteriorated.
- There are multiple areas of brick infill that vary in size from single bricks to larger sections of walls and corners. The brick is a fair match for the existing brick, that is slightly darker in color and with more color variation than the original.
- Sealant around windows and doors appears to be in serviceable condition, date of previous repair or replacement is unknown.
- The roof shingles shows early signs of curling but is overall in good to fair condition. Sealant at chimney flashing shows signs of cracking and should be replaced.
- Wood and paint deterioration at edges of floorboards at the first level of the porch.
- General paint deterioration and wear on porch floor.
- Open joints in the limestone foundation vary and can be very large in size.
- Mortar caps on chimneys are in poor condition and should be replaced during repointing.

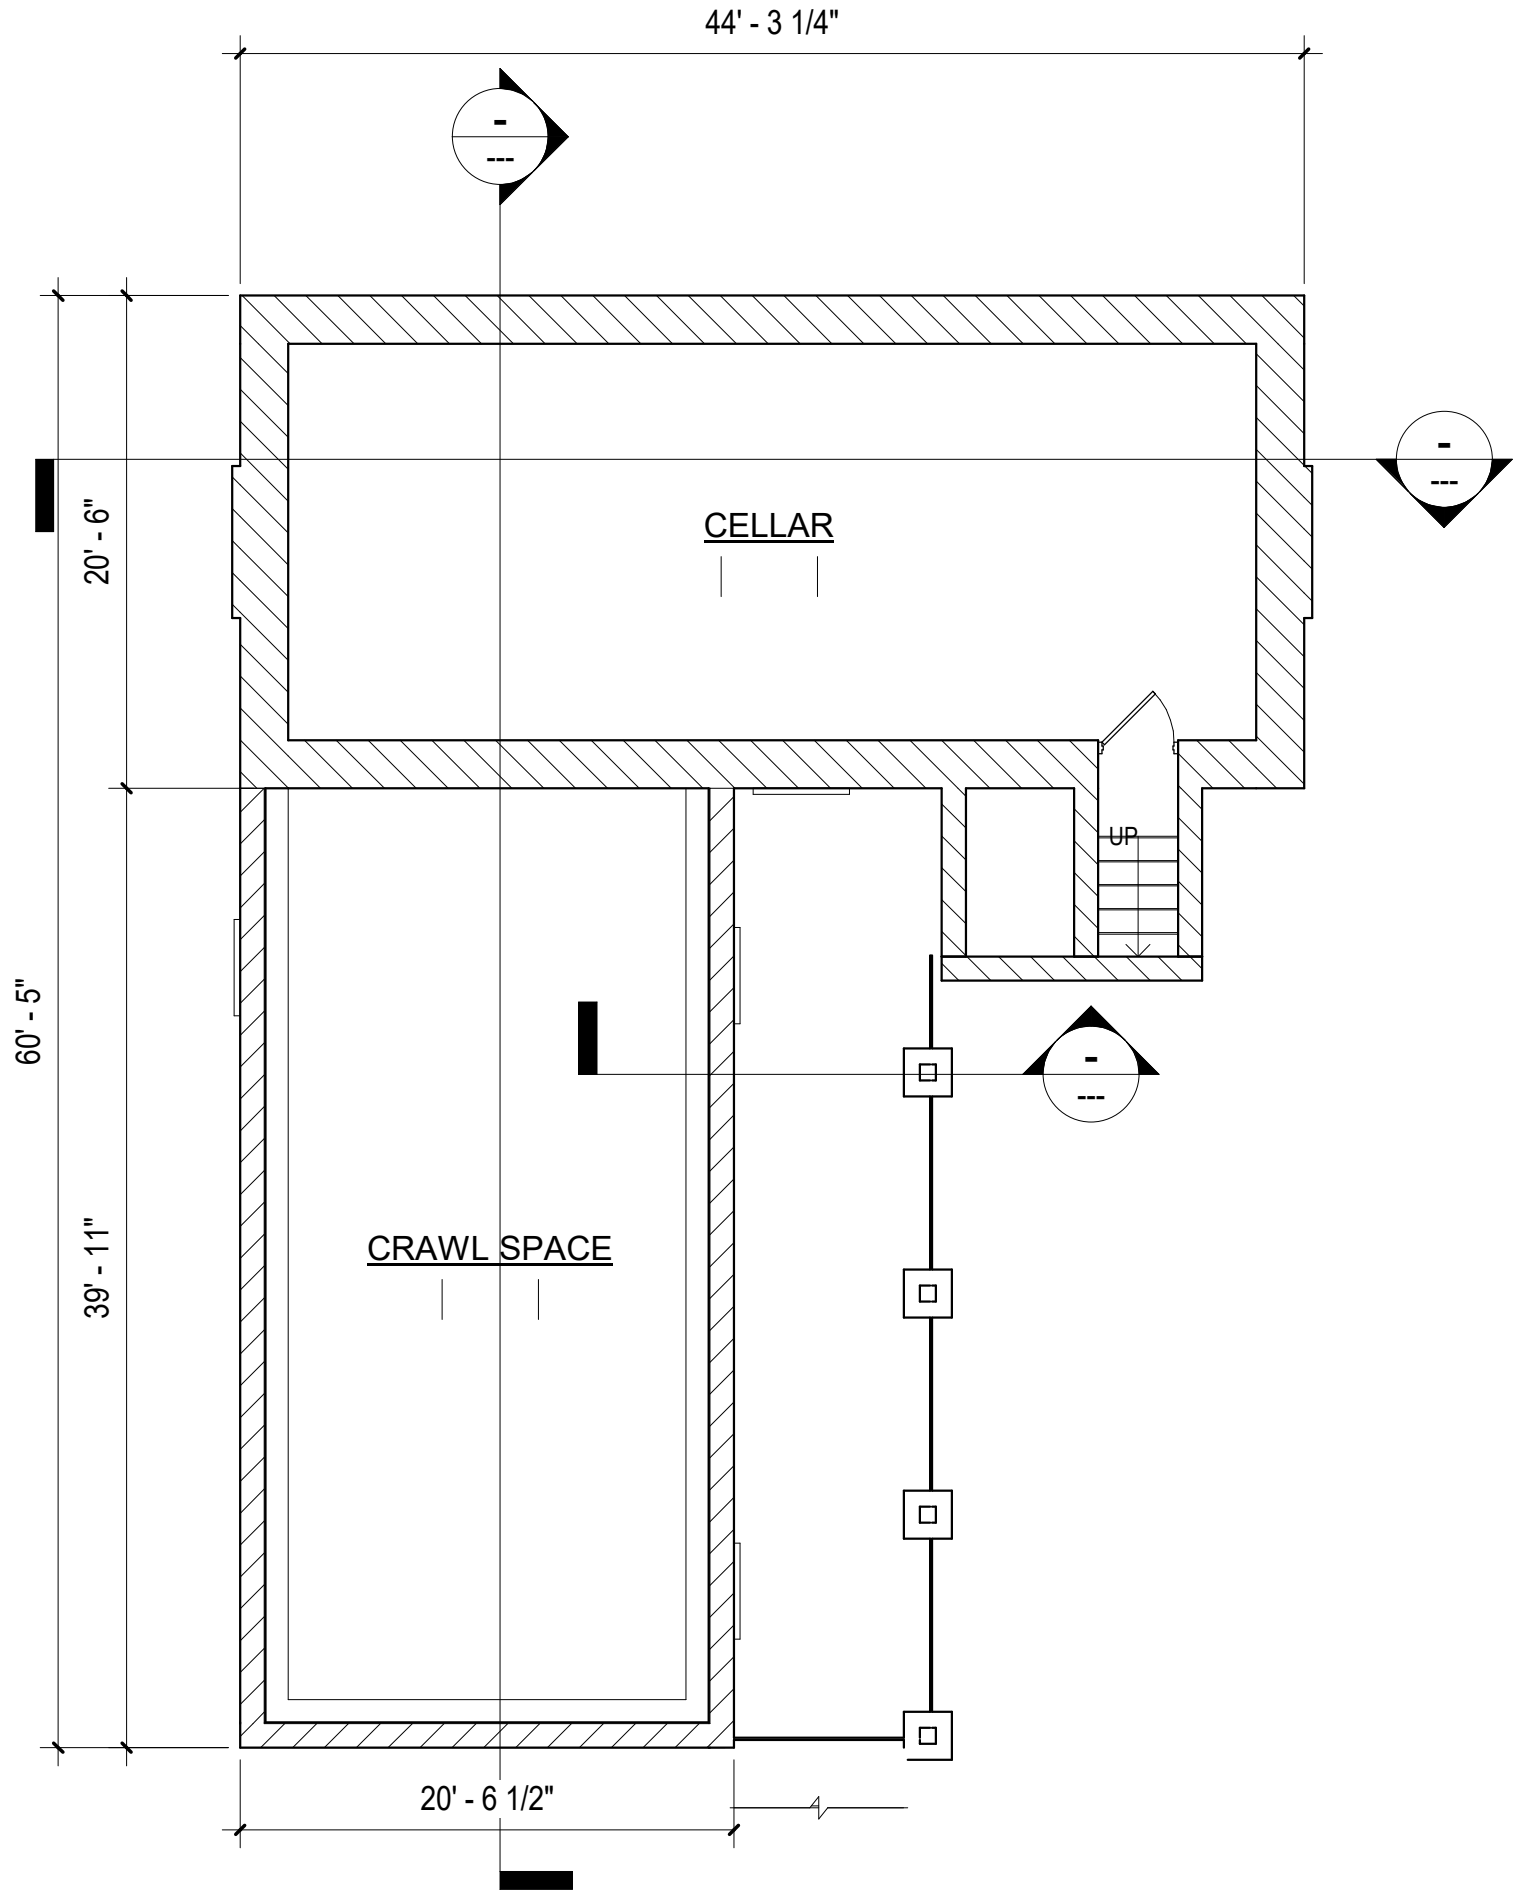
CELLAR FLOOR PLAN

NOTES:
--Cellar has concrete floor and fieldstone partitions at interior.
--At the time of the survey the cellar was clean and not musty.
