Informational Summary Report of Serious or Near Serious CAL FIRE Injuries, Illnesses and Accidents

GREEN SHEET

Firefighter Injuries

Bear Fire

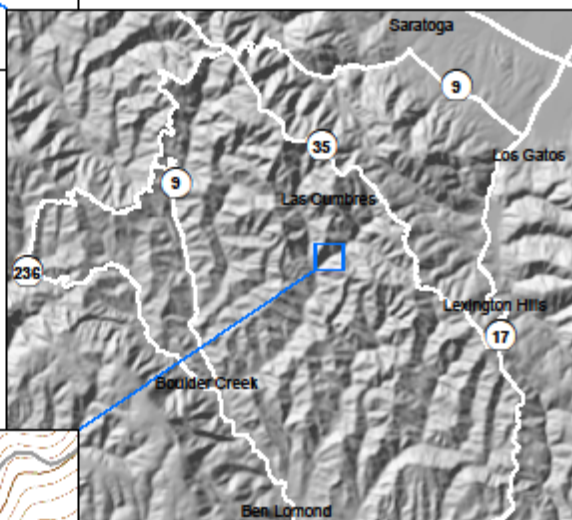
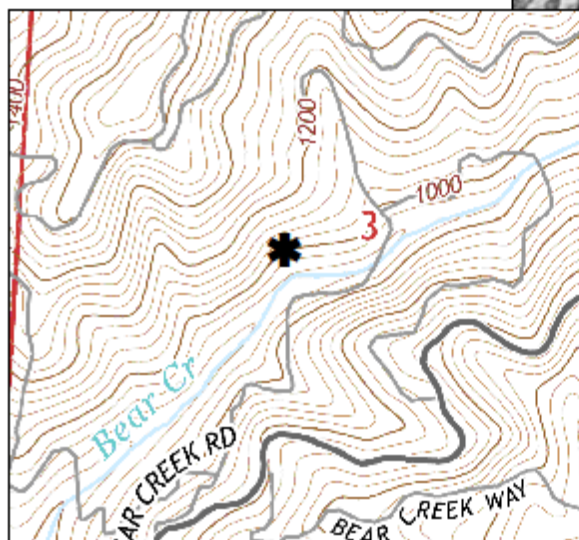
Bear Fire - 17CACZU007822
After Accident Review
Scene Diagram

Accident Location
