FLORIDA FISH AND WILDLIFE CONSERVATION COMMISSION  
DIVISION OF LAW ENFORCEMENT  
INCIDENT NUMBER FWSB-16-OFF-12502

CASE SUMMARY / INCIDENT REPORT

REPORT #: FWSB-16-OFF-12052

On Sunday, September 25, 2016, at 0302 hours, a vessel allision occurred involving one vessel that crashed and flipped upside-down on the north side of the Miami Government Cut north jetty. The vessel was a 32 foot SeaVee center console with three individuals on board. The vessel, V-1 had been traveling southwest from the Atlantic Ocean and allided into the north jetty as it attempted to enter Government Cut Channel at a very high rate of speed. All occupants were ejected from V-1 and died as a result of their injuries. Autopsies completed by Miami-Dade Medical Examiner's Office on September 25th determined blunt force trauma and drowning were the causes of death for all three occupants. A toxicology report determined alcohol and drugs were a factor in this case.

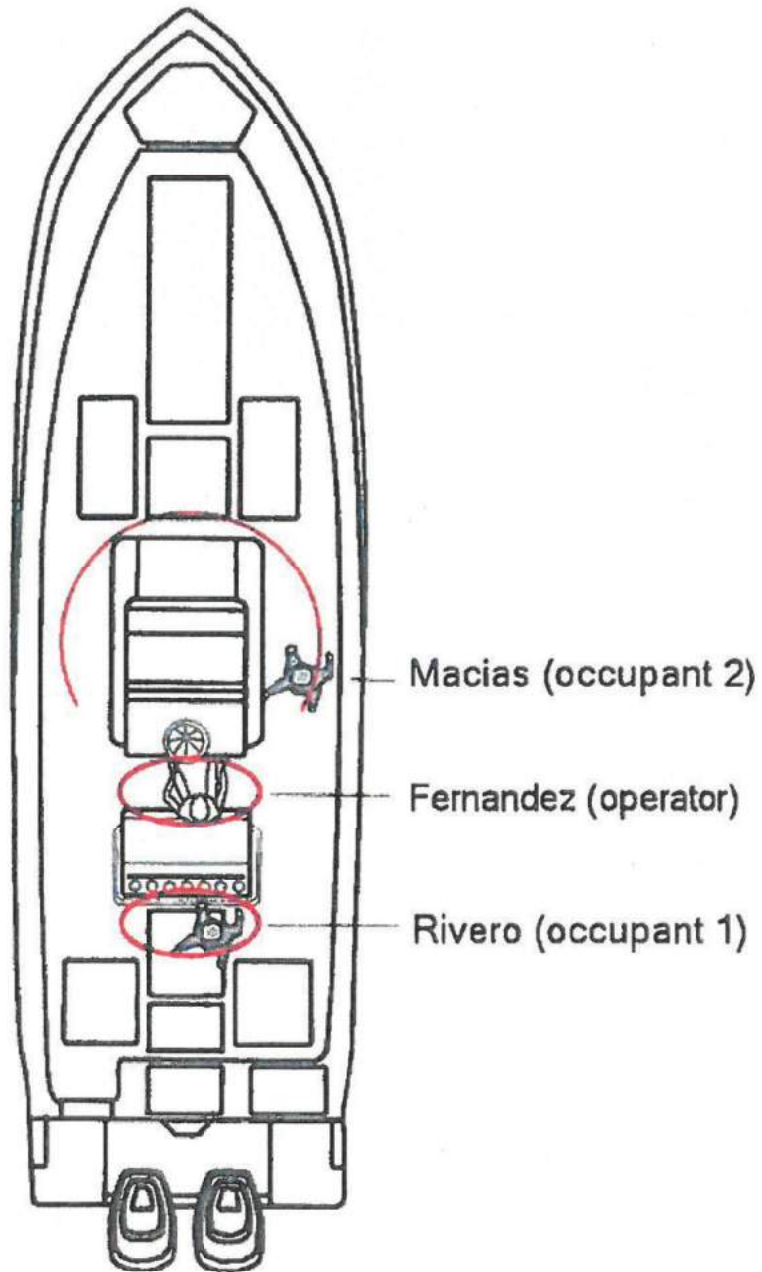
V-1 Seating Diagram:

\*The probable seating location of occupants was based on physical evidence collected during this investigation.

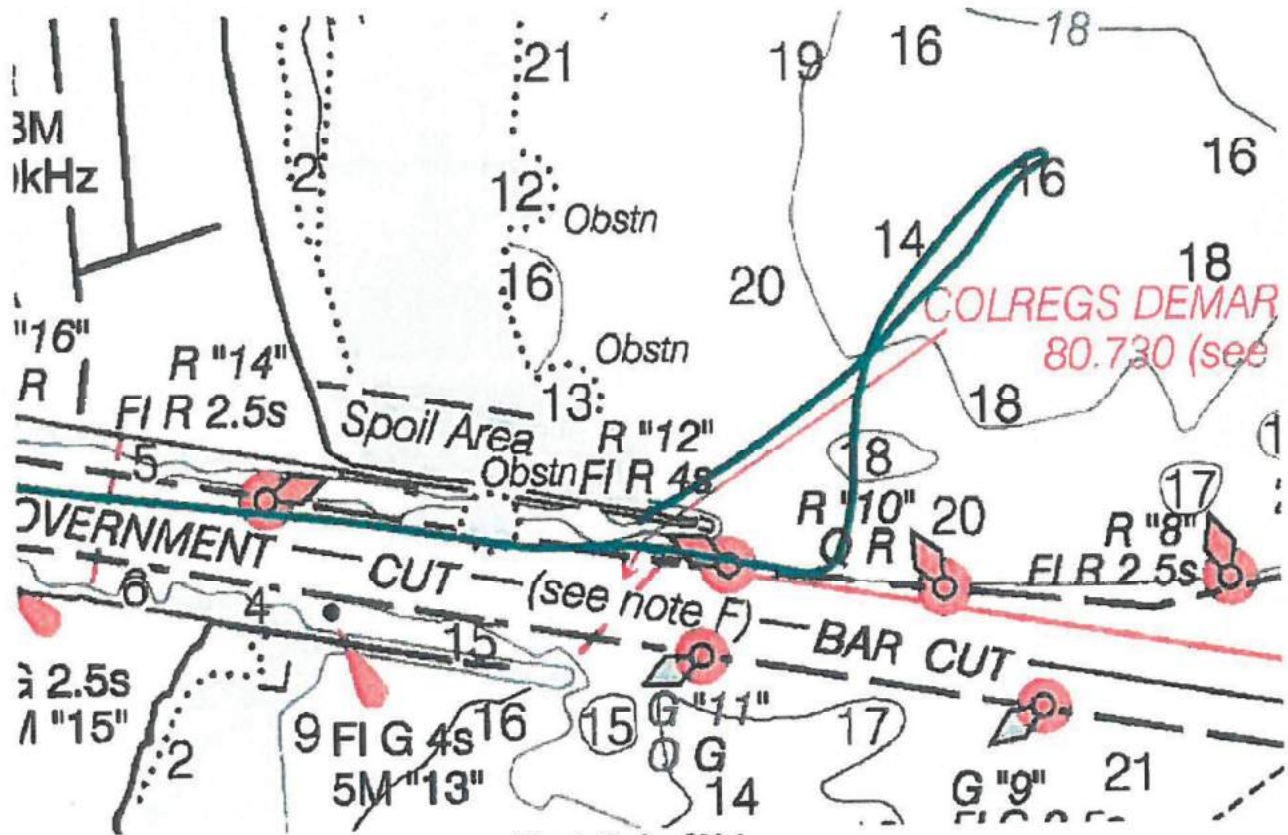
At 0302 hours, V-1 allided with the north side of the north jetty at 65.7 mph; V-1 was stopped almost instantly. As V-1's port bow (left front) struck the initial impact boulder, V-1 began to elevate at the bow. This upward motion caused damage to the starboard bow (right front) as it struck another boulder on the jetty. As the initial impact boulder deeply penetrated the hull, it stopped the port (left) sides forward motion at a much faster rate than its starboard (right) side. V-1's stern (rear) yawed immediately to the starboard (right) as the front left stopped. These dynamics resulted in V-1's starboard chine at midship to strike another boulder which caused its starboard yaw to stop abruptly. V-1's sideways and rolling motion ejected all on board. These crash dynamics caused V-1 to completely roll over and come to rest on its t-top on top of the jetty in a matter of seconds.

Fig. 1. Path of V-1

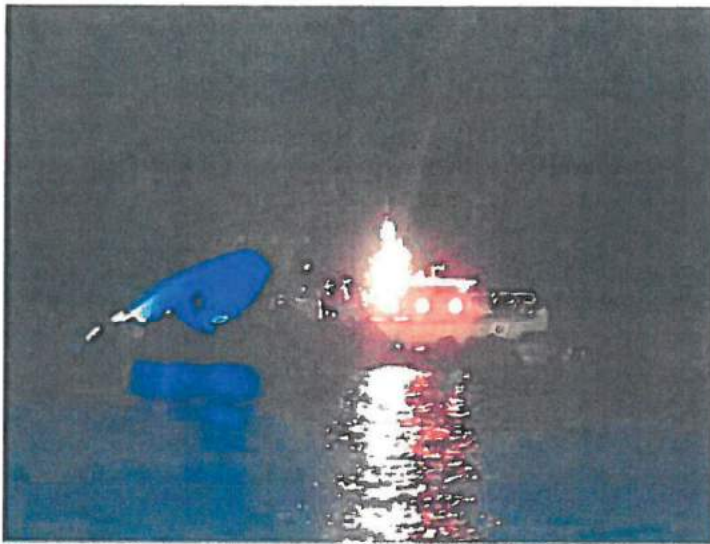
Fig. 2. V-1 view from south side of north jetty

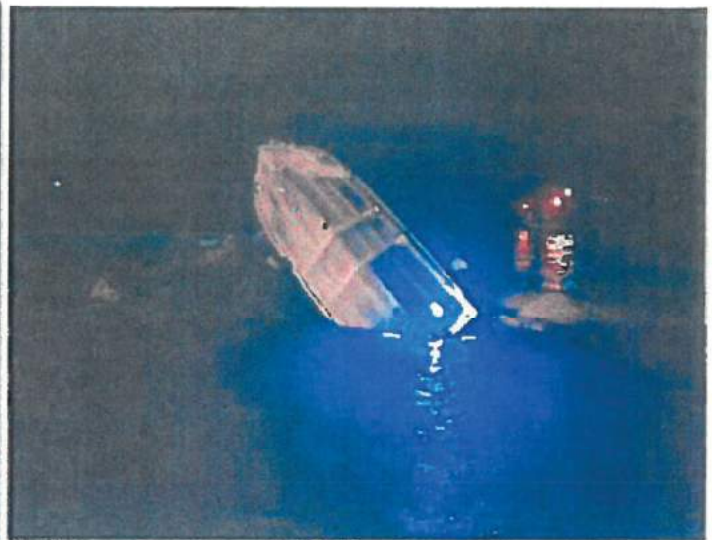
Fig. 3. V-1 view from the north side of north jetty

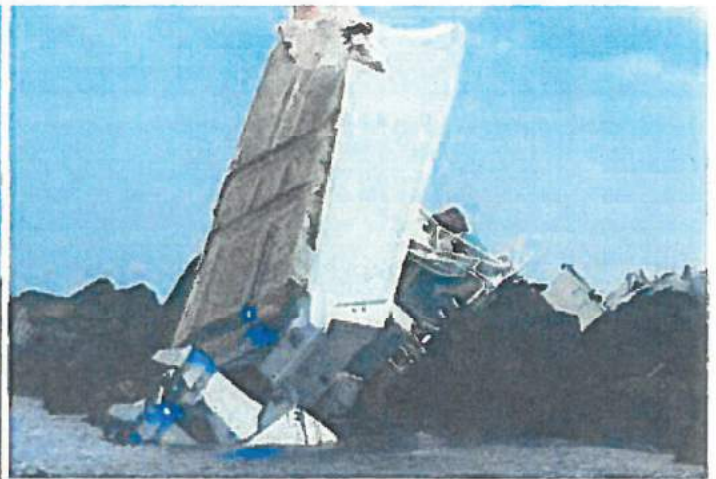
Fig. 5. V-1 blue transom lights illuminated.

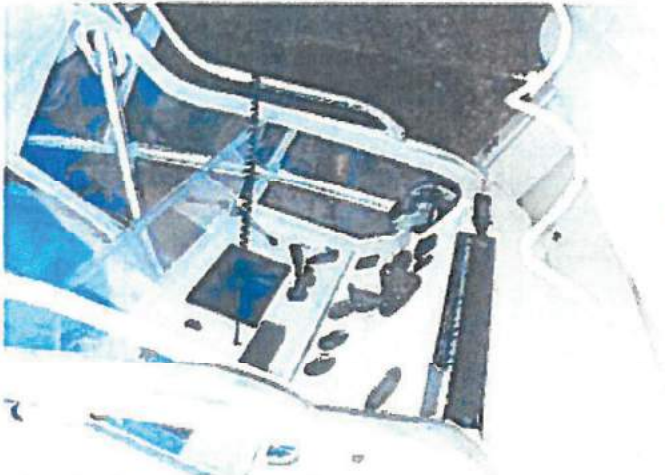
hull. At the helm of V-1, I observed the throttles to be in the forward, full throttle position, the steering column had been broken off and the steering wheel was missing, two of the gauges were gone and a portion of the Plexiglas above the switch panel was broken off and missing. The steering wheel had been placed on top of the T-top after it was located by the MDFRD boat #73 divers for evidence recovery. There was a white cooler and two light blue bean bags belonging to V-1 on top of the jetty, west of V-1. Inside this cooler I located Eduardo Rivero's wallet, one gold chain, one set of keys and one black pair of pants.

Fig. 6. V-1 center console: missing steering wheel, broken lower switch panel, throttles in full Throttle forward position.

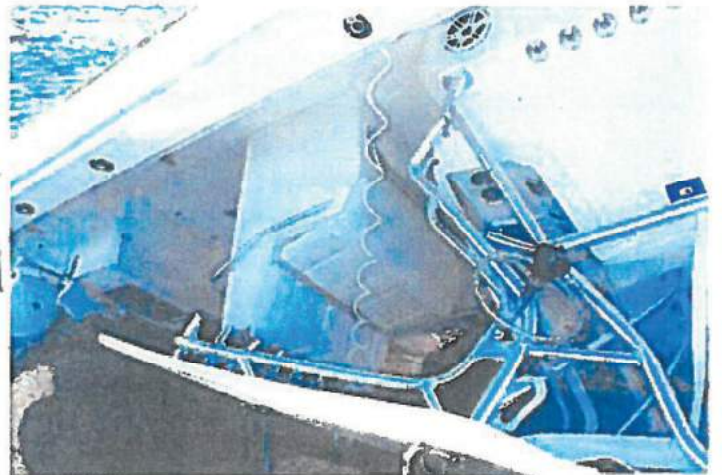
Fig. 7. V-1 upside down on jetty, steering wheel on t-top structure.

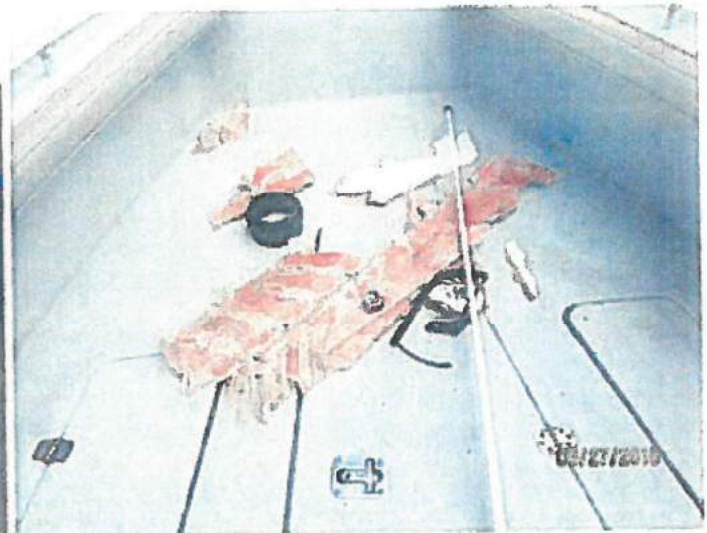
Fig. 13. Two recovered pieces of fiberglass.

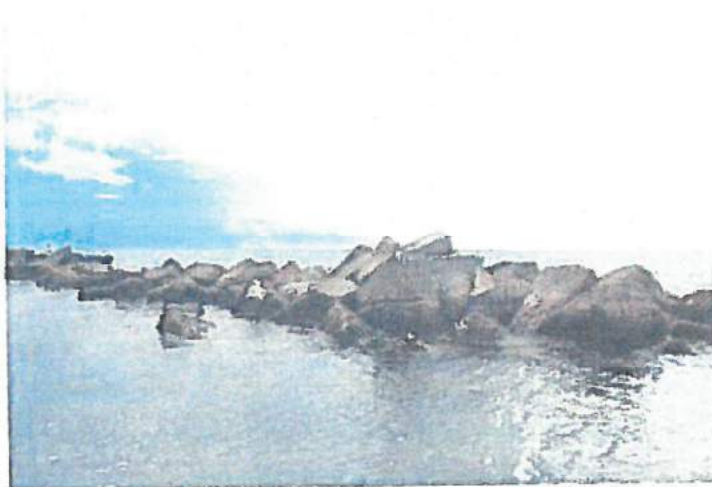
Fig. 14. Southeast view of damage left on jetty by V-1. Fig. 15. Southwest view of damage left on jetty by V-1.

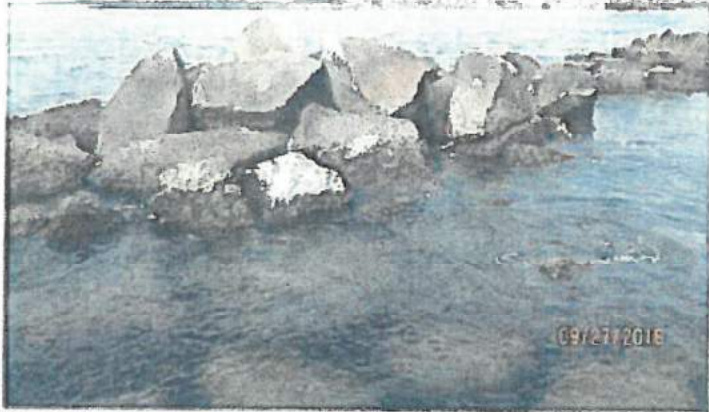
Ofc. Yanez and I dropped off Lt. Pomares on the north jetty. He took several pictures of the boulders and the damage the boulders sustained from the impact at the crash site. The force at which V-1 impacted the jetty's boulders caused them to shift and collide into each other. This was evident from the damage sustained on the edges of the boulders, where they moved and ground against each other.

Fig. 19. View from estimated angle of impact.  
Boulder with most white transfer is initial impact point.

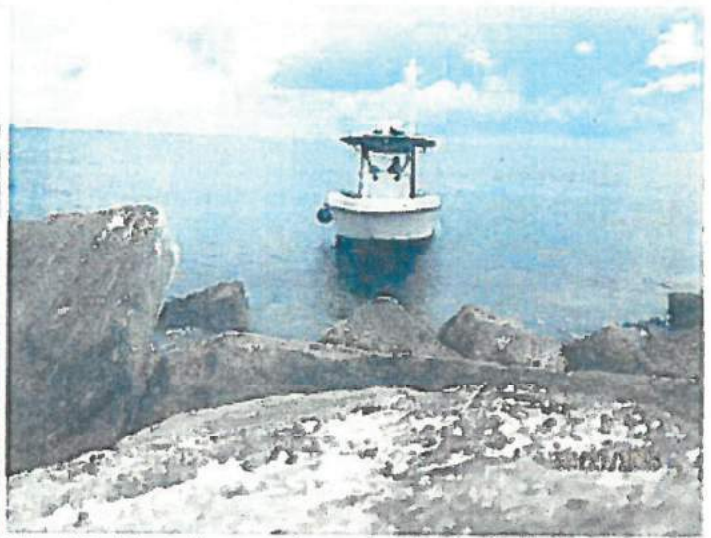
Fig. 20. View from estimated angle of impact

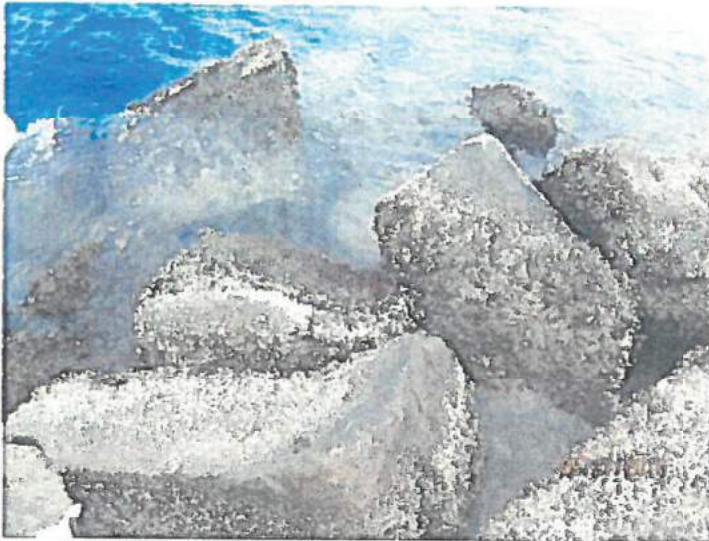
Fig. 21. View of back side of initial impact boulder.

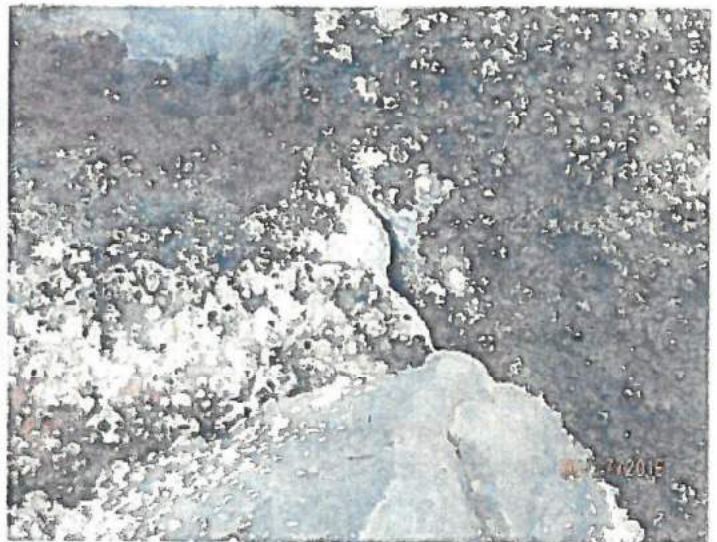
Fig. 22. Damage to west edge of impact boulder

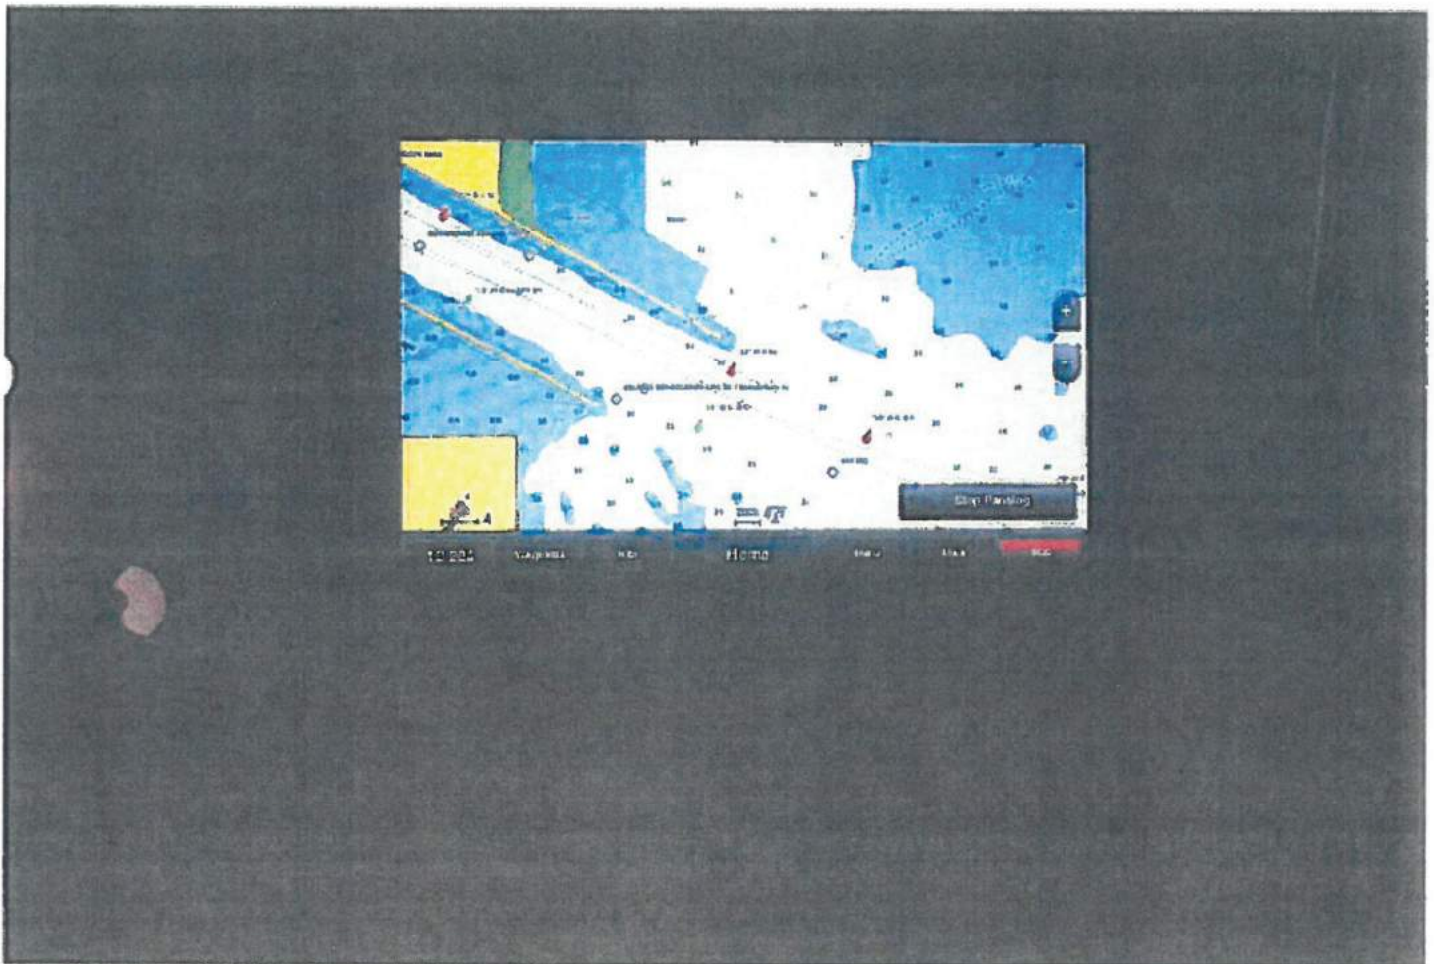
Fig. 23. V-1 GPS unit (right screen) showing the Government Cut jetty and track line from night of accident.

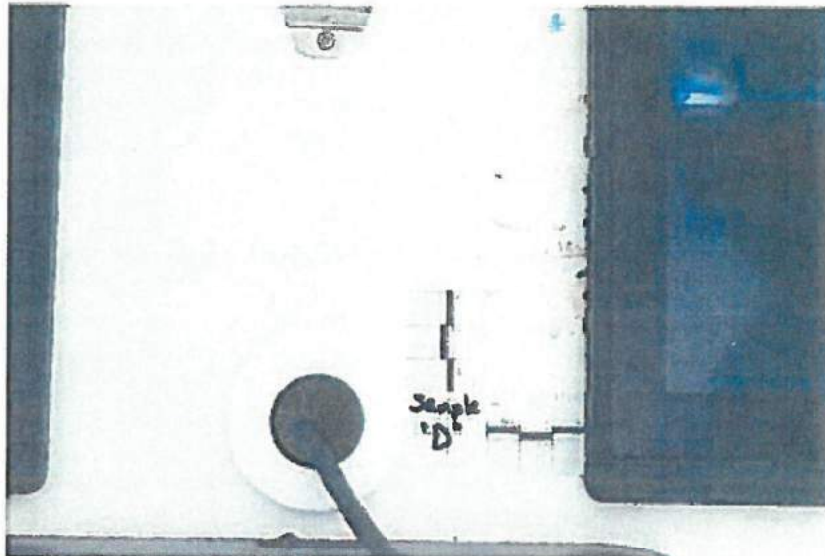
In the video, there are two MDFRD divers; Javier Perez and Jason Vanbuskirk. While Vanbuskirk is recording the video, Perez used a Halligan tool to pry at the starboard (right) Garmin GPS screen in an attempt to remove it from V-1. I later interviewed Perez who advised me their attempts to remove the GPS were in good faith as they hoped to preserve any evidence in the GPS for FWC in case the unit was damaged or later unretrievable.

Fig. 28. Damage cause by MDFRD Halligan tool.

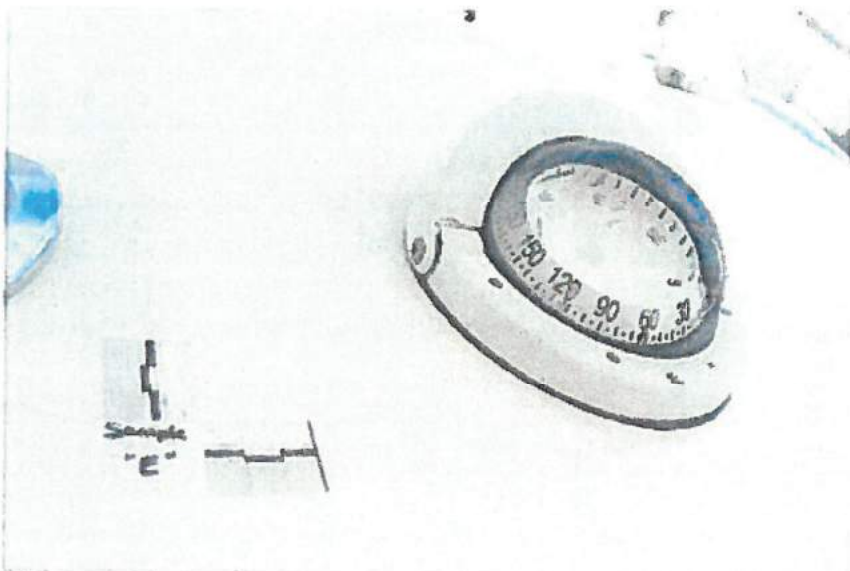
At 1308 hours, Lt. Pomares, Lt. Carcasses and I were conducting an inspection of V-1 within the FWC Miami compound. While inspecting the center console, Lt. Carcasses moved the lid of the compass from its resting forward position, completely to the rear. We observed four chips in the glass. One indentation seems to be filled with a white material. The compass is the mechanism of injury for Fernandez's extensive jaw damage I observed in the autopsy photos. Fernandez's blood, crime scene evidence sample "E", was also found adjacent to the compass.

Fig. 35. Chips on compass of center console.

While reviewing evidence in this case, including autopsy photographs, we noticed a circular wound on the forehead of Rivero. Further examination of this wound matches the shape of the bottom of the rod holders located at the back of the V-1 t-top. The rod holders are the only items on V-1 that could have made this type of injury.

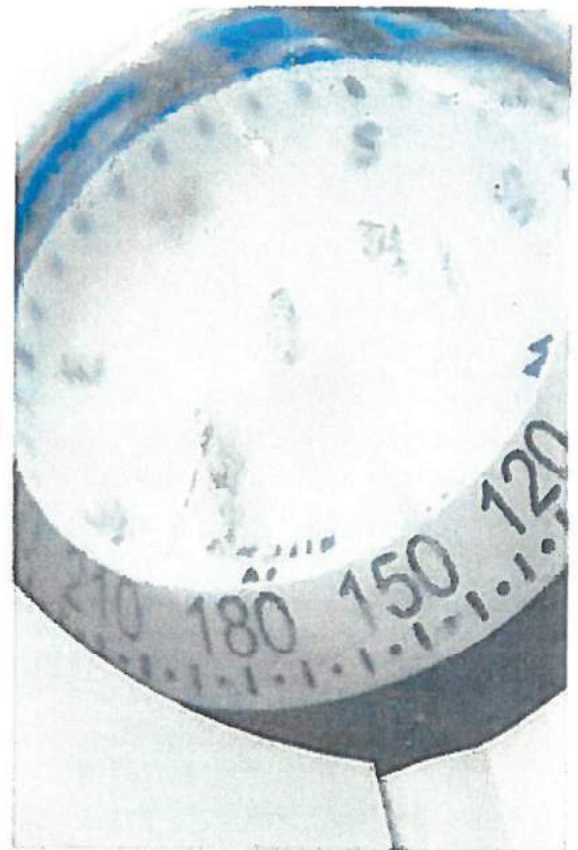
Fig. 36. Close up of chips.

I spoke with Miami Dade Medical Examiner's Office Investigator Mendoza, who conferred with MDME Doctor Hutchins, that the material and impressions on the compass would not be able to be analyzed as a tooth material. They suspected it to be only a surface composite, not the pulp of a tooth, based on the autopsy photos and damage to Fernandez's teeth.

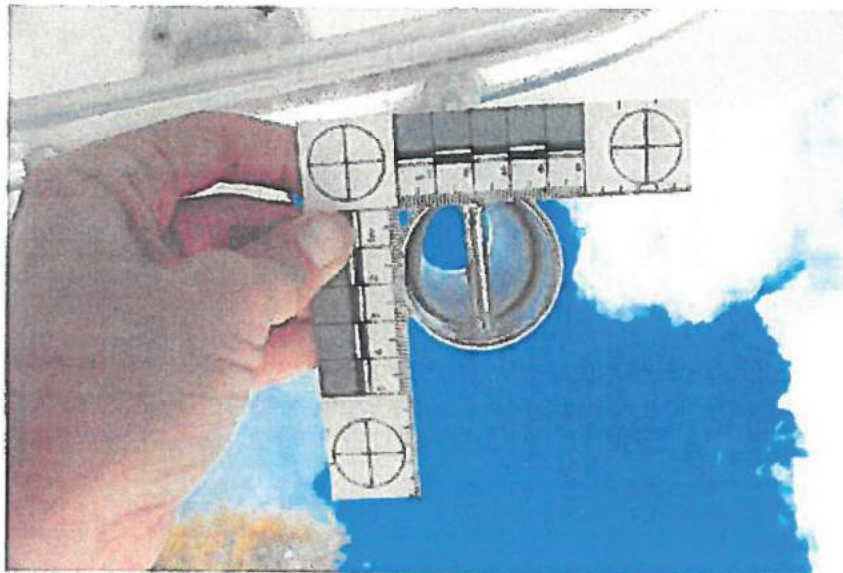
Fig. 40. Diameter of base of V-1 rod holder approximately 4 cm.
