# Aviation Investigation Final Report

| <b>Location:</b> | Watsonville, California | <b>Accident Number:</b> | WPR22FA309 |
| <b>Aircraft:</b> | Cessna 152 (A2); Cessna 340A (A3) | <b>Aircraft Damage:</b> | Substantial (A2);<br>Destroyed (A3) |
| <b>Defining Event:</b> | Midair collision | <b>Injuries:</b> | 1 Fatal (A2); 2 Fatal (A3) |

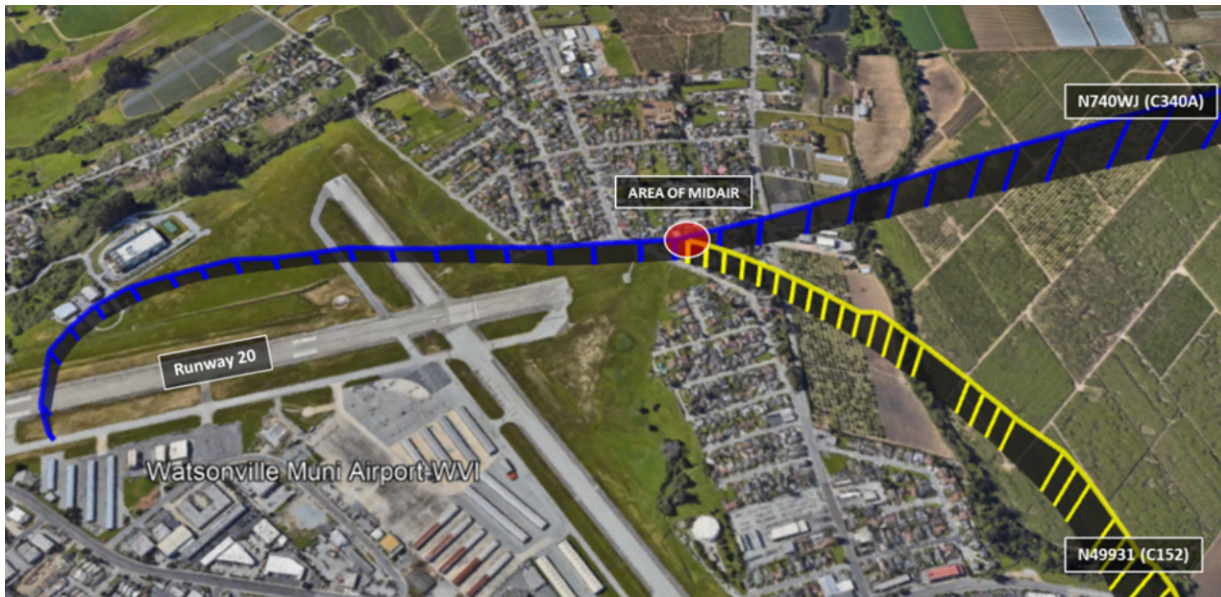
Recorded automatic dependent surveillance-broadcast (ADS-B) data provided by the Federal Aviation Administration (FAA) revealed that the Cessna 340 departed Turlock Airport (O15), Turlock, California, and proceeded west toward runway 20 at WVI. The Cessna 340 maintained about 180 knots ground speed until the collision. The data showed that the airplanes’ flight paths intersected about 1455:13, at an altitude about 225 to 300 ft msl, or about 150 ft agl, as seen in Figure 1.

Figure 1. View of the two airplanes' ADS-B flight track data.

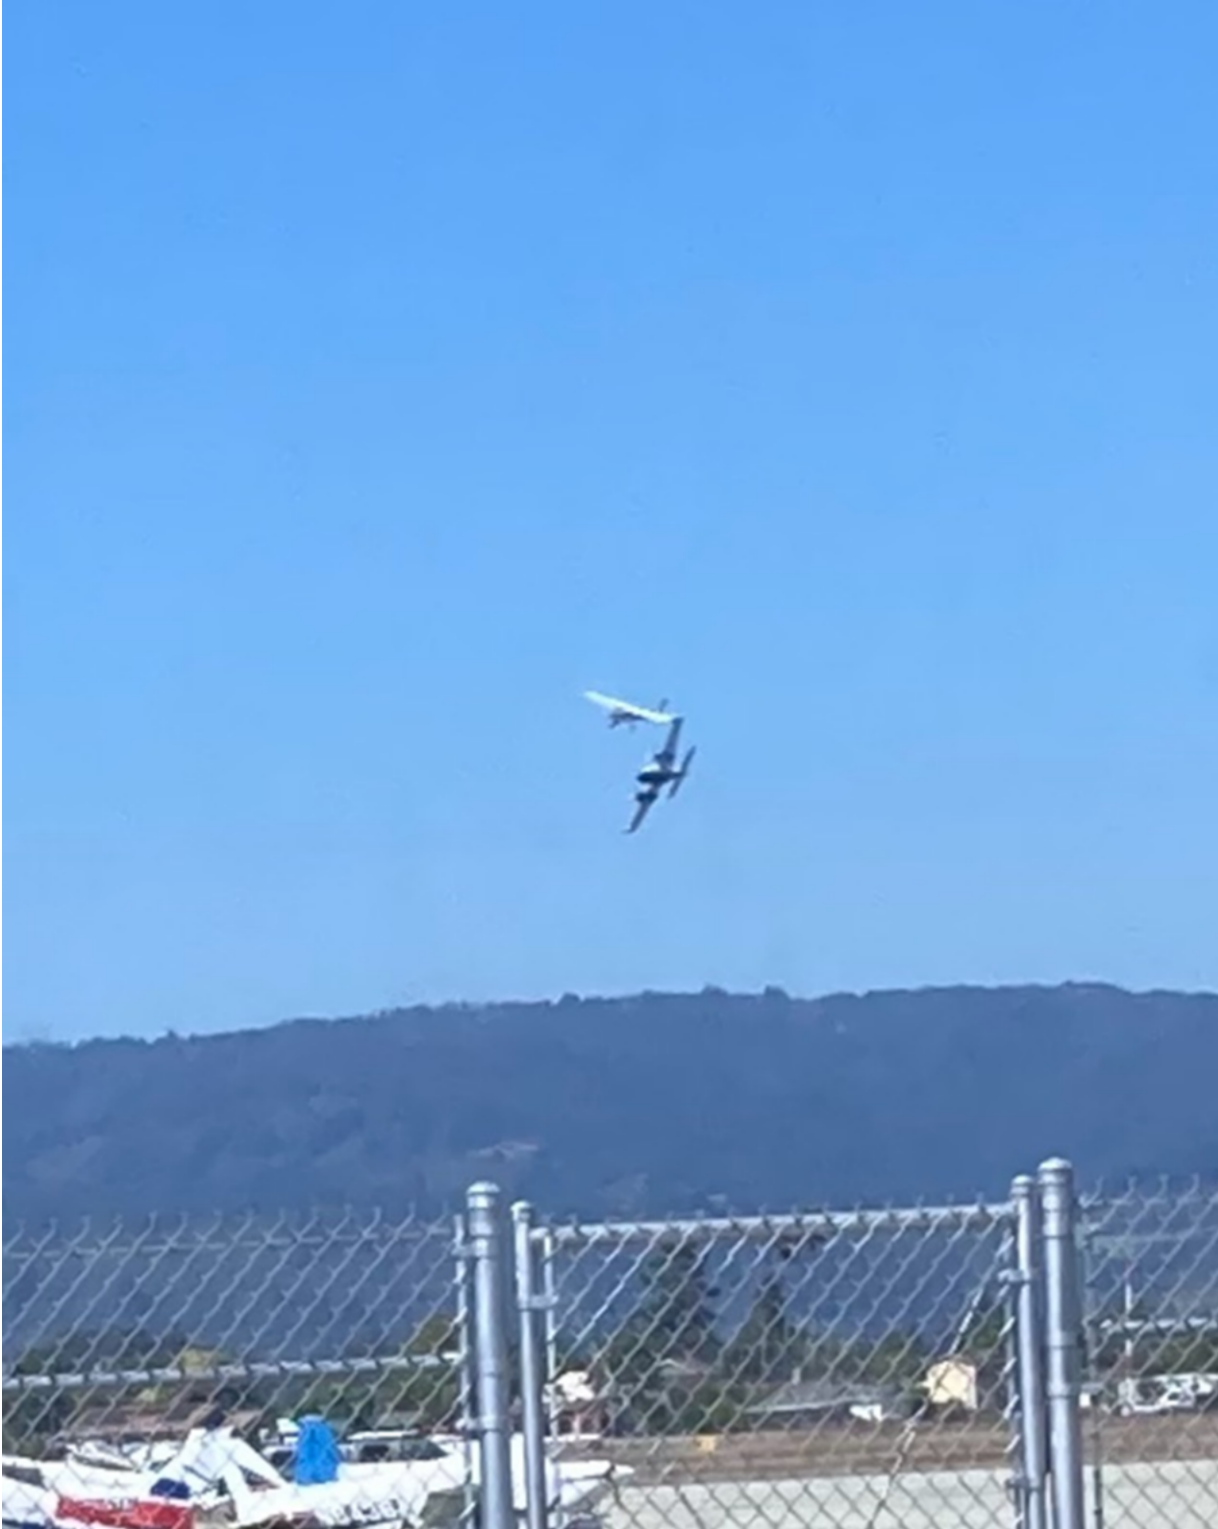
A witness on the ground at WVI captured an image of the two airplanes before the collision, as seen in Figure 2.

Figure 2. Image captured before the collision.
