**KIRKLAND & ELLIS LLP**  
AND AFFILIATED PARTNERSHIPS

July 26, 2019

As you requested, this is a letter report on the vegetation management field inspections (“VM inspections”) the Monitor team is conducting pursuant to the Court’s April 3, 2019 Order (“April 3 Order”). This submission includes: (1) background information on the VM inspections; (2) an explanation of the VM inspections process; (3) the Monitor team’s preliminary observations; (4) PG&E’s feedback based on the Monitor team’s preliminary findings; (5) the Monitor team’s preliminary suggestions to PG&E, as shared with the Company on July 17, 2019; and (6) concluding thoughts.

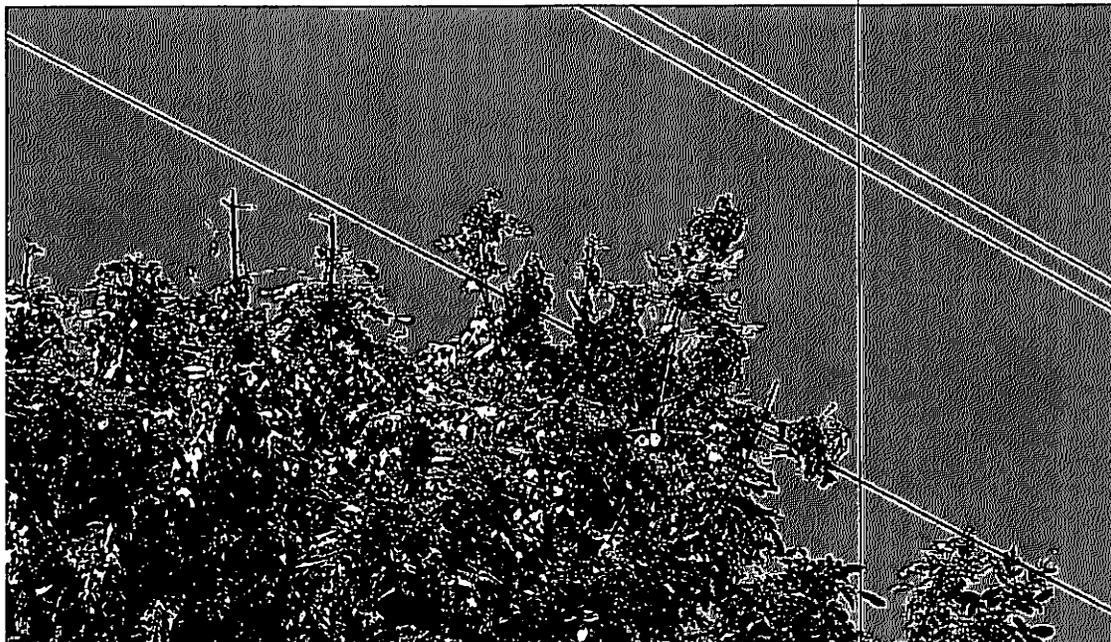
Most recently, on July 12, 2019, the Monitor team informed PG&E of a tree that was within inches of the primary conductor, and had been contacting the conductor during wind gusts. As reflected in Figure 11 below, leaves of the tree had been burned from ongoing contact with the primary conductor. PG&E informed the Monitor team that this particular tree was identified for routine compliance work in November 2018 and a tree work company reported to PG&E that it completed the work in February 2019, even though it was not actually completed (that is, the tree

work company provided a false certification). On April 16, 2019, a different pre-inspector inspected the area under the EVM scope, prescribed the tree for work, but failed to note the urgency.

***Figure 11: Tree found by Monitor team on July 12, 2019 within inches of the primary conductor and with evidence that tree leaves had been burned from contact with the primary conductor in a Tier 3 high fire-threat district.***

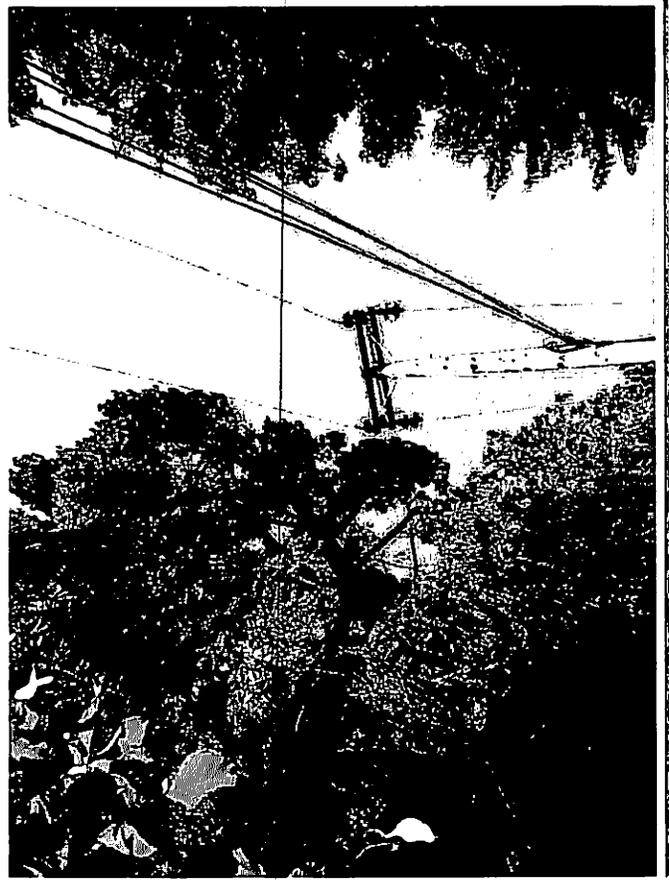
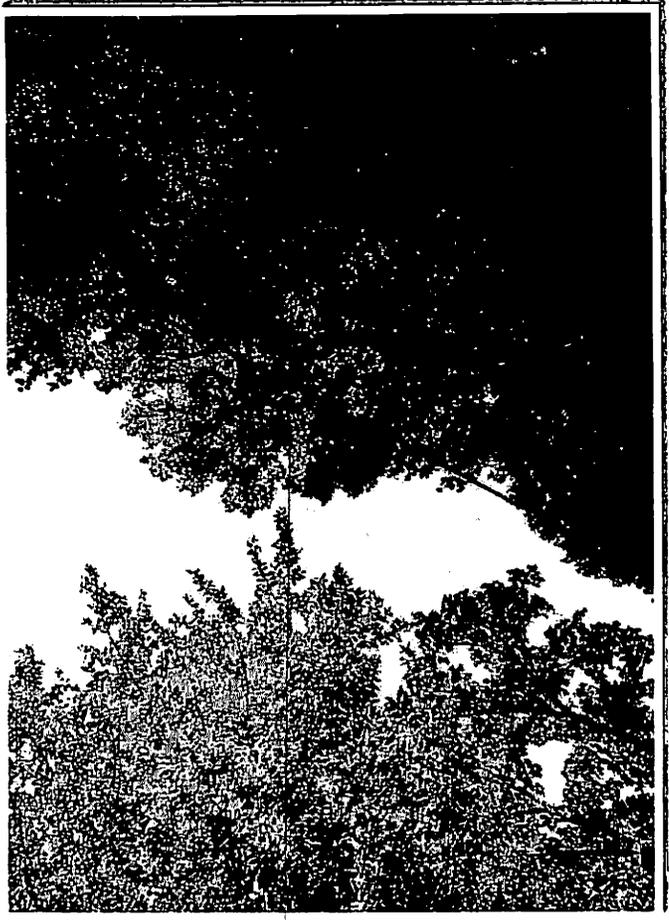
- The Monitor team noted multiple instances where overhangs were not completely cleared (*example photos below*).
- Relatedly, the Monitor team observed that some trees were pruned to clear overhanging vegetation up to a certain height, but the highest portion of the tree was not pruned.

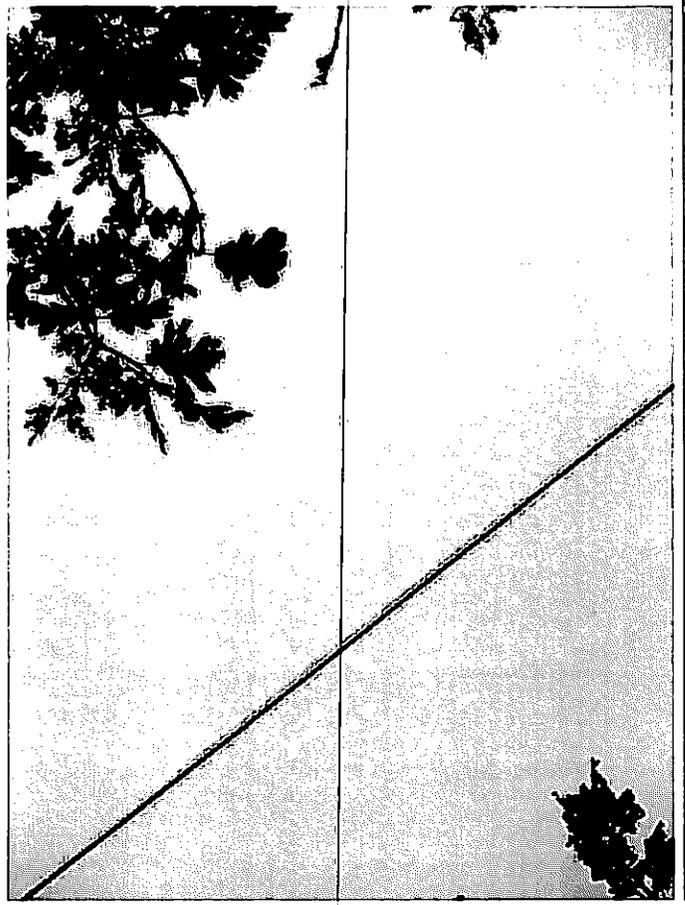
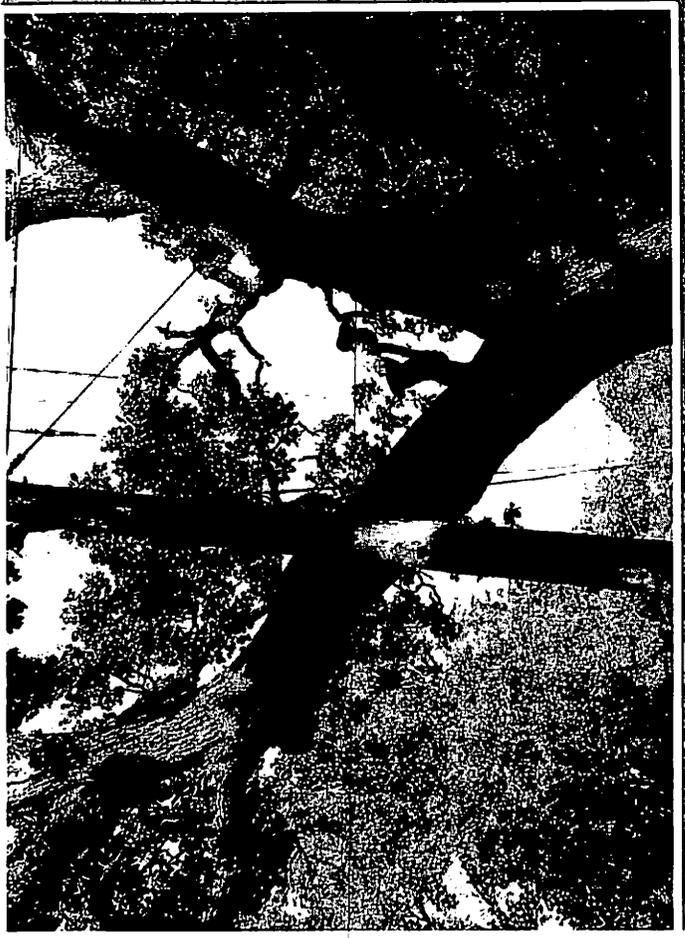
- To date, the Monitor team has not observed any specific trends or other issues unique to potential radial clearance exceptions.
- The example photo on the left shows vegetation observed within 4 feet of a conductor. The example photo on the right shows a tree that was pruned, but 12 feet of radial clearance was not achieved.

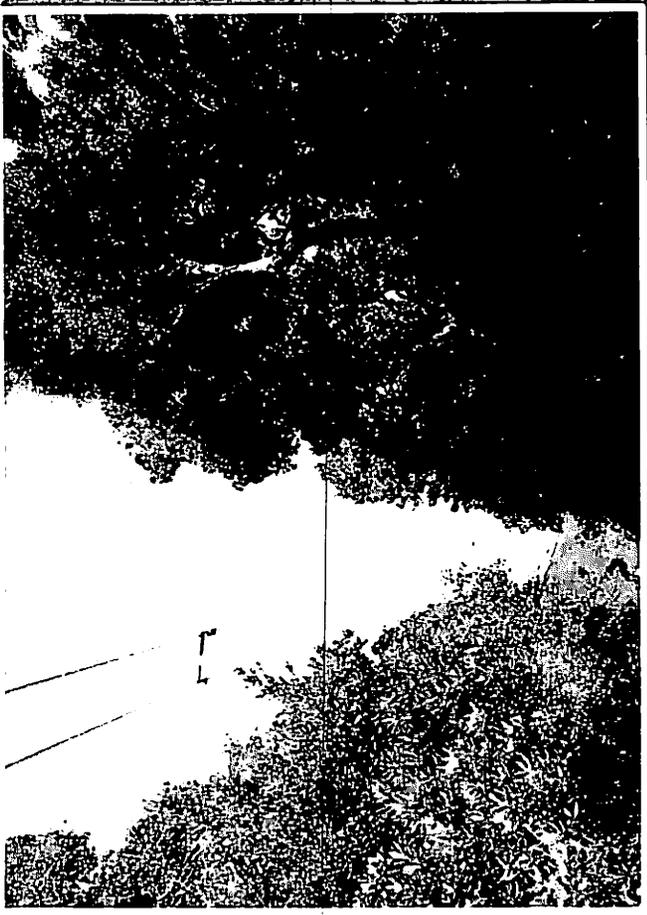
- An example of a hazard tree is shown below. Additionally, in some instances, potential hazard trees were marked with a yellow dot for pruning only (i.e., not removal), despite the fact that decay, rot, or other defects were observable in the area near the paint dot, and the overall health of the tree suggested that removal may have been the appropriate prescription.

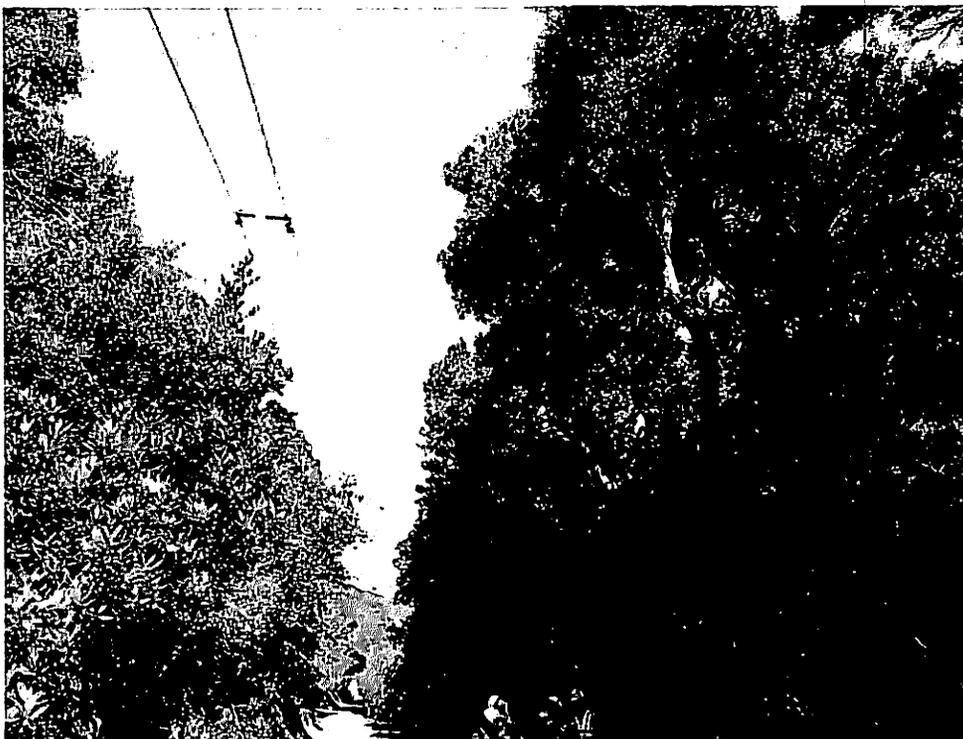
PG&E ArcCollector Project Status	Work Identified	
Monitor Team Observed Tree Work in Immediate Vicinity of Subject Tree	No	
Species	Coastal Live Oak	
GPS Coordinates	37.843595, -121.832268	
Approx. Distance from Primary Conductor	30 feet to the northeast, measured to farthest point of potential contact	
Approx. Height	65 feet	
Veg Type	Potential Hazard Tree	
Comments	<ul style="list-style-type: none"> <li>• Monitor Arborist observations of the tree include (a) a rotten cavity in the trunk, and (b) rotten heartwood</li> </ul>

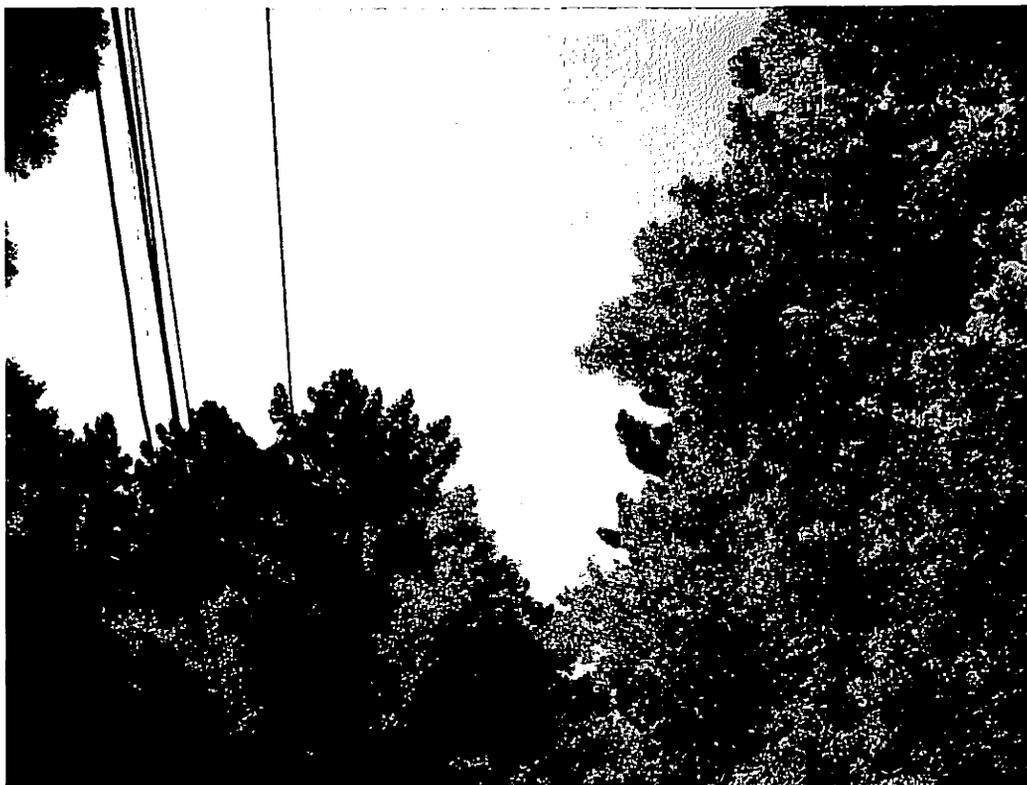
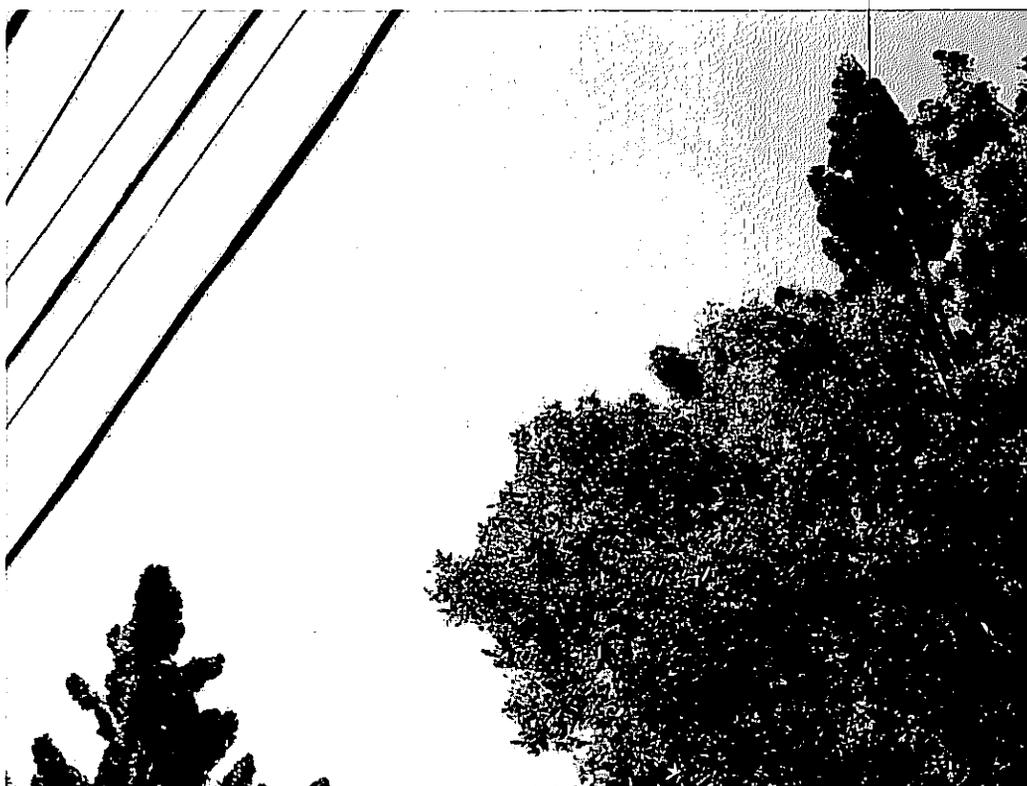
PG&E ArcCollector Project Status	Work Identified	
Monitor Team Observed Tree Work in Immediate Vicinity of Subject Tree	No	
Monitor Team Observed Recent Tree Work on Subject Tree	No	
Tree Paint or Other Markings Observed	No	
Species	Tan Oak	
GPS Coordinates	38.380156, -122.969689	
Approx. Distance from Primary Conductor	Trunk of tree 40 feet south	
Approx. Height	50 feet	
Veg Type	Potential Hazard Tree	
Monitor Arborist Comment	Observations of the tree include (a) trunk showing multiple cracks and signs of decay, (b) tree is leaning towards primary conductor, and (c) if tree fails, tree will contact primary conductor.

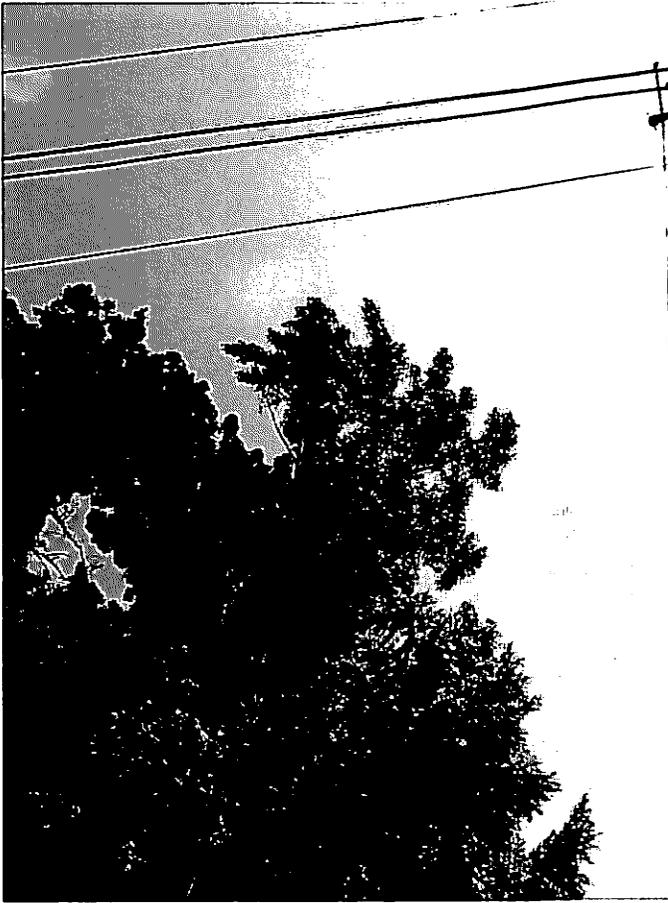
PG&E ArcCollector Project Status	Work Identified	
Monitor Team Observed Tree Work in Immediate Vicinity of Subject Tree	No	
Monitor Team Observed Recent Tree Work on Subject Tree	No	
Tree Paint or Other Markings Observed	No paint observed	
Species	Douglas Fir	
GPS Coordinates	38.4074348, -122.9278607	
Approx. Distance from Primary Conductor	Trunk of tree 50 feet southeast	
Approx. Height	100 feet	
Veg Type	Potential Hazard Tree	
Monitor Arborist Comment	Observations of the tree include (a) tree leaning 40 degrees towards the primary conductor, (b) failure would strike the primary conductor, and (c) no apparent lifting of the roots.

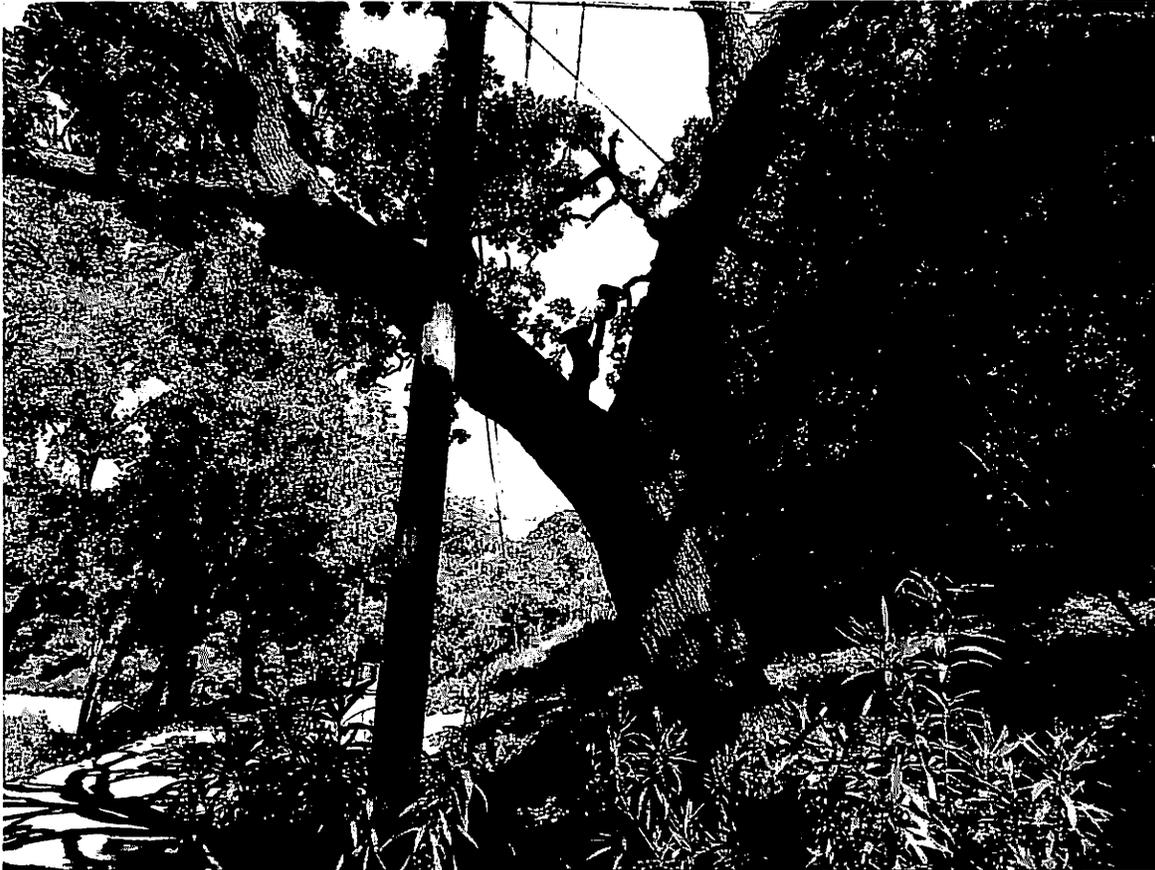
Photograph below shows subject tree and proximity to the primary conductor.
