Pipeline Investigation Report: PIR-26-04

# Exelon Corporation (Baltimore Gas and Electric Company) Natural Gas–Fueled Home Explosion

| <b>Location</b> | Bel Air, Maryland |
| <b>Pipeline</b> | Distribution pipeline<br>0.50-inch plastic service line carrying natural gas |

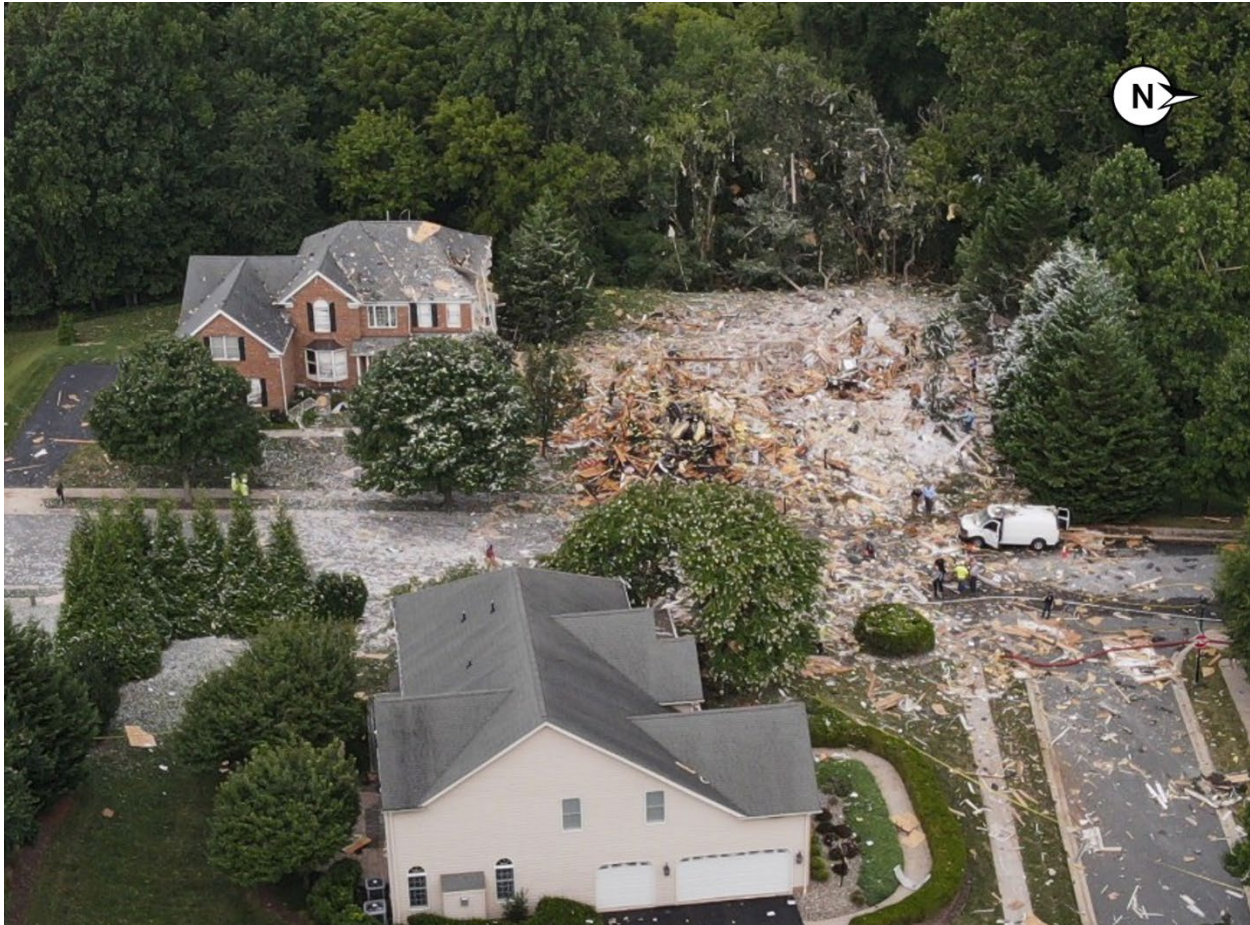
On Sunday, August 11, 2024, about 6:48 a.m., a home explosion and fire occurred at 2300 Arthurs Woods Drive (accident home) in Bel Air, Maryland, resulting in a destroyed home, two fatalities, and three injuries.<sup>1</sup> The explosion also damaged several residences and displaced families. (See figure 1.) At the time of the explosion, it was daylight and clear; the temperature was 67°F with no precipitation.

**Figure 1.** Aerial view of the accident location. (Courtesy of the Harford County Sheriff's Office.)

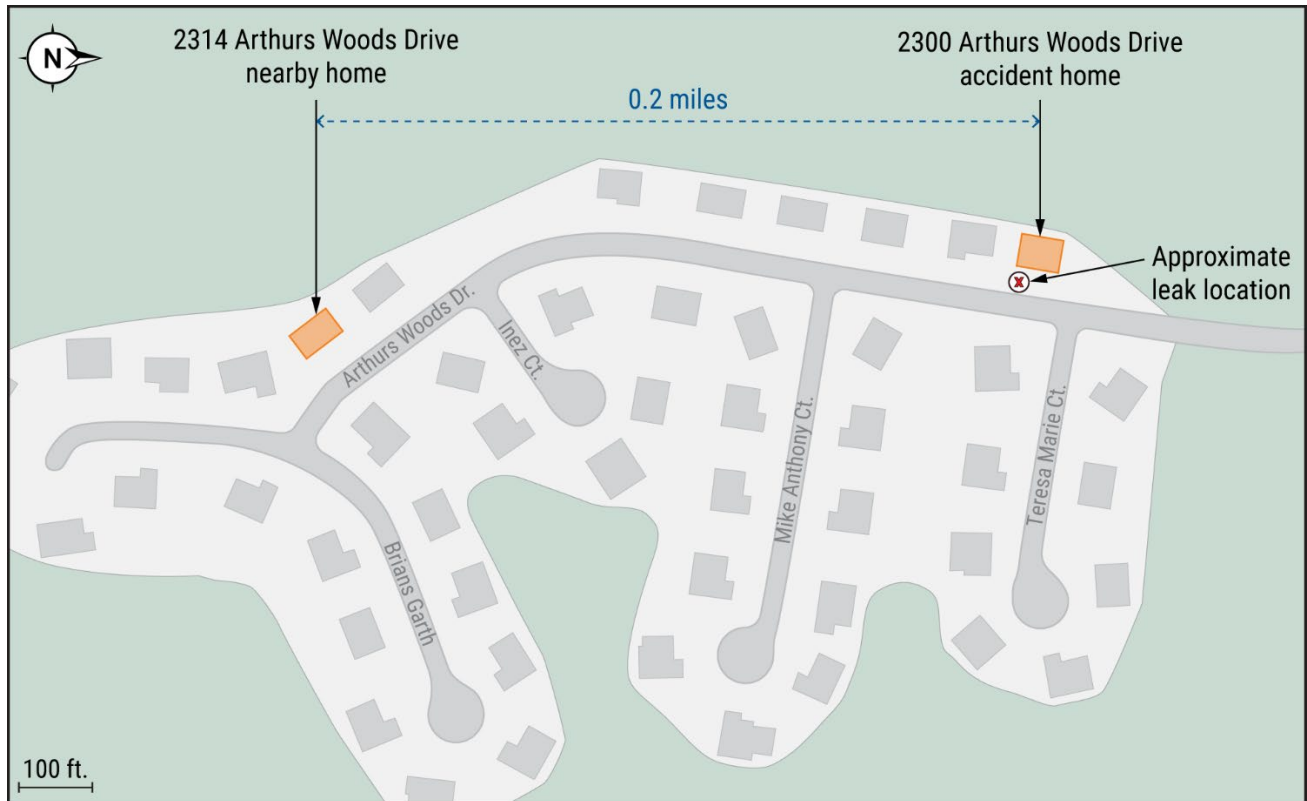
**Figure 2.** The accident neighborhood.

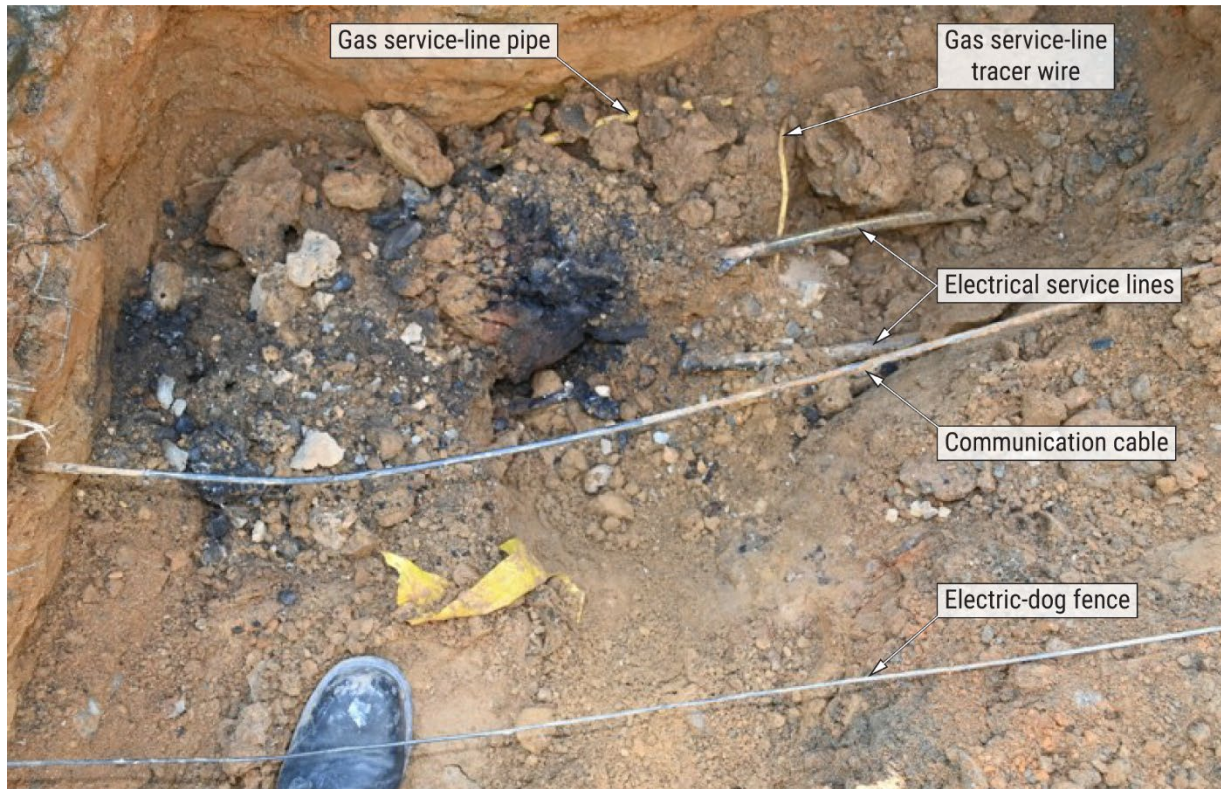
Excavation of the natural gas utilities also found that the accident gas service-line pipe was in a common trench with multiple other utilities near the accident home driveway. In addition to the gas service-line pipe, the common trench also included a gas service-line tracer wire, remains of the accident electrical service lines, a communication cable, and a wire from an electric-dog fence.<sup>15</sup> Between the natural gas main and the accident home, the separation between the gas and electrical service lines varied, ranging from 3 inches to 15 inches. Because the accident electrical service lines were involved in an electrical fault and large portions of them had melted, the NTSB could not determine the separation distance between the accident gas service-line pipe and the accident electrical service lines at the time of the accident. Figure 3 shows the excavated accident common trench (the gas service-line tracer wire had likely been installed parallel to the gas service-line pipe, and the excavation disturbed it).

**Figure 3.** The accident trench.

The accident gas service-line pipe and the accident electrical service lines were located in a common trench. Although the NTSB could not determine how closely the gas service-line pipe and the electrical service lines were located at the leak site because of the damage the electrical fault caused, an excavation of the accident trench showed that the two utilities were located from 3 inches to 15 inches apart at various points. This indicates that, after the explosion, there were some areas where the utilities had less than 12 inches of separation, the minimum Exelon required between gas and electric utilities in common trenches.<sup>20</sup>

The National Electric Safety Code recommended a 12-inch separation between utilities to prevent damage from arcing, leaks, or maintenance operations. The NTSB found evidence of arcing and a leak in this accident, including the melted electrical

- Created a program to install a device, a resin conduit called a "split," in all common trenches that are opportunistically exposed (uncovered through digging) during construction activities. The split creates a thermal barrier between the gas and electrical service lines.

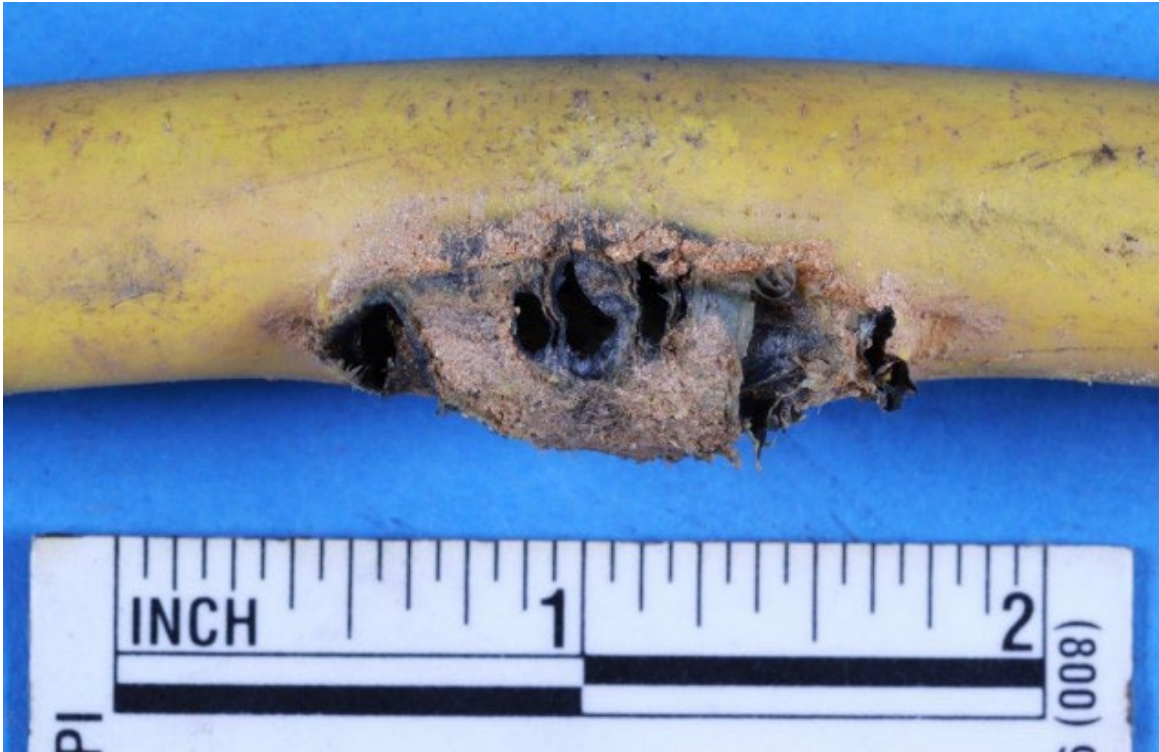
The NTSB examined a portion of the accident service-line pipe that was approximately 87 inches long between the capped end and the coupling end, with a 0.5-inch outer diameter.<sup>16</sup> The examination found that approximately 17 inches upstream of the coupling, the gas service-line pipe exhibited a bulging feature (a “blister”) that was about 1 inch long and oval shaped.<sup>17</sup> The blister resulted in a breach of the pipe wall, which allowed the pipe to leak natural gas. (See figure 4.) The accident gas service-line pipe tracer wire, which was in the common trench next to the gas service-line pipe, was thermally damaged and had separated into two pieces. The tracer wire was copper and insulated, which made it a good thermal conductor. The soil and debris in the accident trench contained large masses of vitrified soil that included aluminum slag, evidence of the electrical fault (high temperatures create vitrified soil and aluminum

slag). The accident electrical service lines (secondary power cables) were thermally damaged and had missing sections, which had melted as a result of the electrical fault.

**Figure 4.** The “blister” on the accident service-line pipe.

service lines and the “blister,” a 1-inch puncture, on the gas service-line pipe. The gas service-line tracer wire, which was thermally conductive and located near the gas service-line pipe, likely transferred and localized the heat from the electrical fault to the pipe, causing the blister on the gas service-line pipe.
