# National Transportation Safety Board Aviation Accident Final Report

| <b>Location:</b> | LAFAYETTE, Louisiana | <b>Accident Number:</b> | CEN20MA044 |
| <b>Date &amp; Time:</b> | December 28, 2019, 09:21 Local | <b>Registration:</b> | N42CV |
| <b>Aircraft:</b> | Piper PA 31T | <b>Aircraft Damage:</b> | Destroyed |

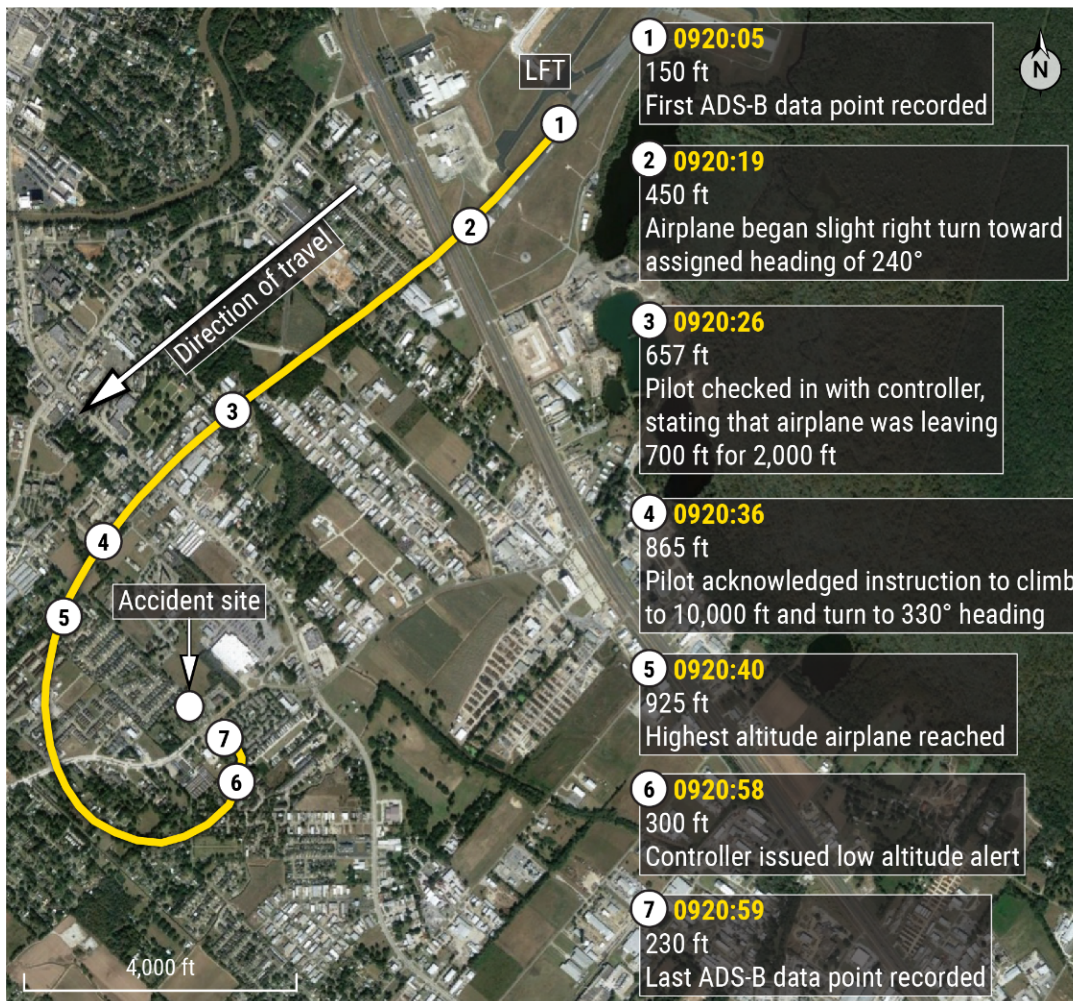
The Federal Aviation Administration (FAA) provided automatic dependent surveillance-broadcast (ADS-B) data for the accident flight. These data were used to calculate the airplane’s performance, including its true altitude. (See the Tests and Research section of this report for more information.) The ADS-B data started at 0920:05 as the airplane climbed through an altitude of 150 ft. The airplane then began a slight right turn immediately afterward toward its assigned heading of 240°. The airplane reached a peak altitude of 925 ft from about 0920:37 to 0920:40 and then started a continuous descent toward the ground.

At 0920:58, the controller issued a low altitude alert, stating that the pilot should “check [the airplane’s] altitude immediately” because the airplane appeared to be at an altitude of 300 ft. The pilot did not respond, and no mayday or emergency transmission was received from the airplane. The last ADS-B data point, at 0920:59, showed the airplane descending through an altitude of 230 ft. Figure 1 shows the airplane’s flight track and key points based on aircraft performance calculations and radio transmission information.

**Figure 1.** Flight track overview.
