National Transportation Safety Board

Aviation Accident Final Report

Location:	Presque Isle, Maine	Accident Number:	DCA19FA089
Date & Time:	March 4, 2019, 11:29 Local	Registration:	N14171
Aircraft:	Embraer EMB145	Aircraft Damage:	Substantial
Defining Event:	Wrong surface or wrong airport	Injuries:	3 Minor, 28 None
Flight Conducted Under:	Part 121: Air carrier - Scheduled

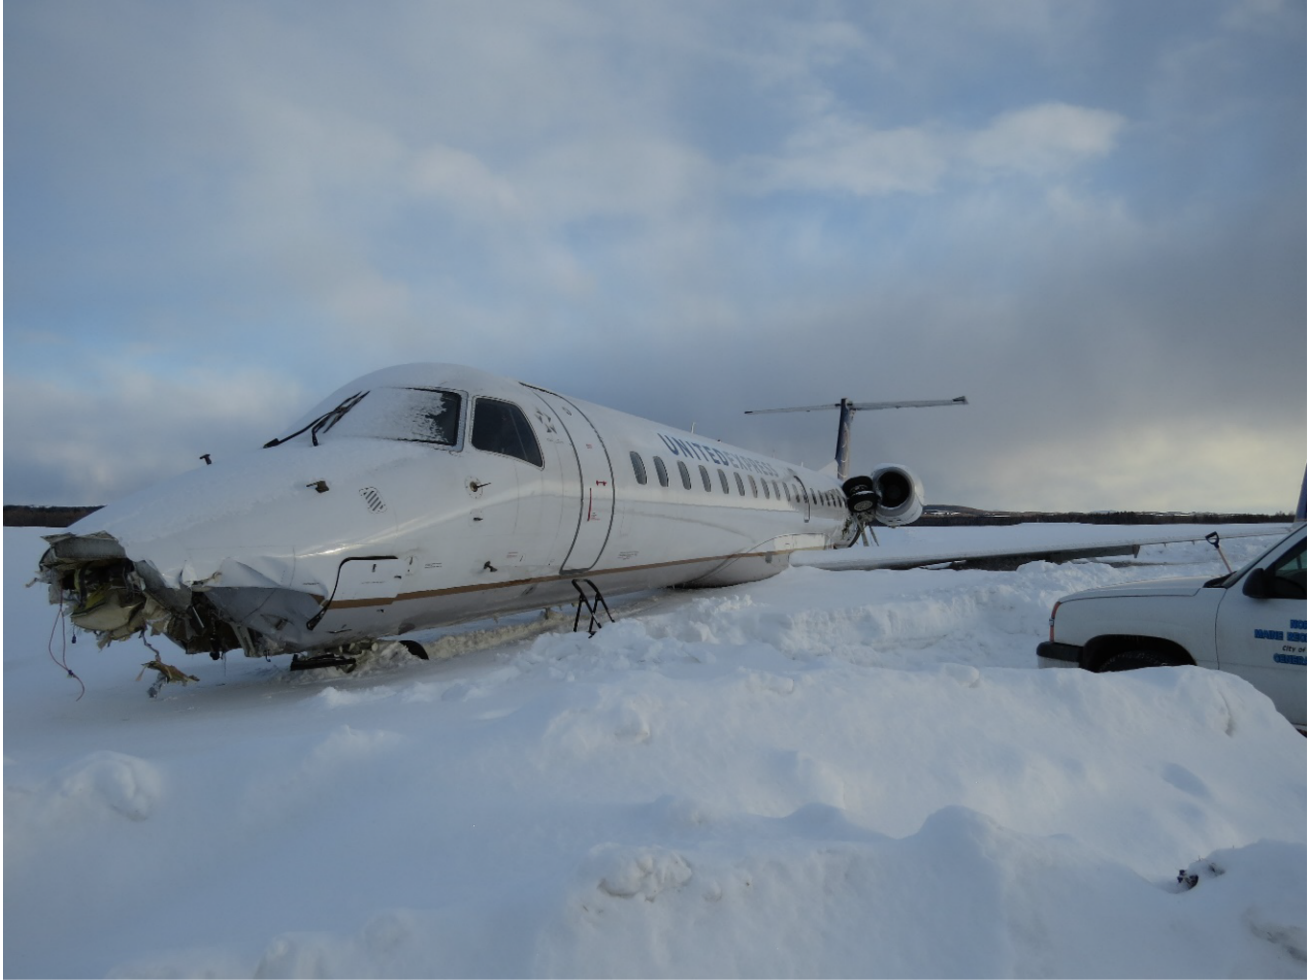
After the main cabin door was opened, the flight attendant noticed that the snow reached the bottom of the belly of the airplane. Firefighters came aboard the airplane; one attended to the first officer, who was injured, and one walked through the cabin to check on passengers. A snow plow created a walkway so that the crewmembers and passengers would not have to walk through the snow after exiting the airplane.

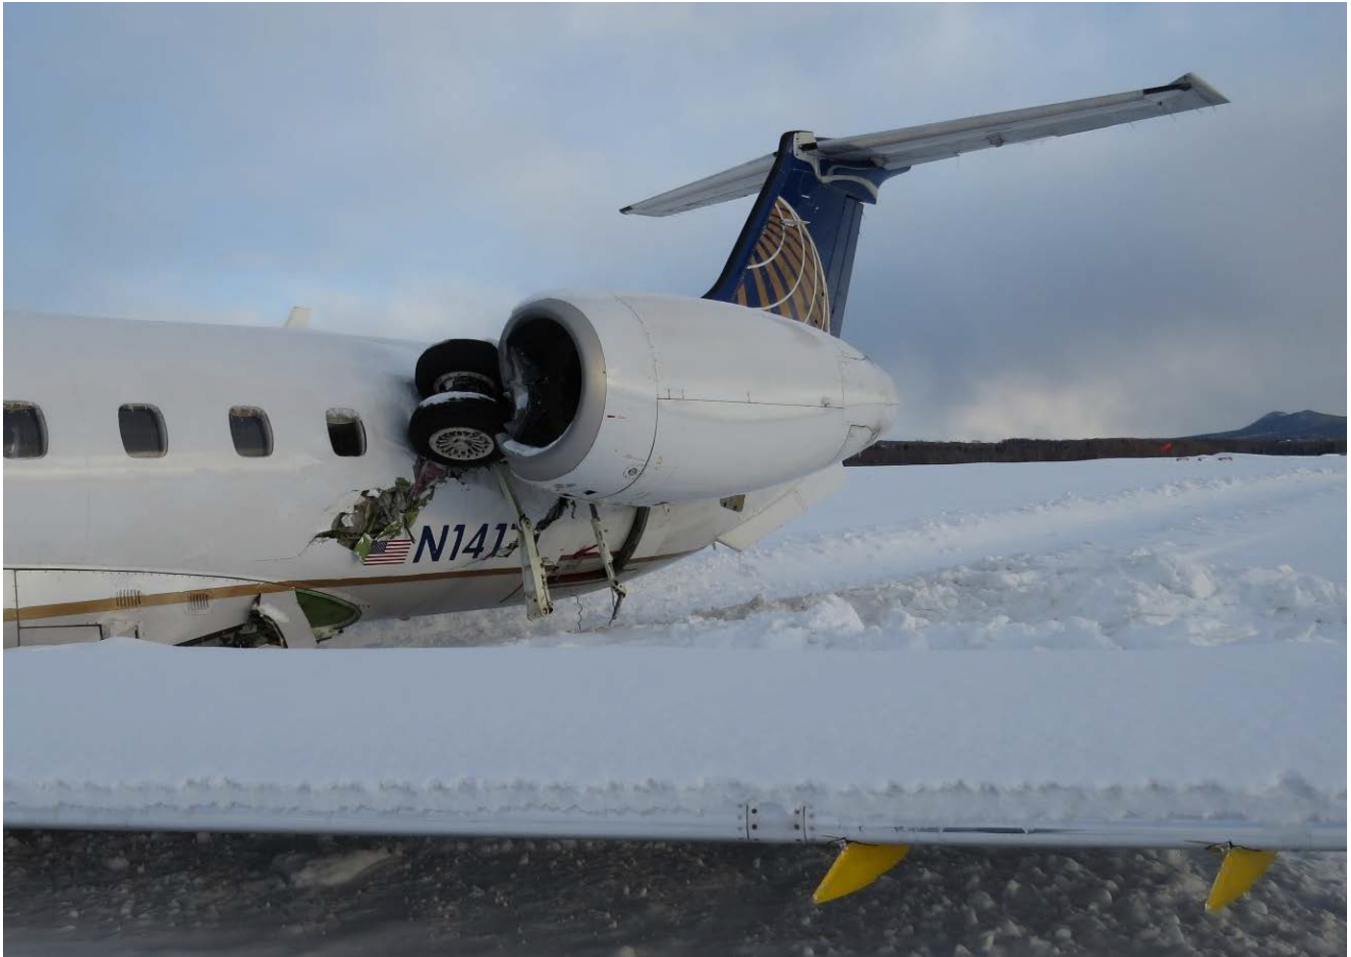
The left main gear was lodged between the left engine nacelle and fuselage. The fuselage structure in the area of the gear was ripped and damaged, and the fuselage around the gear wheels was distorted. The landing gear trunnion had penetrated the left engine gear box.

Figure 2: Left main landing gear lodged between left engine nacelle and the aircraft fuselage
