# Aviation Investigation Preliminary Report

| <b>Location:</b> | Boston, MA | <b>Incident Number:</b> | DCA26LA242 |
| <b>Date &amp; Time:</b> | June 20, 2026, 11:34 Local | <b>Registration:</b> | N328NB (A1);<br>N316PF (A2) |
| <b>Aircraft:</b> | AIRBUS INDUSTRIE A319-114<br>(A1); Boeing 737-800 (A2) | <b>Injuries:</b> | 136 None (A1); 182<br>None (A2) |

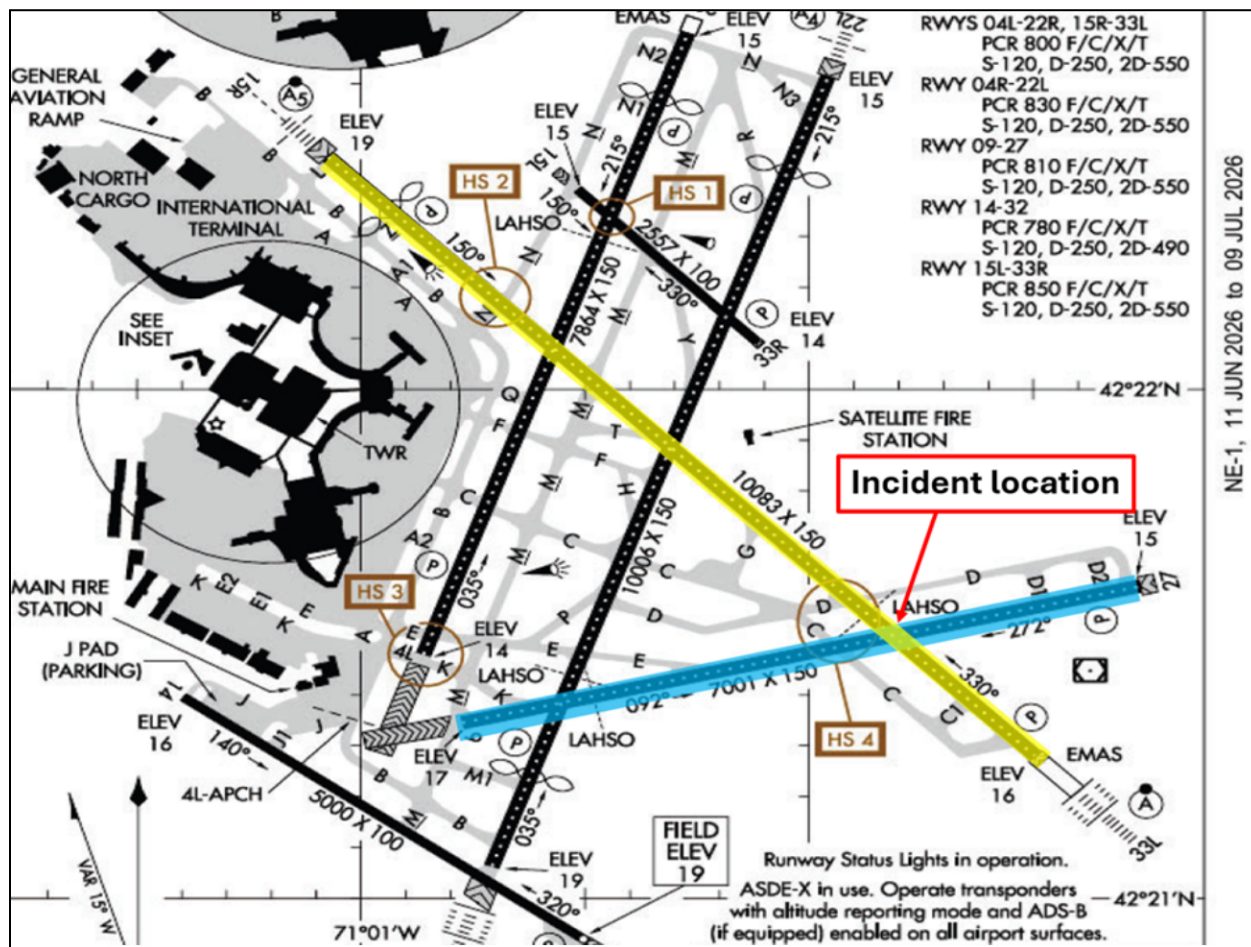
At the time of the incident, a local control west (LCW) controller, a local control east controller (LCE), a ground control (GC) controller, a clearance delivery (CD) controller, and an operations supervisor (OS) were present in the BOS ATC tower cab. The LCW controller was responsible for aircraft departure and arrival operations on runways 27 and 33L. The LCE was responsible for traffic coordination, monitoring the LCW position, writing flight strips, and local helicopter traffic. See figure 1 below for a BOS airfield diagram.

**Figure 1.** BOS airfield diagram showing runways 27 (highlighted blue) and 33L (highlighted yellow). A red arrow points to the runway intersection for this incident.

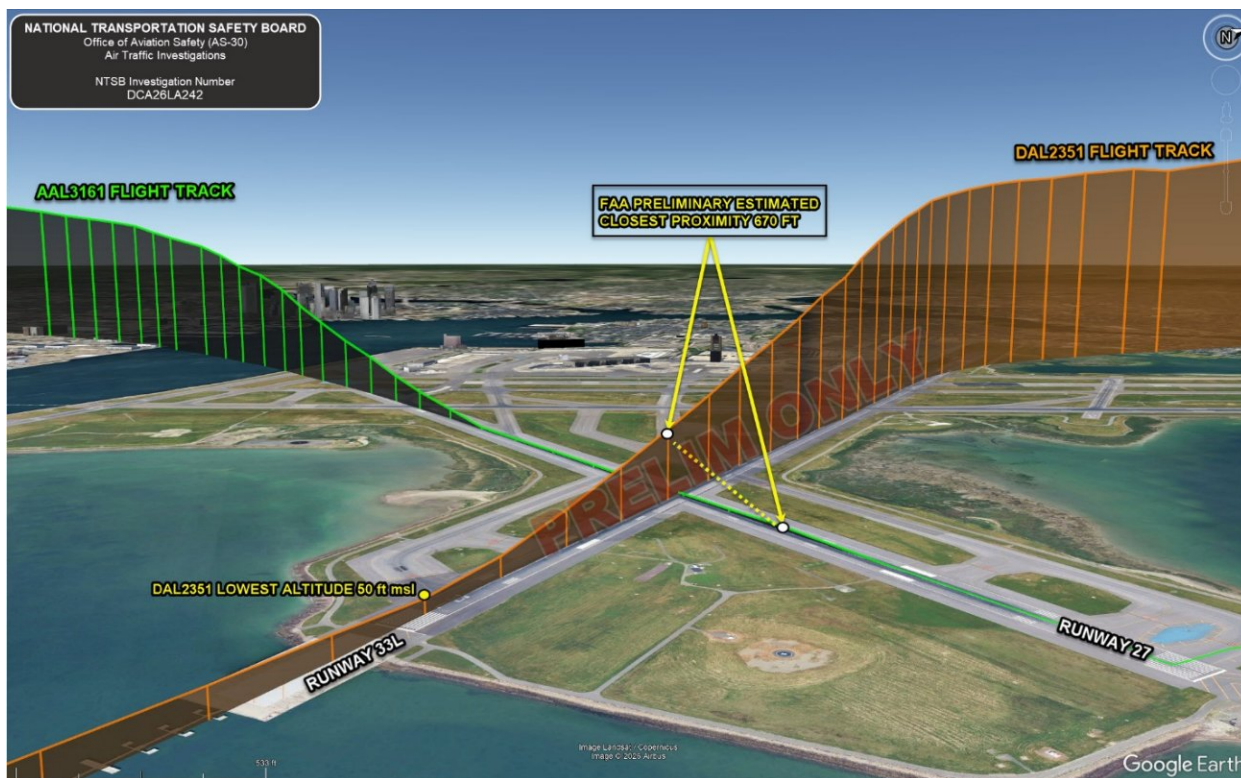
A preliminary estimate of the closest proximity between DAL2351 and AAL3161 determined they were about 670 ft apart, as shown in figure 2.

**Figure 2.** Profile view of the DAL2351 and AA3161 flight tracks. The yellow arrows point to the locations of the two airplanes at the time of their closest proximity to each other, which was about 670 ft.
