## National Transportation Safety Board Aviation Accident Preliminary Report

<b>Location:</b>	Monterey, CA	<b>Accident Number:</b>	WPR21FA270
<b>Date &amp; Time:</b>	July 13, 2021, 10:42 Local	<b>Registration:</b>	N678SW
<b>Aircraft:</b>	Cessna 421C	<b>Injuries:</b>	2 Fatal
<b>Flight Conducted Under:</b>	Part 91: General aviation - Personal

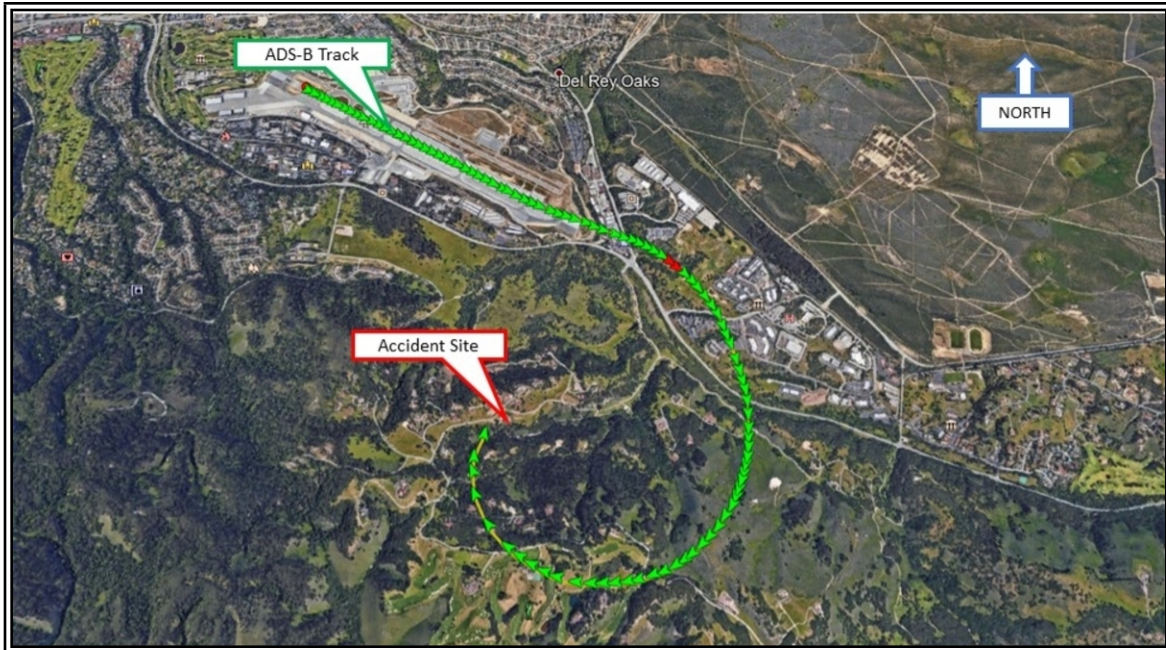
Recorded Automatic Dependent Surveillance-Broadcast (ADS-B) data provided by the Federal Aviation Administration (FAA) showed that the airplane departed from runway 10R at 1738:44 and ascended to 1,075 ft msl before a right turn was initiated. The data showed that at 1740:14, the airplane continued to ascend in a right turn and reached an altitude of 2,000 ft msl before a descent began. The data showed that the airplane continued descending right turn until ADS-B contact was lost at 1740:38, at an altitude of 775 ft, about 520 ft southwest of the accident site as seen in figure 1.

*Figure 1: View of airplane ADS-B track.*

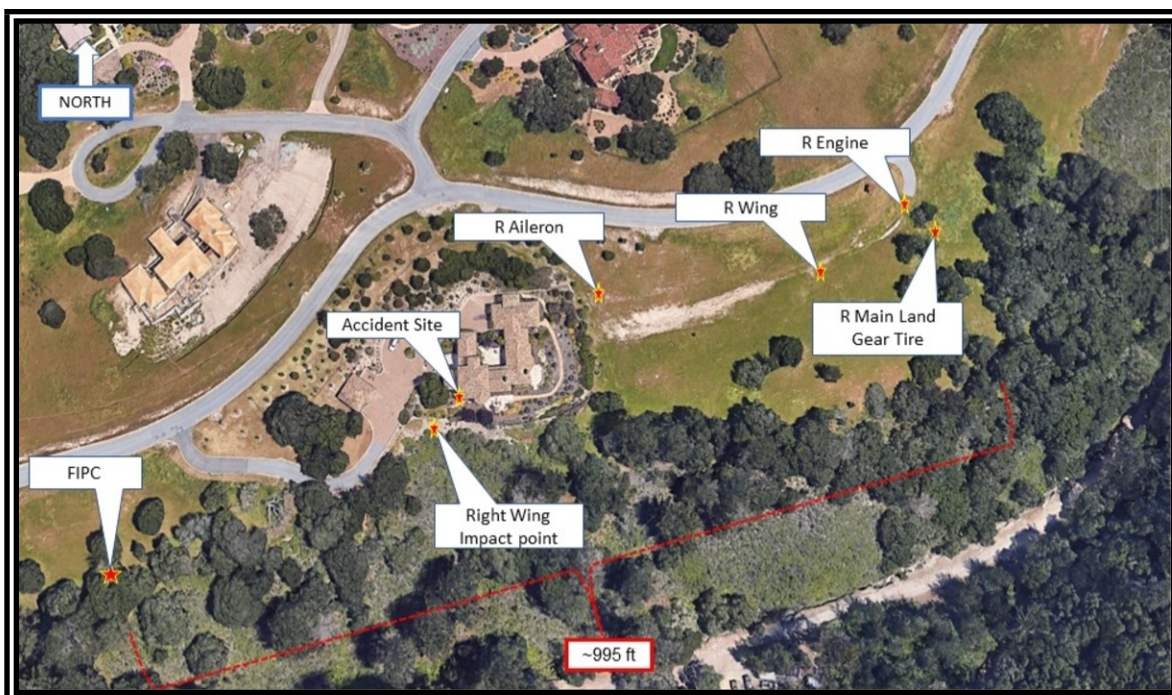
Examination of the accident site revealed that the airplane impacted trees about 1 mile south of the departure end of runway 10R. The first identifiable point of contact (FIPC) was a 50 to 75 ft tall tree that had damaged limbs near the top of the tree. The debris path was oriented on a heading of about 067° and was about 995 ft in length from the FIPC, as seen in figure 2. The main wreckage was located about 405 ft from the FIPC. Various portions of aluminum wing skin, right wing, flap, aileron, engine, propeller blades, and propeller hub were observed throughout the debris path. Additionally, several trees were damaged throughout the debris path. The fuselage came to rest upright against a residential structure on a heading of about 045° magnetic at an elevation of 447 ft msl. The wreckage was recovered to a secure location for further examination.

Figure 2: Accident site diagram.
