Analysis and Assessment of MBTA Green Line Light Rail Track System

The Commonwealth of Massachusetts
DEPARTMENT OF PUBLIC UTILITIES (DPU)
TRANSPORTATION OVERSIGHT DIVISION

November 23, 2017

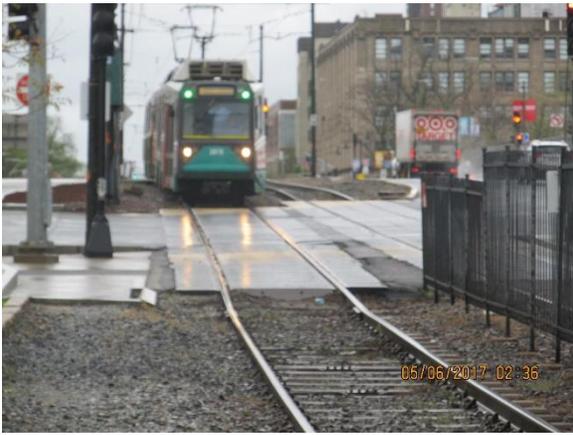
Figure 3 - Surface Deviation After a Road Crossing

The majority of the surface deviations observed on the Green Line are either dips or humps which deviate from uniform profile at the mid-ordinate of a 62' cord in various measurements between ¼" to 2". Those shown in Figure 3 and Figure 4 are around 1" - 2" deviations. Figure 3 is a "Yellow" condition and requires a 15 MPH speed restriction and require the track for surfacing within 30 days per MBTA Green Line Track Standards. As these areas are adjacent to road crossings with an operational 15 mph speed restriction, no "track based" restriction was placed on these defects. However, these conditions have been in place for an extended period and are the result of various factors. Figure 3 illustrates a common issue on the Green Line in which immediately past a road crossing, there are bolted joints directly across from each other. This situation leads to a "pounding" impact condition as solid axle trains leave the roadway crossing and each axle of the train impacts and pounds both joint simultaneously eventually resulting in ballast degradation and a low spot. This condition is highlighted to demonstrate that some issues requiring repeated repairs can be eliminated or minimized with up-dating and modifying track standards to industry and APTA/FTA best practices.

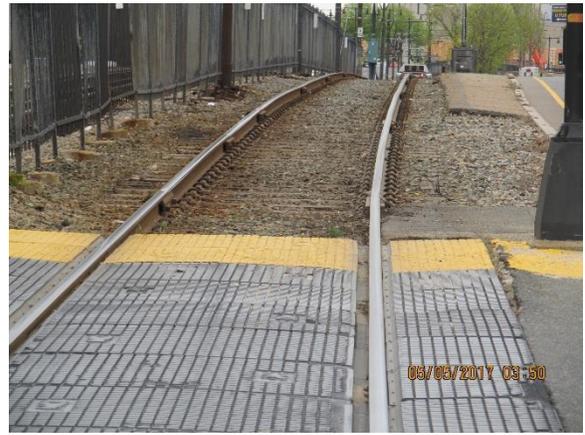
Figure 4 - Surface Deviation on Jointed Rail Area

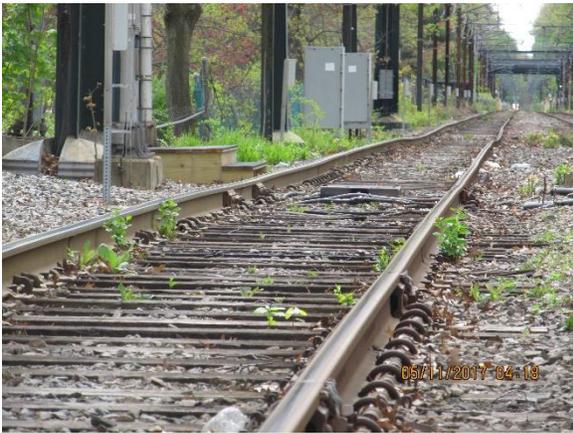
Figure 5 - 2.5" Surface Deviations on Approach to Riverside

The surface deviation shown above (2.5" +) was the most severe alignment deviation observed by the assessment team. The escorting supervisor immediately placed a speed restriction on the area and scheduled a crew for repair. In areas as shown above, with standard running track, a well planned and executed annual or bi-annual surfacing program would eliminate deviations of this extreme. Additionally, well trained inspectors should have noted this condition long before it deteriorated to this level. In areas of repeated settlement, sub-surface and track foundation evaluations should be undertaken.

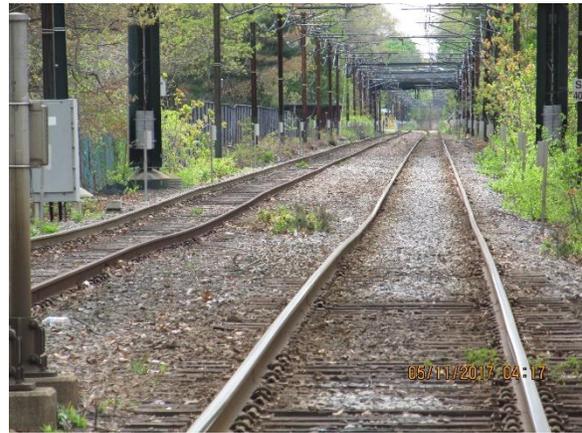
Figure 6 - Eastern View of 2.5" Service Deviation at Riverside

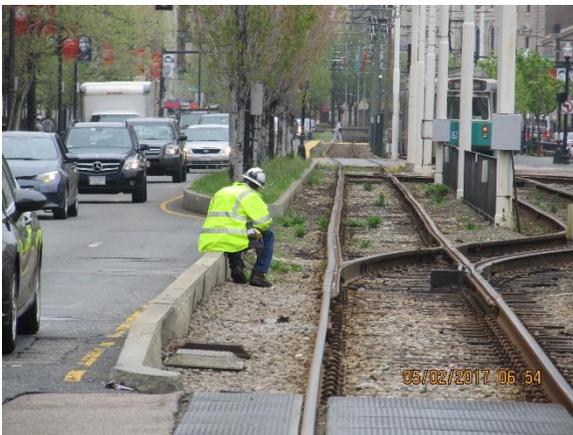
Green Line crossovers and special trackwork areas also show alignment and surfacing issues. These areas are subject to not only vertical loads but lateral forces as well during crossover moves.

Figure 7 - Alignment Issues on Special Trackwork

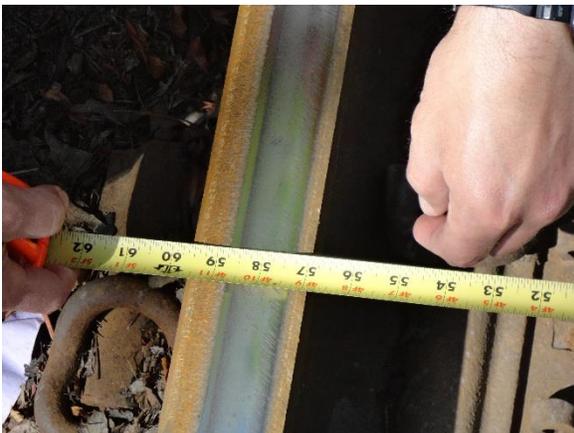
Figure 9 - 57" Wide Gauge - Green Condition

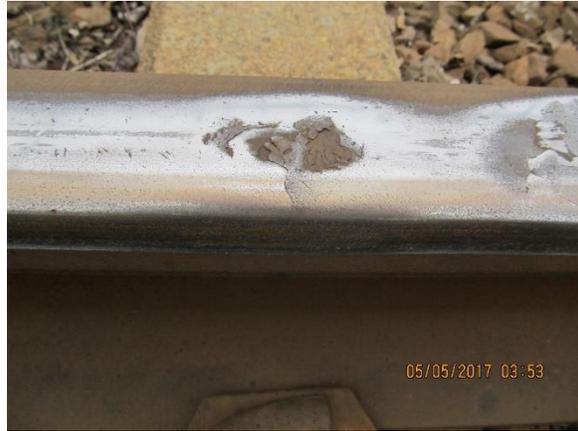
Figure 12 - Engine Burn Fracture

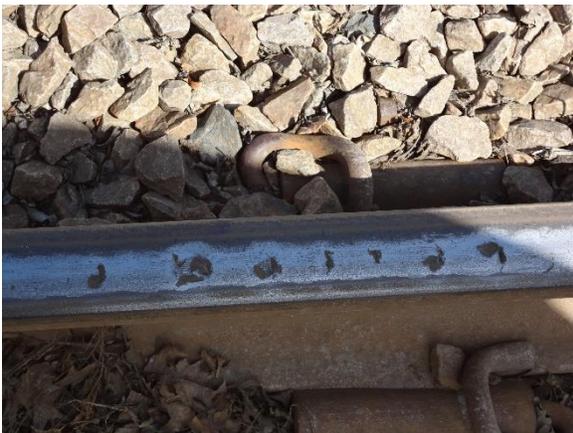
Figure 13 - Spalling Rail

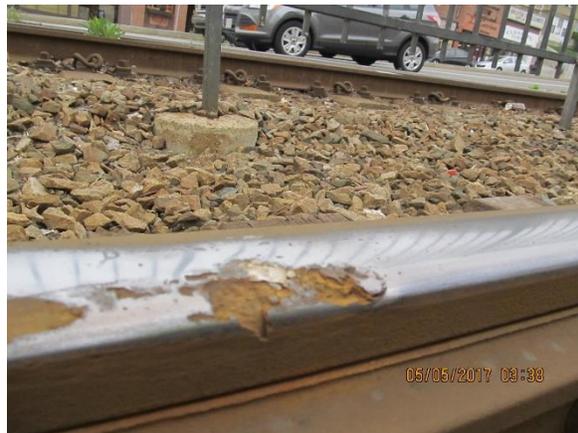
Figure 14 - Shelling Rail, Gauge Face Defect

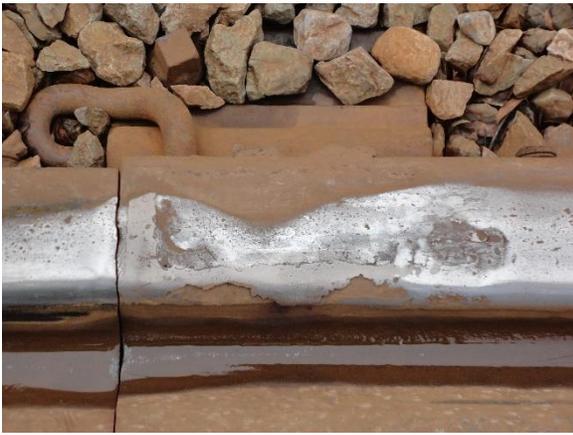
Figure 15 - Rail End Batter, Girder Rail, Poor Weld Repair

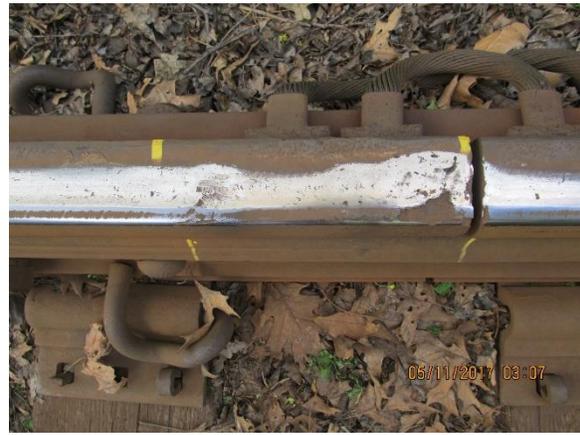
Figure 16 - Rail End Batter, Tee Rail

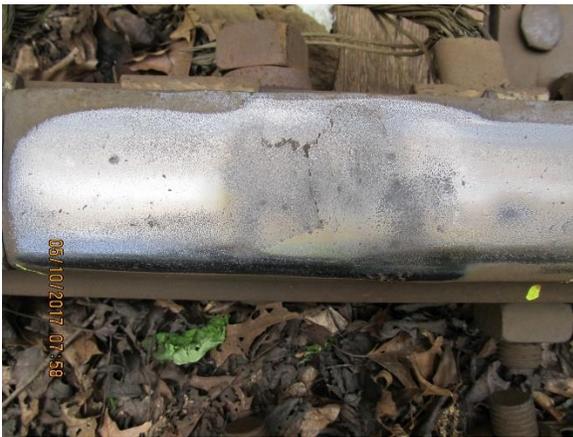
Figure 17 - Squat Defect

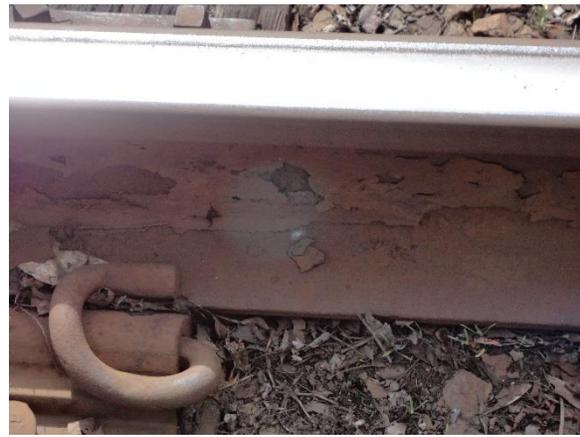
Figure 18 - Minor Rail Corrosion

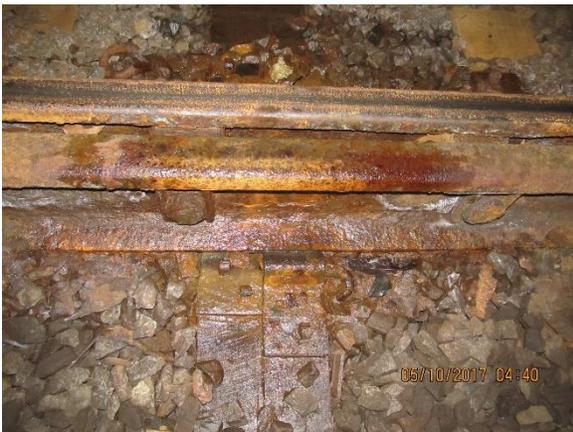
Figure 19 - Severe Rail Corrosion

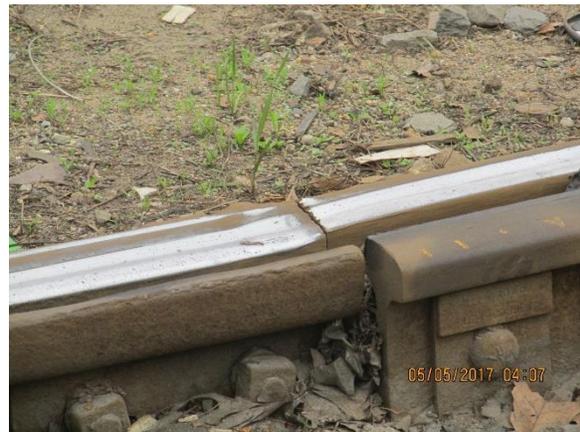
Figure 20 - Rail End Mismatch causing flattening of rail

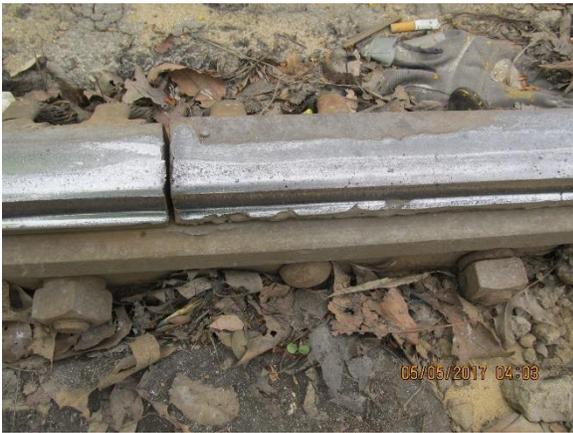
Figure 21 - Worn/Flattened Rail with Shelf

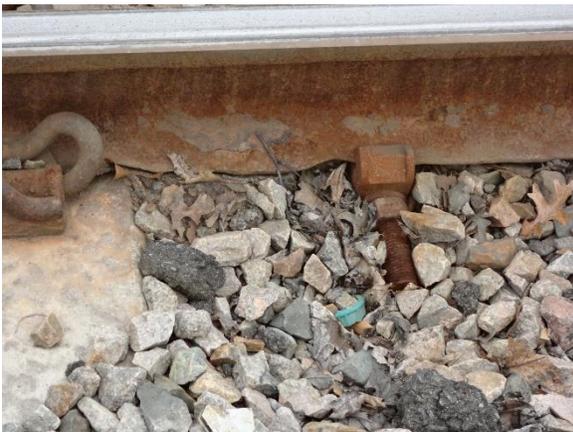
Figure 25 - Base Corrosion

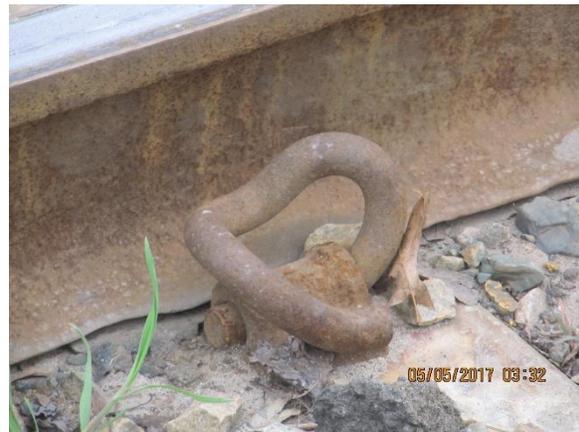
Figure 26 - Severe Base Corrosion, Most of Base Missing

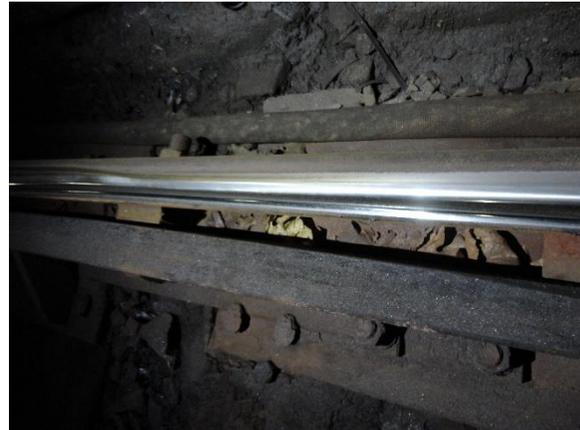
Figure 30 - 5/8" side wear in double restrained area indicating gauge deviation and worn restraining rail.

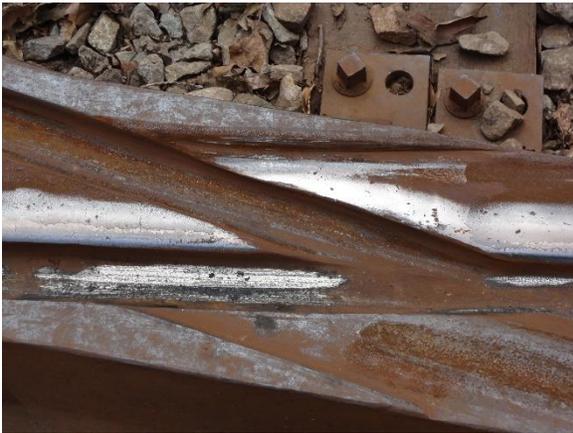
Figure 32- Worn flangeway and indications of impact from hollow tread wheels.

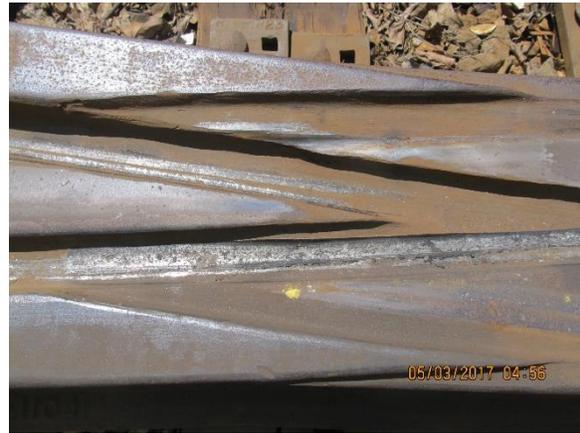
Figure 33- Worn Flangeway and Impact Damage to Frog from Hollow Tread Wheels.

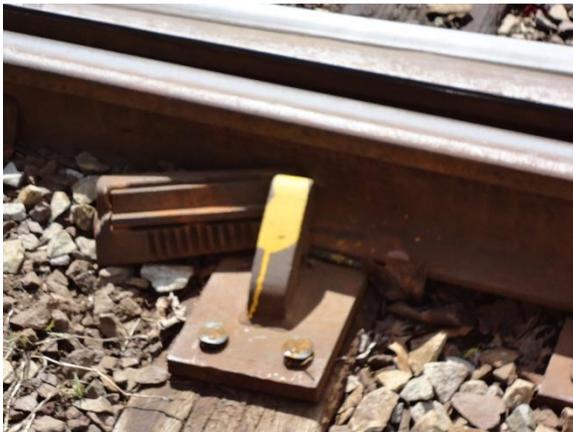
Figure 34 - Loose Wedges, Allowing Stock Rail Movement

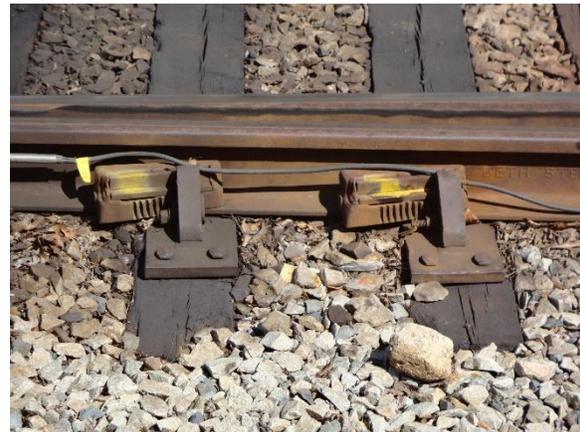
Figure 35 - Consecutive Wedges Loose, Allowing Stock Rail Movement and Gauge Widening

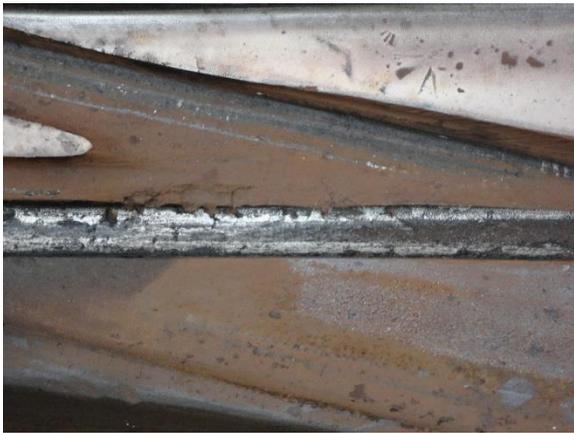
Figure 36 - Severe Flangeway Wear - Red Condition at 5/16"

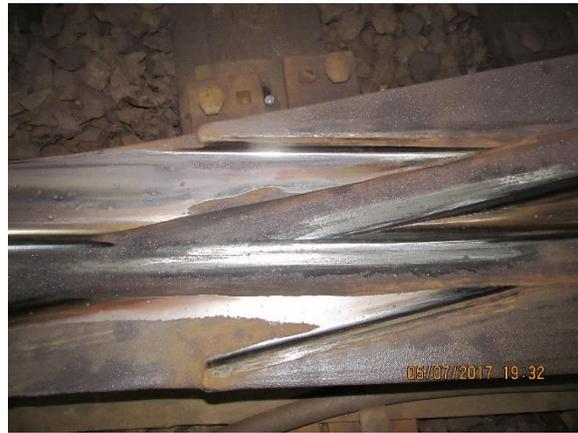
Figure 37 - Severe Flangeway and Tread Wear on Frog with Gauge Corner Spalling

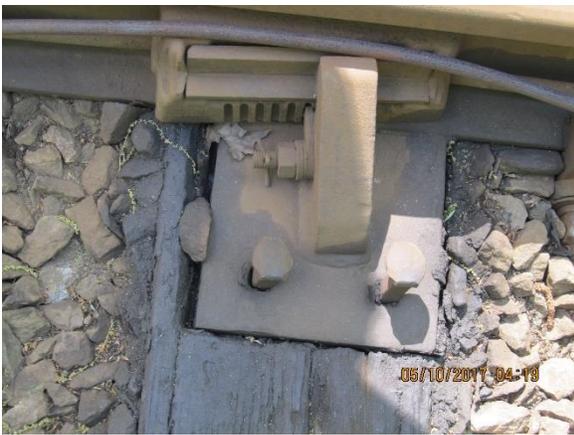
Figure 38 - Plate Cut Wedge Plate - Allowing Movement of Stock Rail

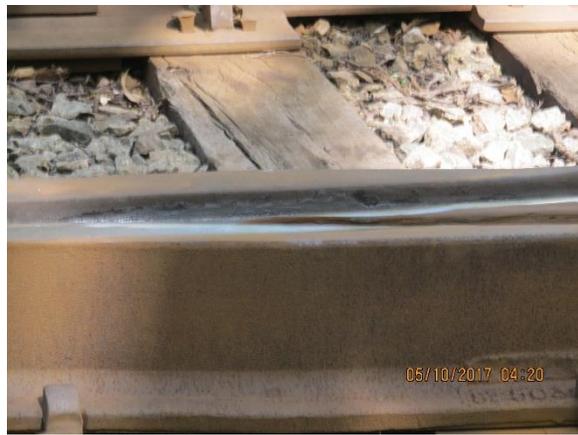
Figure 39 - Severely Worn Frog Point - 9/16" - Red Condition Frog Requires Replacement or Rewelding.

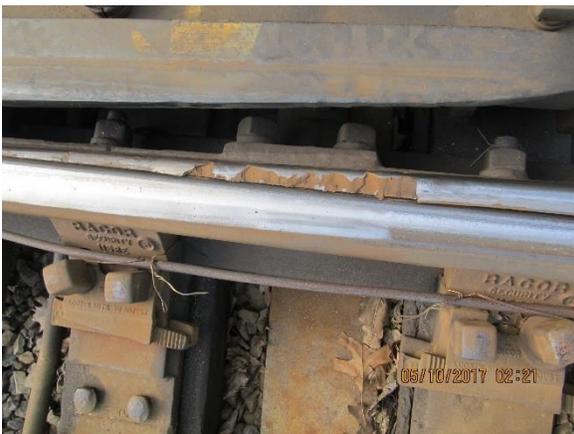
Figure 40 - Chipped Switch Point, Approx. 10" back from Point

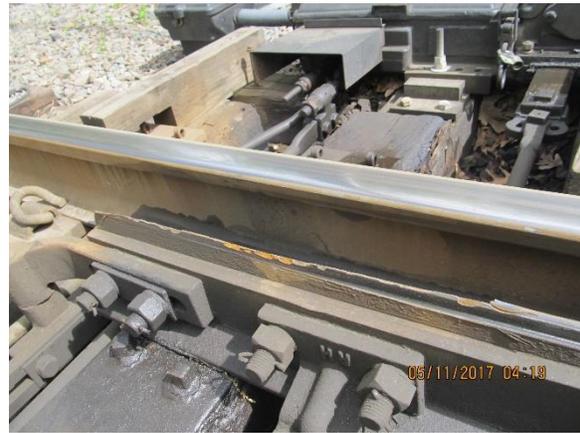
Figure 43 - Same Switch Point Showing total extent of chipping and wear.

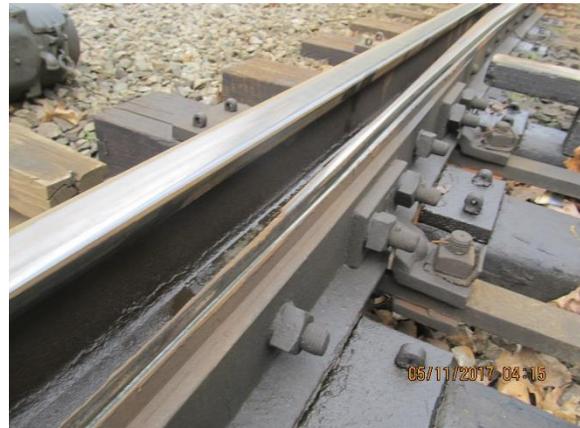
Figure 45 - Worn and Chipped Switch Point

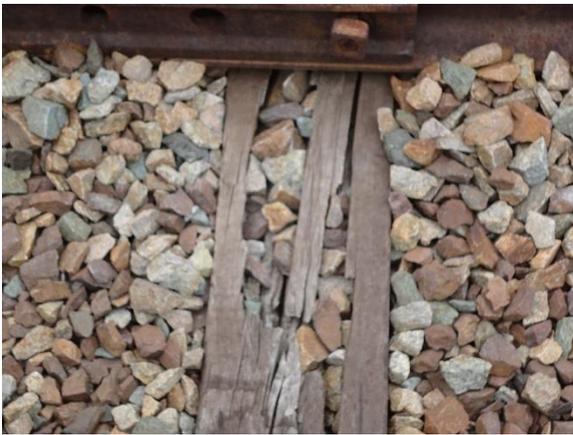
Figure 46 - Split Through Tie, No Fastener

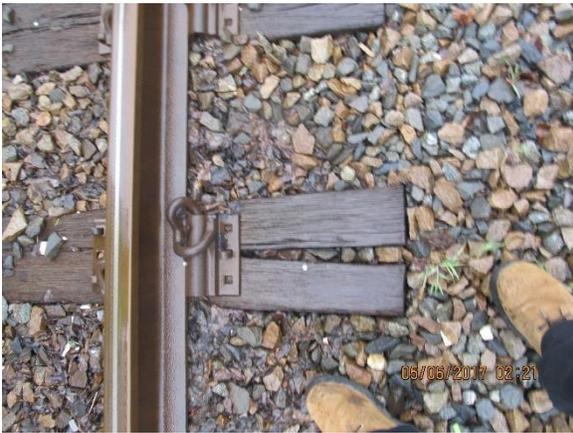
Figure 50 - Through Cracked Tie

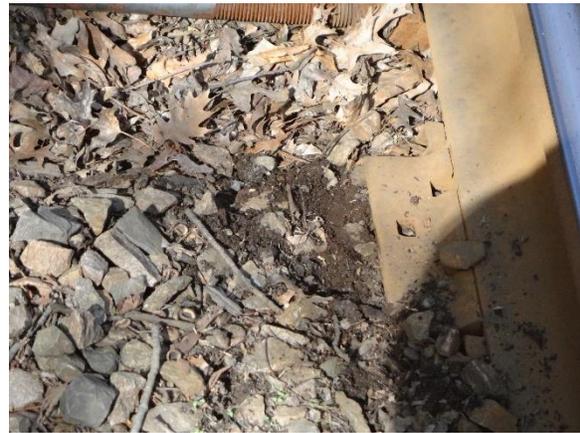
Figure 51 - Deteriorated Tie Under Debris

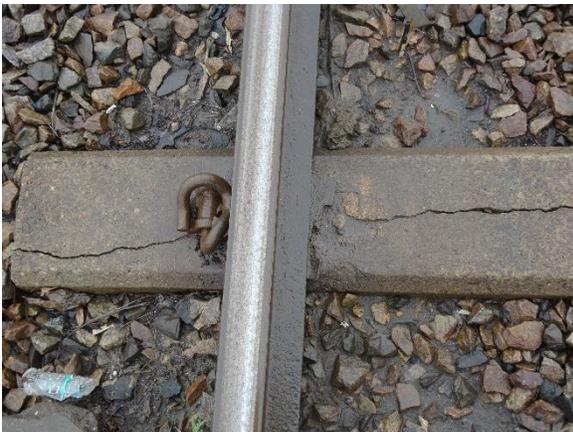
Figure 52 - Cracked Concrete Tie with Shoulder Casting Missing

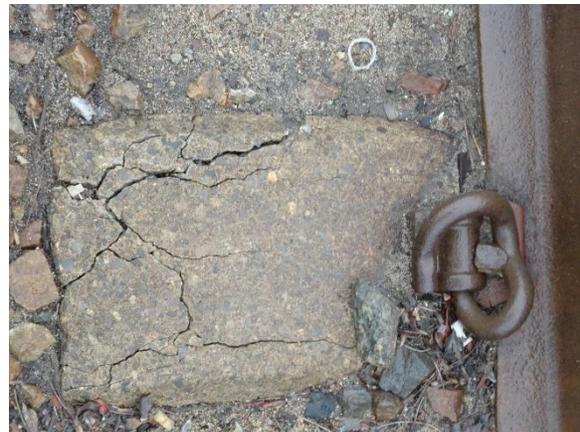
Figure 53 - Cracked Damaged Concrete Tie

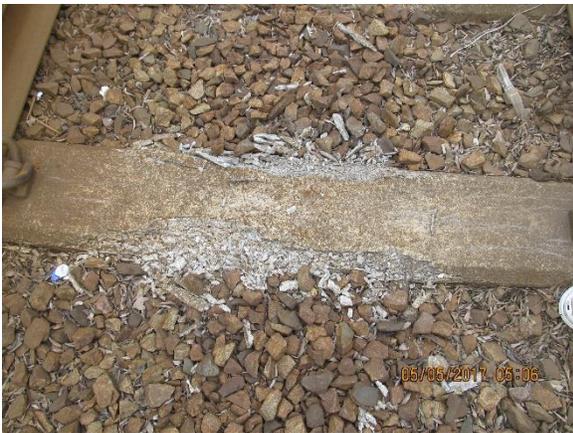
Figure 54 - Center Bound Tie

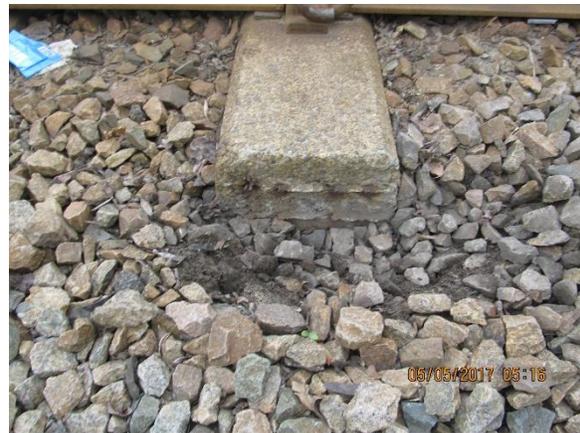
Figure 55 - Concrete Tie End showing corrosion on tension cables.

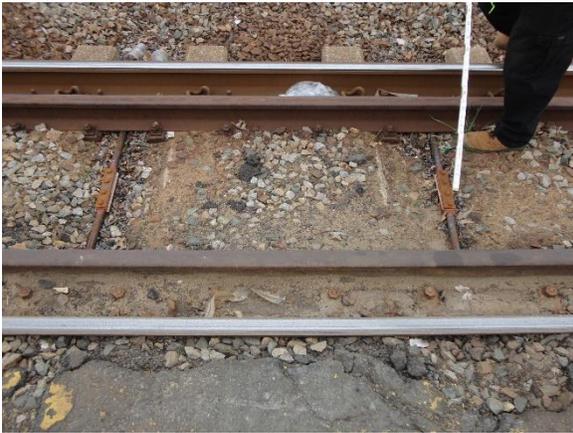
Figure 56- Due to coverage over ties - Conditions cannot be seen until there is a gauge issue.

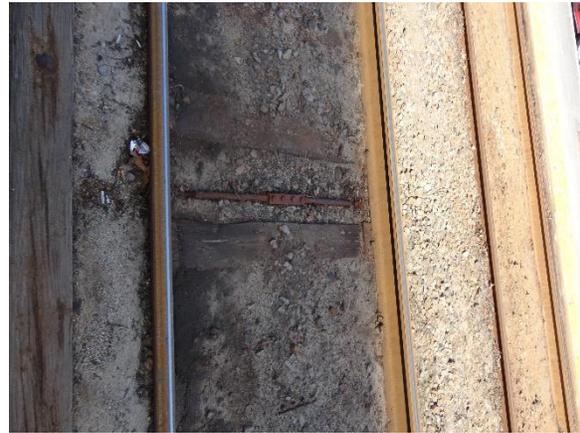
Figure 57 - Gauge Rod Installed in area where issue was only discovered after a gauge issue.

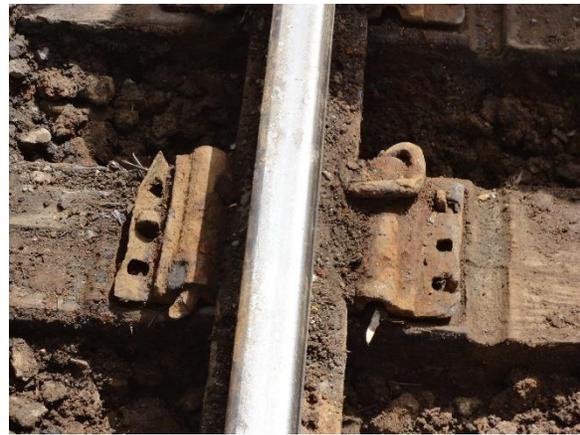
Figure 59 - Tie and Fastener Condition Under Removed Crossing.

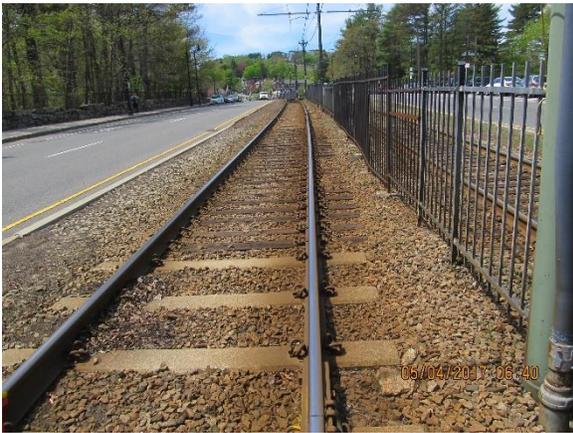
Figure 60 - Mixed Concrete and Wood Ties, Requiring Different Surfacing Maintenance

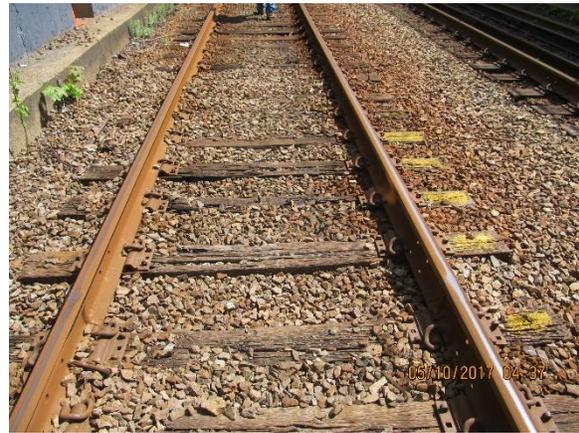
Figure 61 - Five Defective Ties in Row. Requiring a Speed Restriction.

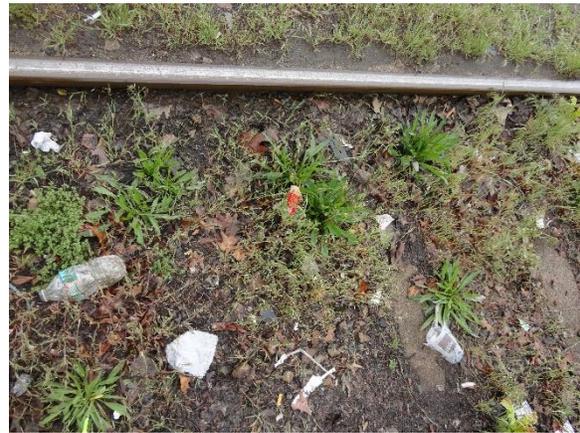
Figure 77 - Vegetation growth in severely contaminated ballast area. This ballast needs to be replaced.

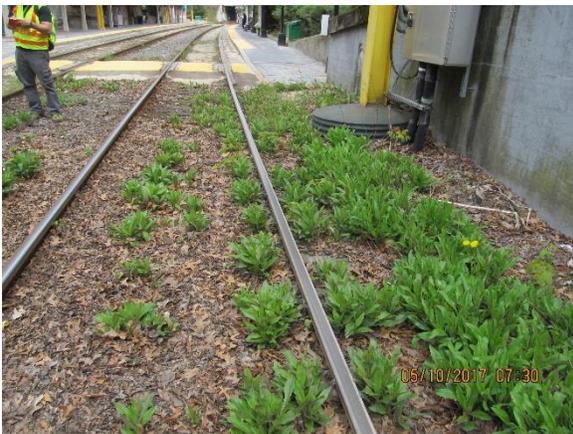
Figure 78 - Severely Contaminated Ballasted Area with Vegetation.

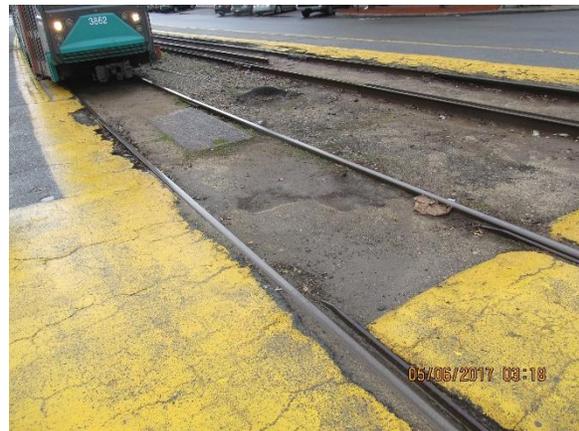
Figure 85 - Deteriorated Crossing and Platform ADA Edge that impedes Track Maint and Insp.

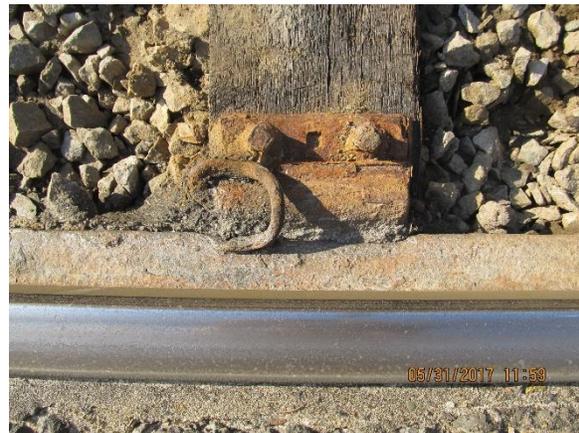
Figure 89 - Close-up showing corrosion which was hidden by sand and debris.

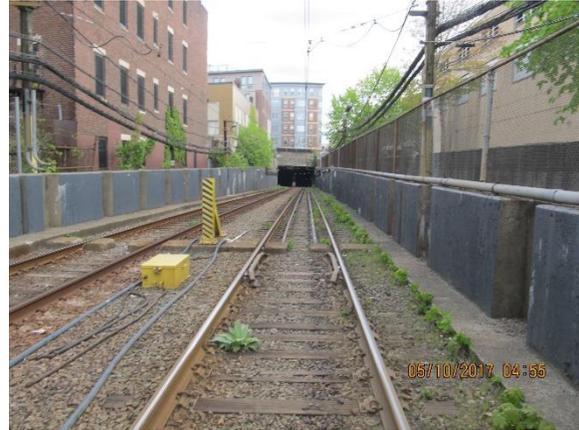
Figure 91 - Non-Functioning Rail Lubricator on Surface Track

Rail lubricators prevent wear which is a result of friction between the wheels and rails. Gauge side wear on the high rails of sharper curves is a common problem. Wear affects the life and performance of rails and wheels. The influential wear factors are: axle loads, lateral forces, longitudinal force, creepage, curve radius, gradient of the track, cant/superelevation, track gauge, surface conditions of the wheels and the rails, train speed, train length, frequency and type of trains, rolling stock performance, and operational and environmental issues.

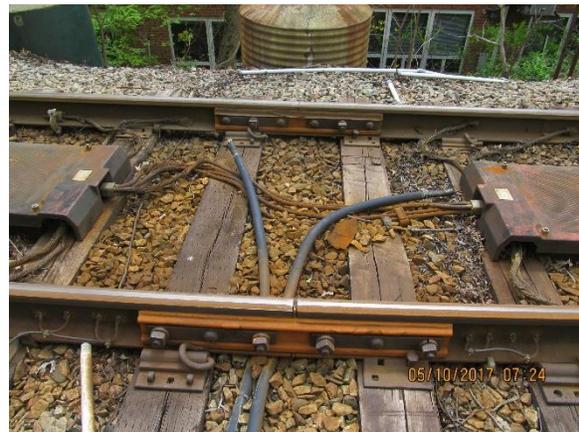
Figure 93 - Non-Staggered Joints on Wood Tie Area

Joint stagger is especially important in areas where there is poor ballast and sub-surface conditions. As a solid axle train passes over these locations they receive the full impact of both wheel loads on the axle. This causes surface pounding and eventually surface deviations at the joint locations. There are no joint stagger requirements in the MBTA Track Maintenance and Safety Standards, section LRT213.121. It is recommended that a minimum of 2' or one tie spacing, whichever is larger, for joint stagger requirements.

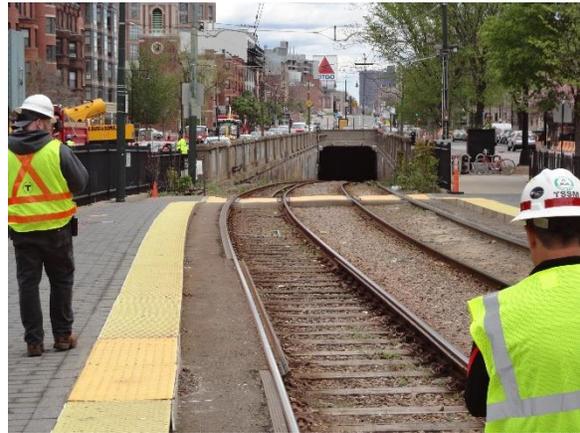
Figure 101 - Small section of girder rail mixed with tee rail.
