## **PRELIMINARY COLLISION RECONSTRUCTION REPORT**

Conducted for the El Dorado County District Attorney's Office

May 31, 2023, Major Injury Traffic Collision  
Pollock Pines, California

Case No: 63231097

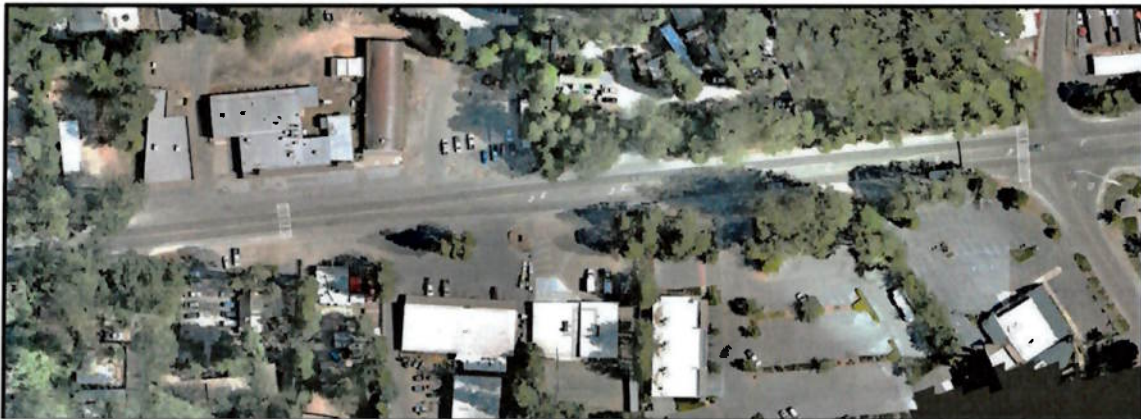
Drone Orthomosaic Photograph

The site assessment identified specific reference points, highway and environmental features, and the location of the video surveillance cameras. These items and the surrounding environment were documented and measured utilizing the equipment as outlined above. The TSSI survey and aerial drone imagery allowed for the creation of scale diagrams utilizing AutoCAD drawing software (the various scale diagrams are exhibited in the Annex section). A sample of the drone orthomosaic is shown below:

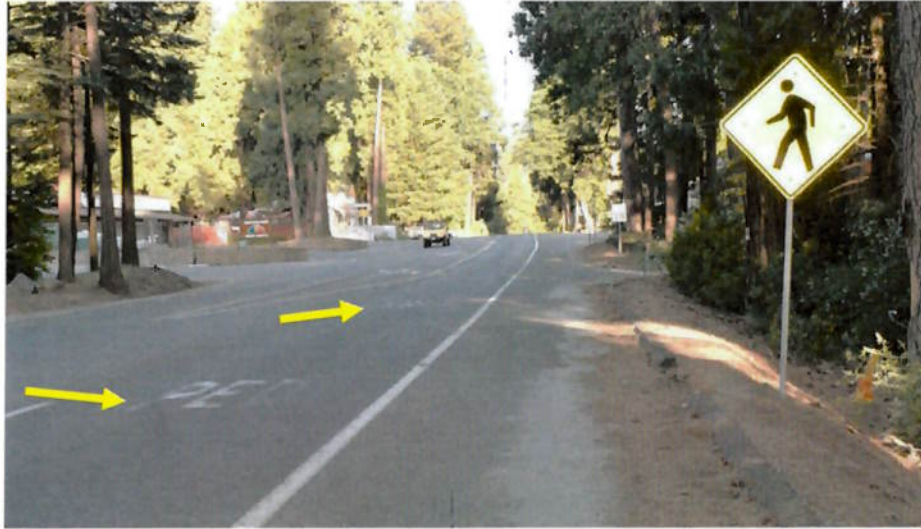
Photo #0072 (cropped)

The speed limit for Pony Express Trail was posted at 35 mph within the area of the collision. A speed limit sign for westbound Pony Express Trail was located 355 feet east of the marked crosswalk where this incident occurred. A black and yellow pedestrian crossing warning sign was posted for westbound traffic 512 feet east of the crosswalk. Roadway markings indicating “PED” and “XING” were painted on the pavement within the westbound lane beginning 510 feet east of the crosswalk (refer to the following photographs and the Collision Environment Diagrams in Annex A).

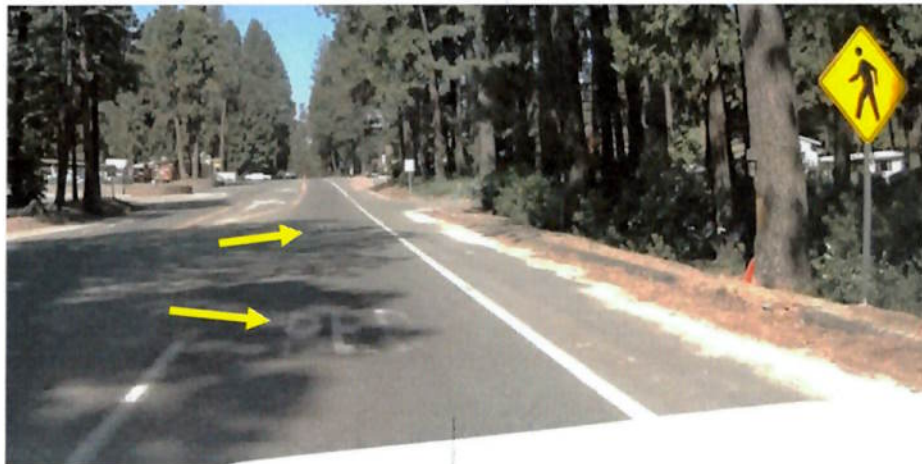
Screen Capture from Drive-thru video “63231097 DT Video 1042 Hrs”

The following images are scene captures taken during video recorded drive through testing we completed on the morning of June 4, 2023. At 10:42 am the sun was positioned southeasterly of the incident location. The many large trees located along the south side of Pony Express Trail created shadows that extended into the westbound travel lane in the area where the “PED” and “XING” markings were painted on the pavement.

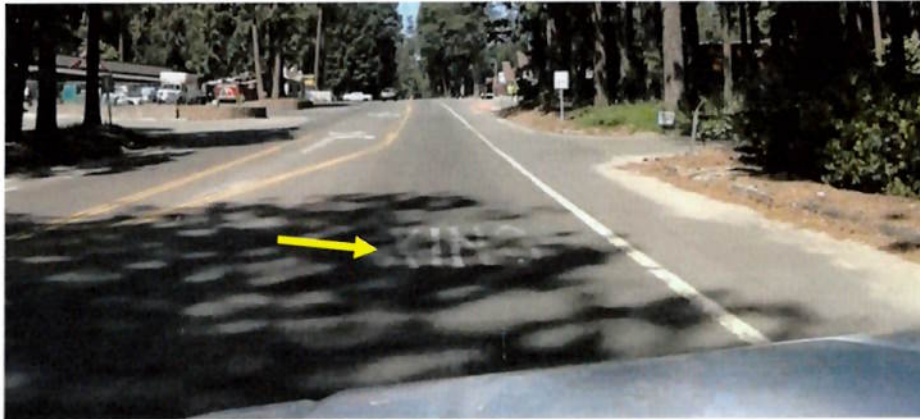
Screen Capture from Drive-thru video "63231097 DT Video 1042 Hrs"

The westbound lane of Pony Express Trail is relatively tangent from the intersection with Sly Park Road with a slight left horizontal curve located between Hub Street and the crosswalk where the collision occurred.

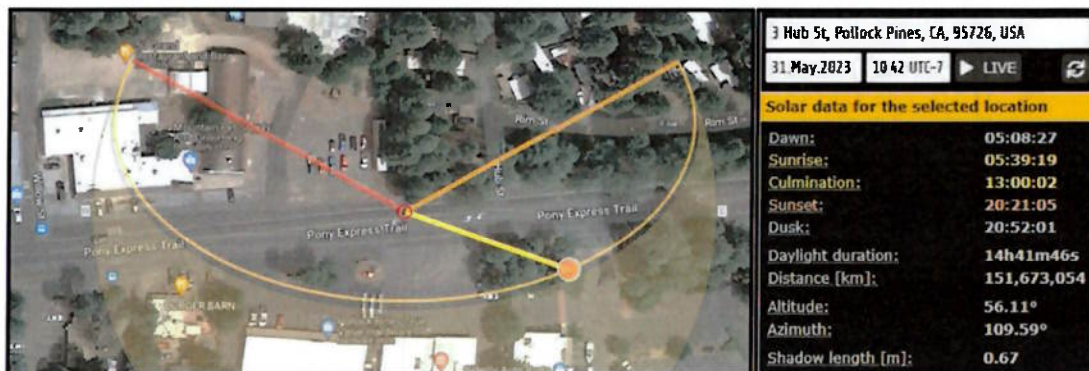
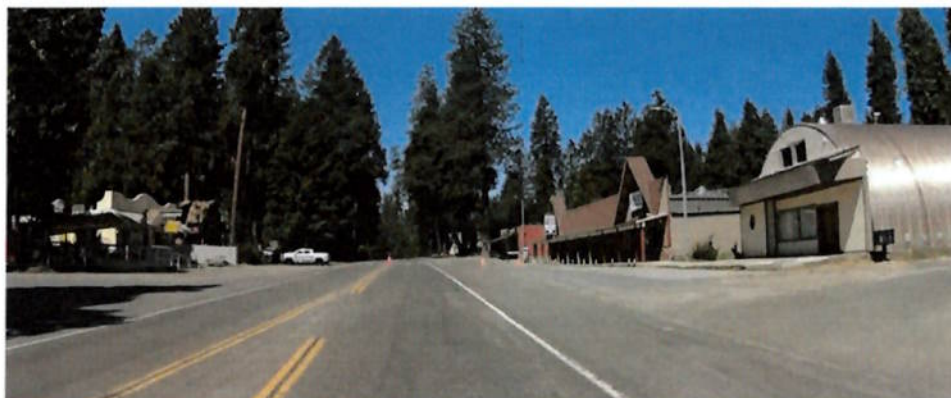
Screen Capture from 10:42 am Drive-thru video "63231097 DT Video 1042 Hrs"

- Sunrise was 5:39 am, with culmination<sup>8</sup> at 1:00 pm. At 10:42 am, the sun was at an altitude<sup>9</sup> of 56.11 degrees and an azimuth<sup>10</sup> of 109.59 degrees. The position of the sun would be behind and to the left of a westbound driver as noted in the following graphics:

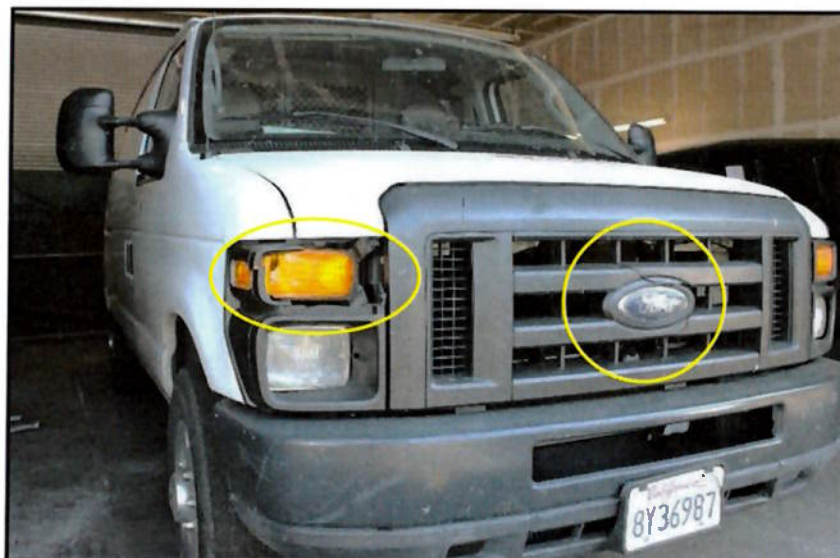
Photo #4604

An assessment of the Ford E150 3-door cargo van was conducted on June 13, 2023, at the Extreme Towing impound facility. Minor pre-existing external damage was observed around the entire van. Collision related contact and induced damage, consistent with the impact with the two male children, was observed to the plastic bezel surrounding the right front amber parking light and the plastic front grille in the area of the *Ford* emblem (refer to the yellow circles in the following photograph). Blood smears were observed to the left side of the van near the trailing edge of the driver's door.

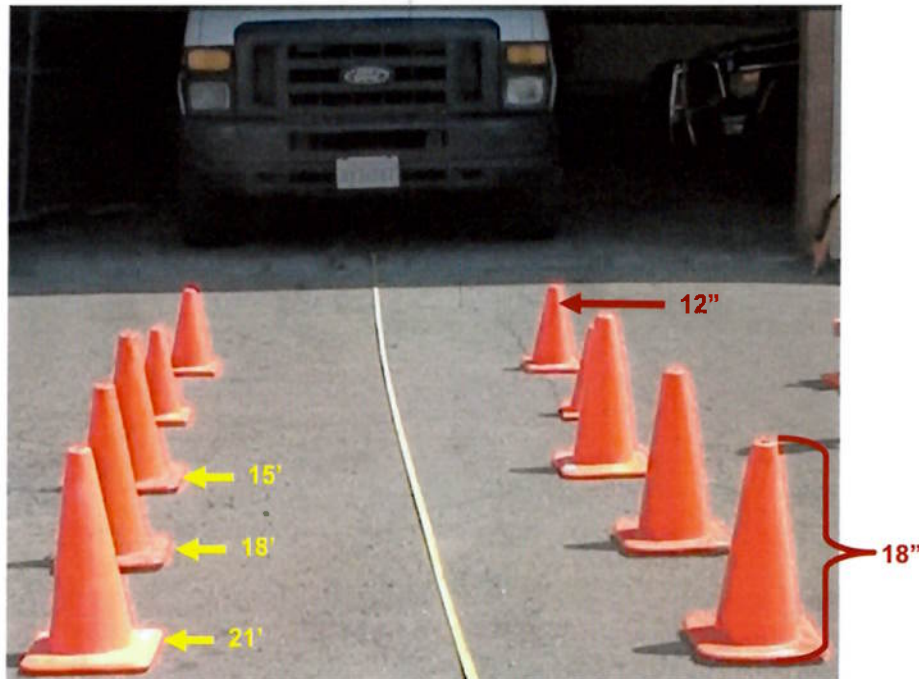
Screen Capture from video "63231097 Ford Frontal Damage"

During the inspection of the Ford, a series of 12 and 18-inch orange traffic cones were placed at three-foot-intervals in front of the stationary vehicle. The furthest pair of cones were located 21 feet ahead of the Ford's front bumper.

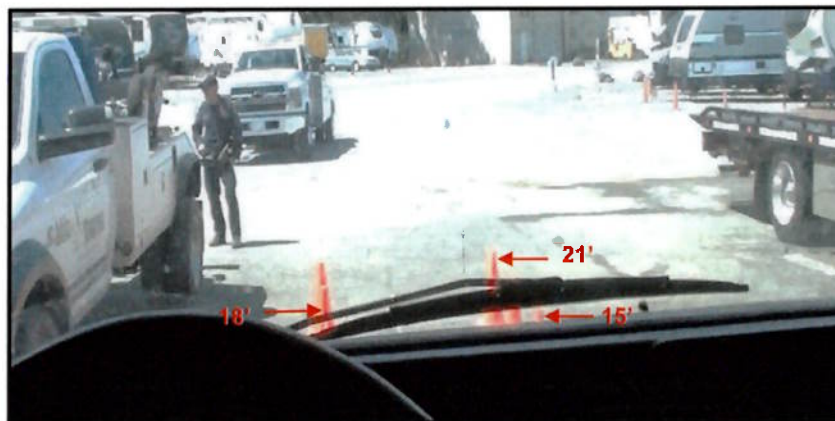
VideoMach Image A14.PNG

Video footage was recorded from the driver's seat of the Ford looking forward through the van's windshield using a Sony HDR-XR150 video camera held at eye height of a 5-foot 9-inch-tall male.<sup>12</sup> VideoMach video editing software was used to separate the video into individual still-frames. The following frame represents the general view from the driver's seat of the Ford looking forward directly ahead of the van:

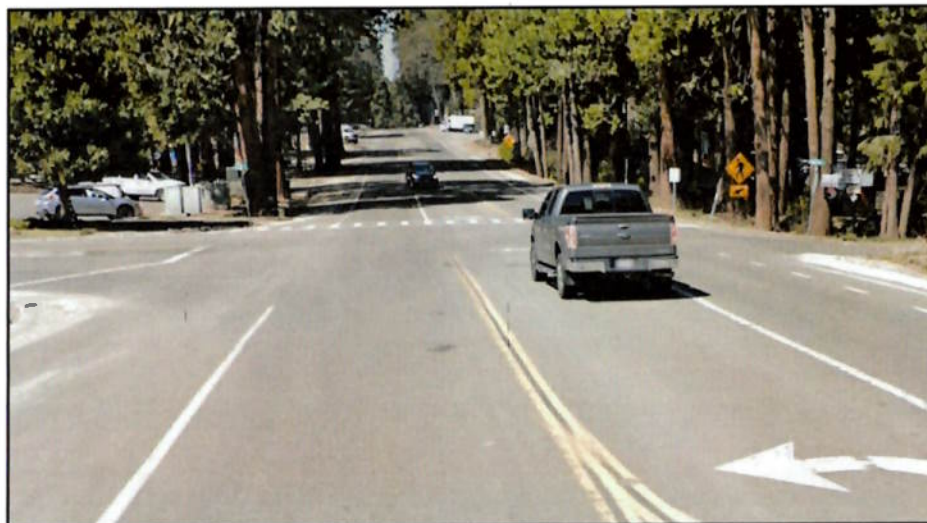
Google Earth Pro Image (view toward the west from east of Forebay Road)

Line-of-sight visibility assessments were completed at the collision site during the morning hours of June 4, 2023, utilizing video and still photography. The area where the crosswalk traversed Pony Express Trail was easily visible to a westbound driver for a considerable distance due to the tangent alignment of the roadway and the ascending grade toward the collision site.

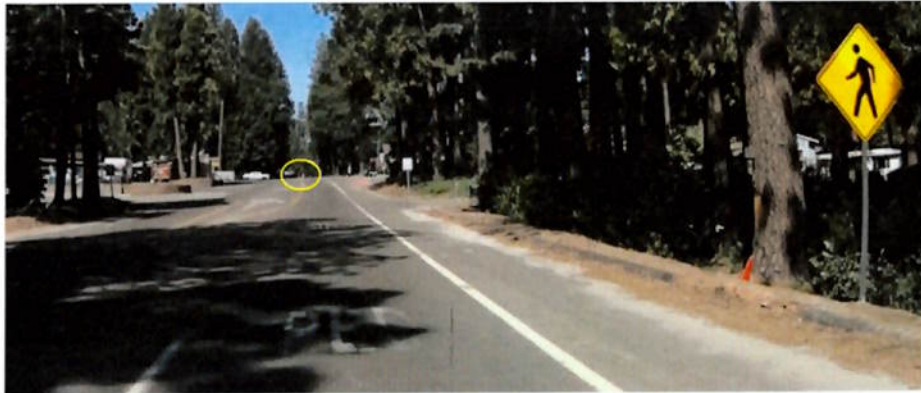
Screen Capture from Drive-thru video "63231097 DT Video 1042 Hrs"

The following image represents the forward view of a driver traveling west on Pony Express Trail from a location 525 feet east of the crosswalk where the pedestrians were crossing the roadway.

Imaged was recorded at 10:42 am on June 4, 2023

The yellow circle highlights a 30-inch traffic cone that was located at the crosswalk

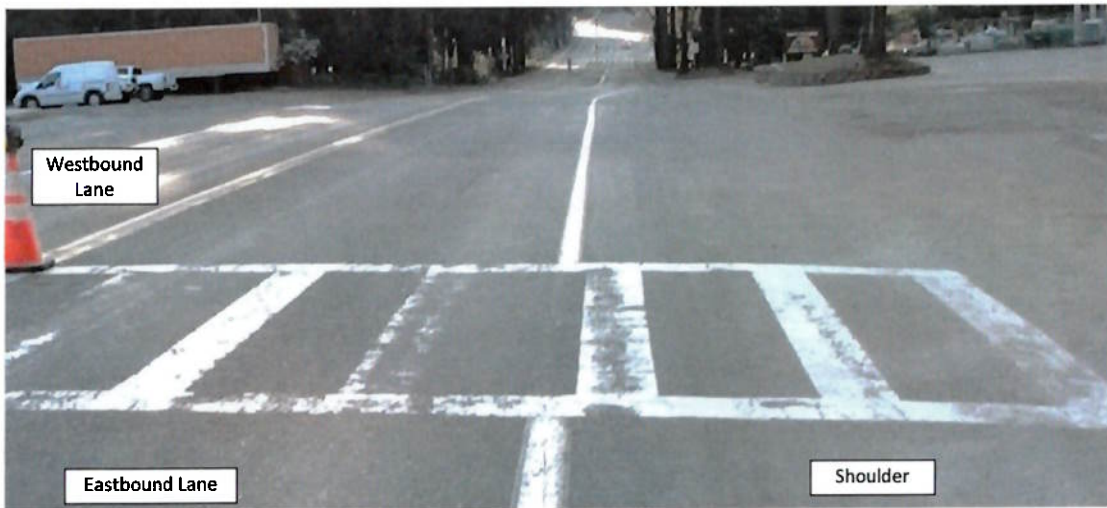
Screen Capture from scene video "63231097 Site 3"

The corresponding view from the pedestrians vantage point is shown in the following image.

View is toward the east from the south shoulder of Pony Express Trail

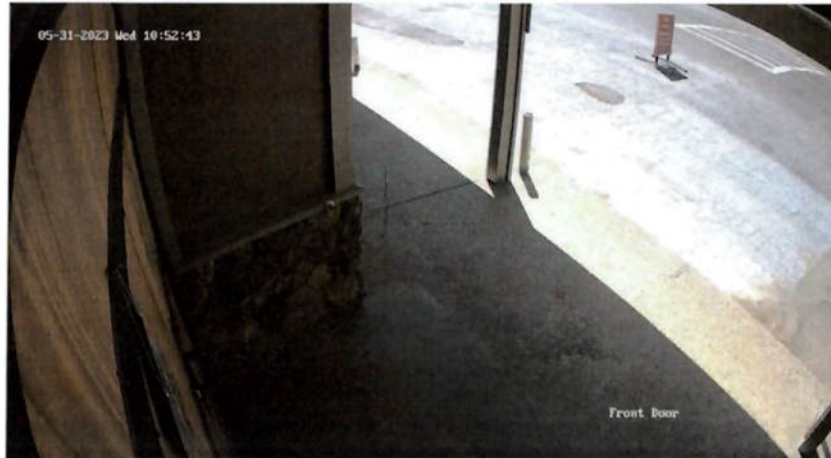
- CH03: Mounted above the entrance to the restaurant with a southerly view of the area in front of the door
  - ch03\_20230531105245.MP4
  - ch03\_20230531114604.MP4

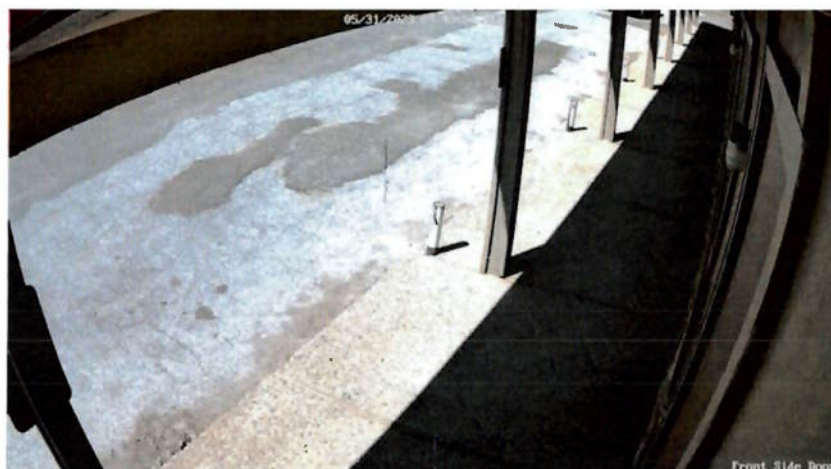
- CH21: Mounted at the front of the restaurant near the eastern-most door with a westerly view of the area directly in front of the building
  - ch21\_20230531105245.MP4
  - ch21\_20230531105251.MP4
  - ch21\_20230531105838.MP4
  - ch21\_20230531112115.MP4
  - ch21\_20230531114400.MP4

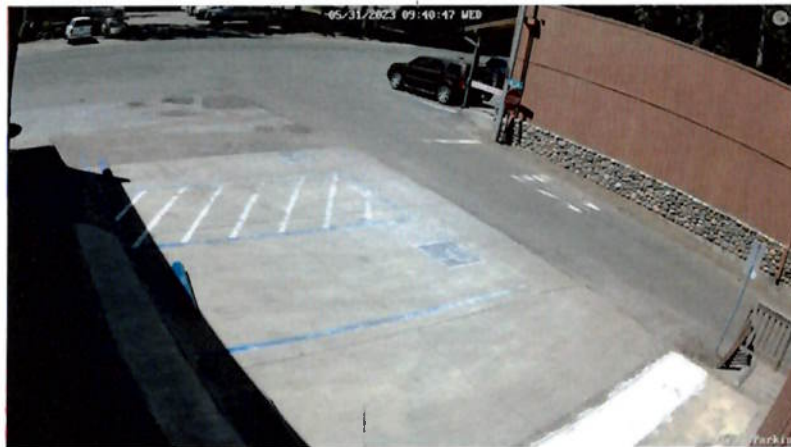
- CH24: Mounted at the east side of the restaurant with a southerly view of the area and Pony Express Trail
  - ch24\_20230531105245.MP4
  - ch24\_20230531105251.MP4
  - ch24\_20230531110724.MP4
  - ch24\_20230531112947.MP4
