CONDITIONS ASSESSMENT REPORT

Shawnee Indian Manual Labor Boarding School

Shawnee Tribe Cultural and Historical Preservation Committee | December 6, 2021

Architectural
Resources Group

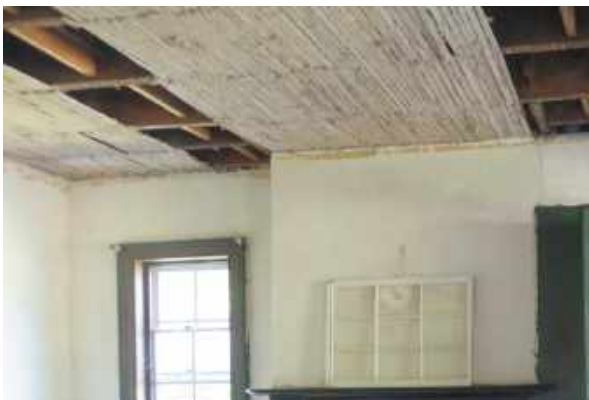
West Building. Missing ceiling in the first floor west room. Note the ghosting from a crown molding.

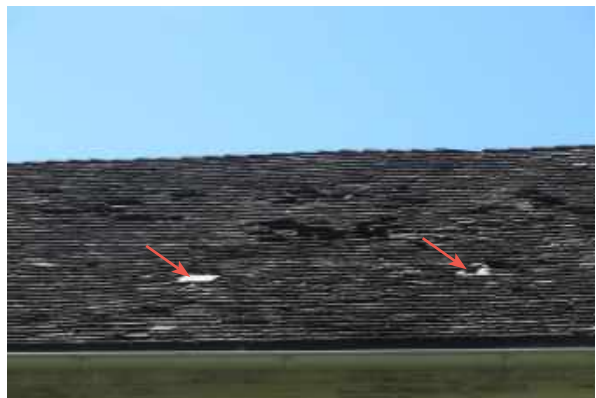
Lifting and curling shingles. Note the plastic sheets used instead of shingles, indicated with red arrows.

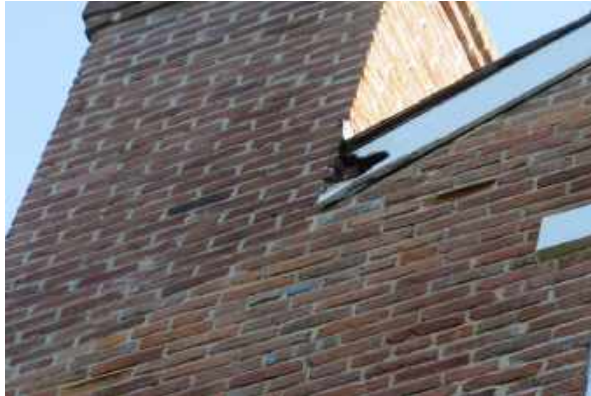
North Building. Hole in fascia panel on west elevation.

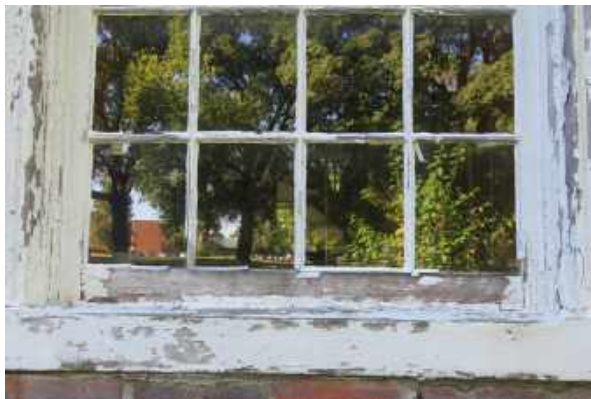
Paint and glazing putty deterioration at a north elevation window.

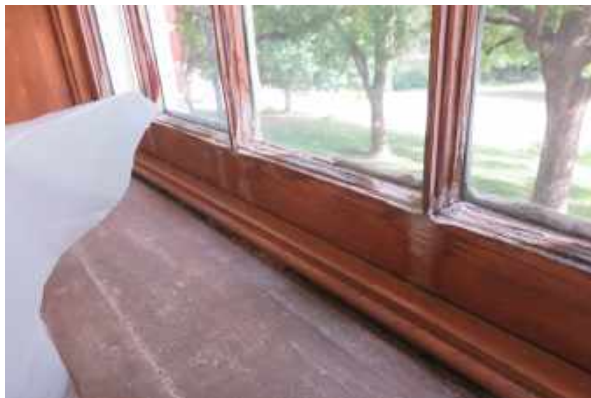
North Building. Water damage at new sash, deteriorating finish at window sill.

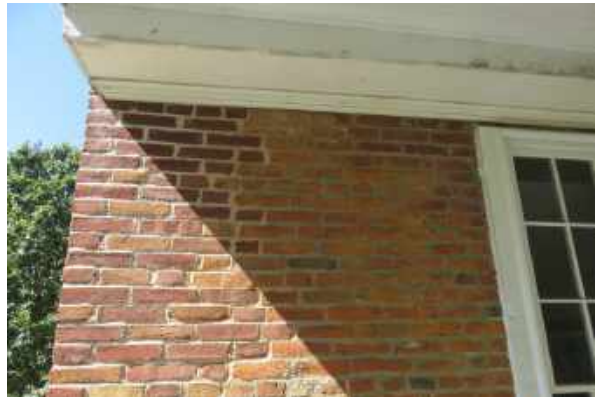
Repointing at an area of brick replacement. Note the different colors of mortar and the yellow coating on the bricks to the right.

- The crack in the masonry should be repaired and the brick should be repointed. A mortar analysis should be completed to identify the original mortar. A new repointing mix should match the original in color and should be compatible with the historic masonry.

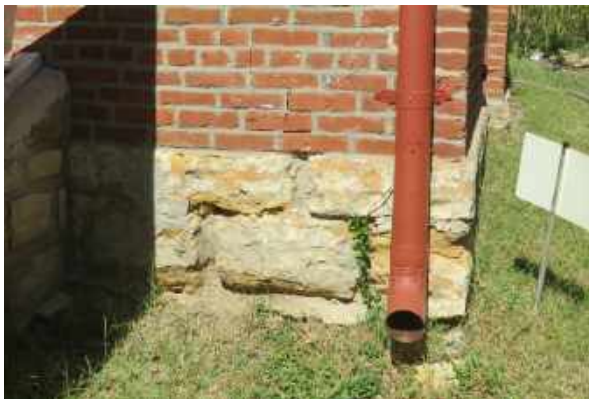
Open joints and previous repointing efforts at the ashlar foundation.

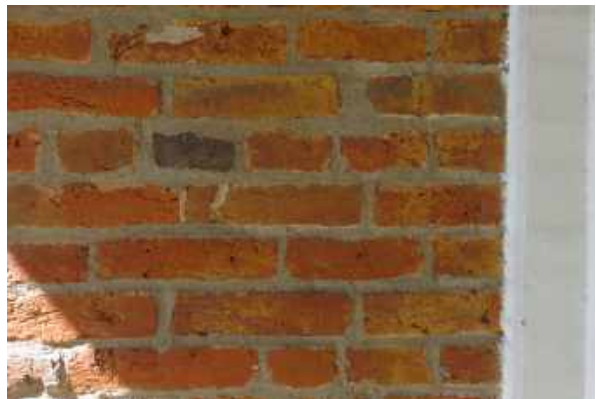
Brick with traces of yellow coating.

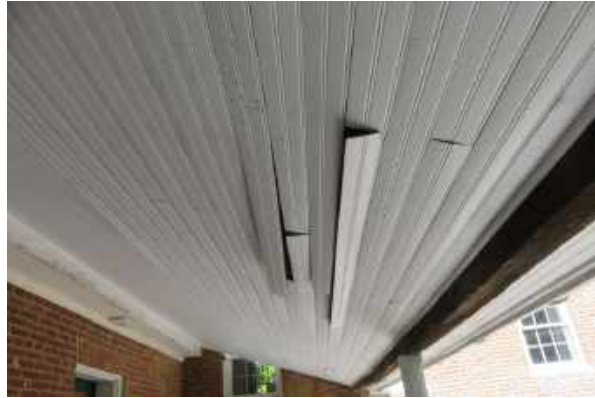
Falling cladding at the second floor of the east porch.

- The porch floors should be inspected annually for paint deterioration. As paint is the first line of defense for wood, areas of bubbling, cracking, or peeling should be removed and repainted.
- Depending on the amount of foot traffic it may be necessary to repaint areas of the floors every 2-3 years.
- Areas of standing water should be cleared with a broom after rains.
- Wood trim elements should fit snugly together to minimize gaps and seams.

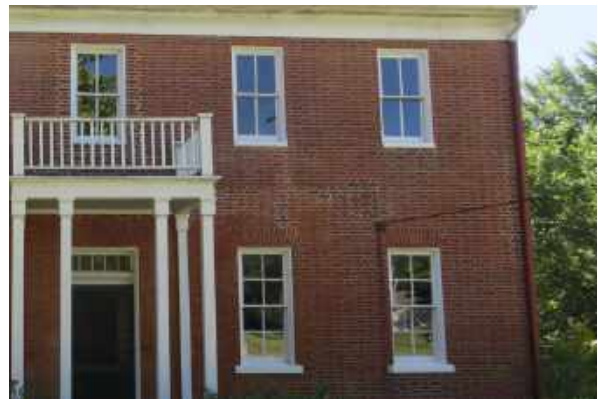
Window pattern at the north elevation.

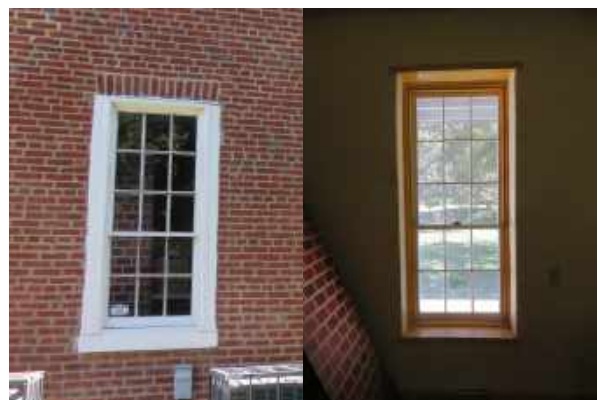
Nine over six double hung window, exterior and interior from the rear addition.

- Window and door hardware should be repaired as needed. Ghosting from previous installations should be patched and repaired.
- Glazing putty should be replaced and any deteriorated wood should be repaired before the windows are repainted.
- Condition of perimeter sealant at windows and doors varies, with the windows generally in better condition. All sealant should be replaced, and can be done so on the same schedule.
- Most of the windows are operable, with friction stops located on the tracks but require a tune up to function easily.

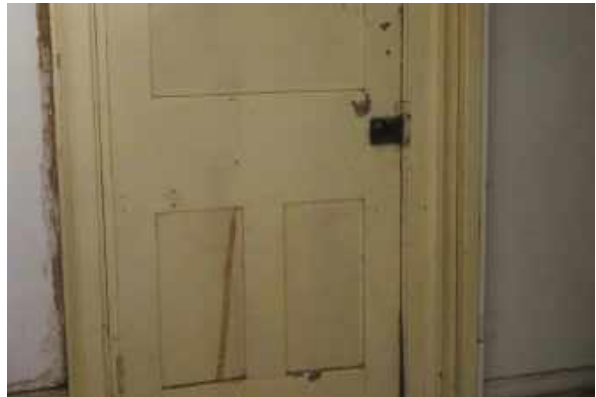
Old box lock on the porch door. Note the repaired wood check in the lower left panel.

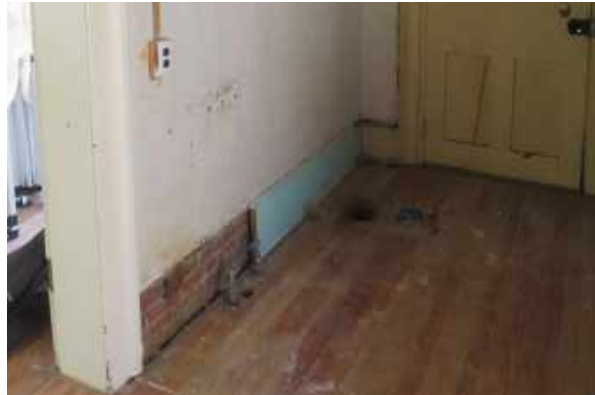
Exposed portion of brick wall below plaster in foyer.

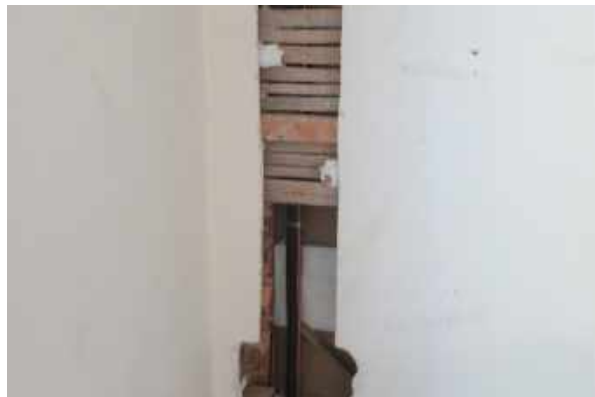
Opening in rear addition south room showing lath behind wallboard.

- Water stained or damaged plaster should be assessed and replaced as needed. Note that in many cases, if the source of water has been removed the staining may be cosmetic and can be concealed with paint or wallpaper.
- Damaged or missing wallboard or plaster should be replaced in kind.
- Plaster cracks should be repaired in kind.
- The floors should be refinished and repaired as needed. Holes should be filled and heavily damaged boards should be replaced to match the existing.

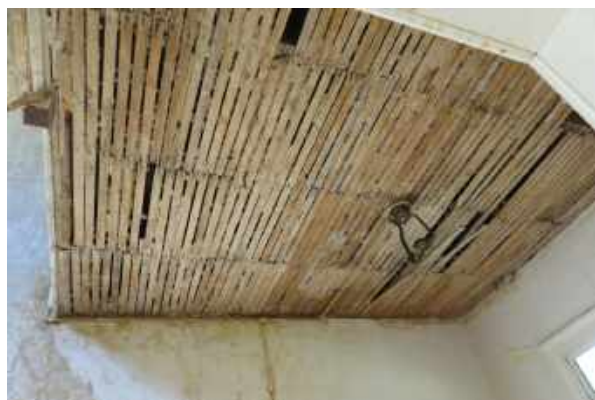
- Nearly all interior finishes in the original structure are heavily worn, damaged, or missing. In many areas the plaster shows signs of cracking and water damage.
- Many rooms have cracking plaster around windows, doors, and in corners. Some windows show signs of multiple previous repairs.
- In the original structure the plaster ceilings in the foyer and west room have been lost and the lath is exposed.

Exposed lath in foyer.

- Exposed lath should be inspected and new ceilings should be installed. Where ceilings are intact but require repair, the lath should be inspected and plaster repairs should be completed. Where whole ceilings are missing, replacement with wallboard may be appropriate depending on historic documentation.
- Moldings and other trim should be replaced or reinstalled based on historic documentation.

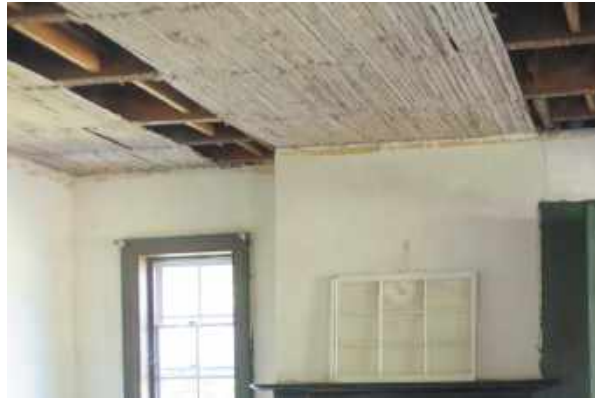
- There is ghosting from a crown molding in the west room of the first floor of the original structure.
- The ceiling of the second floor north bedroom in the rear addition is in poor condition, with damaged wallboard at the center of the room.

Missing ceiling in the west room. Note the ghosting from a crown molding.

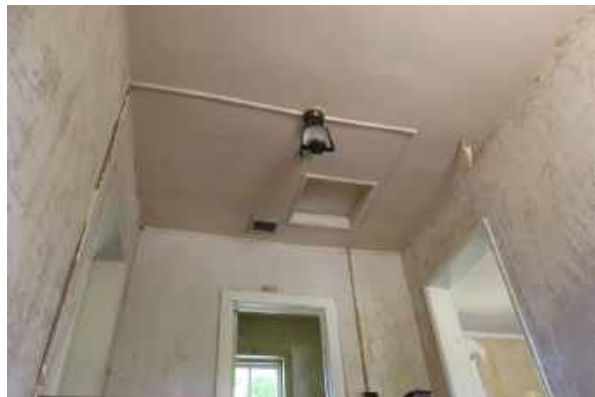
Wallboard ceiling at the second floor landing. Note the surface mounted conduit. The east and west walls of the foyer and stair are solid masonry with no room wiring behind the plaster.

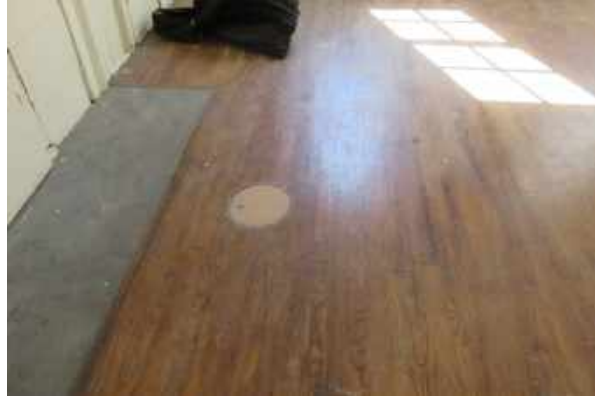
- The east rooms at the first and second floors and the stair landing at the second floor have multiple patches over holes in the floorboards.
- A section of baseboard is missing in the foyer, corresponding with piping and holes in the floor suggesting there was a radiator in this location.

Repaired hole in the floor of the first floor east room.

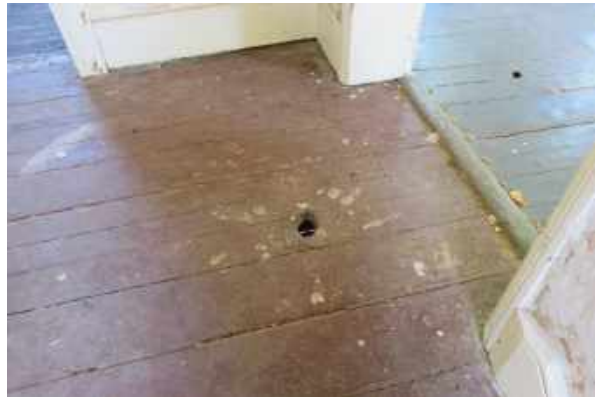
Holes in the floor of the second floor landing and second floor east room.

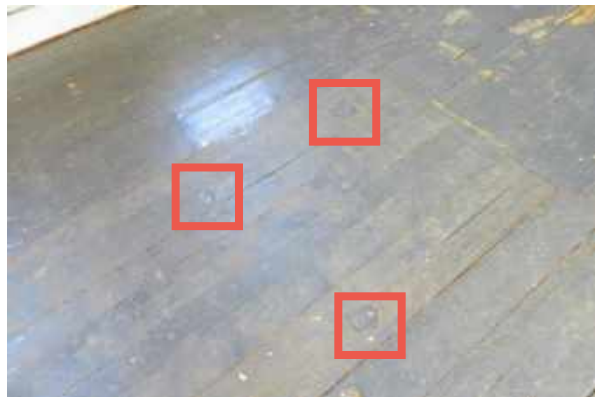
Repaired holes in the floor in the second floor east room, outlined in red.

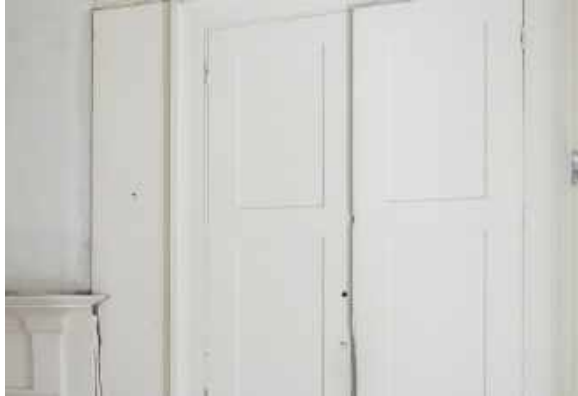
- The built-ins in the first floor east room are in poor condition. Much of their hardware is missing or painted over. The other built-ins have been converted to closets and are missing their original doors.

Missing and over-painted hardware on built-ins.

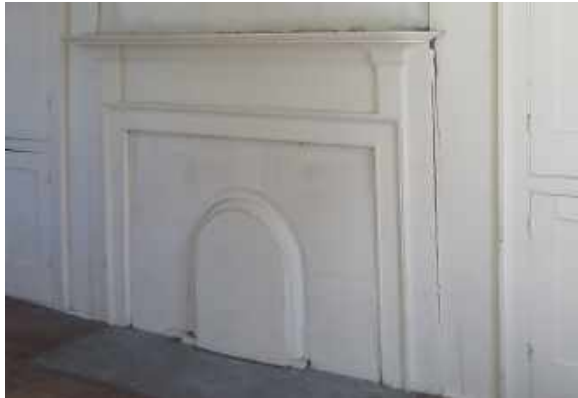
- The fireplaces in all but the first floor west room have been filled in. The west room fireplace appears to have been modified.
- The mantel in the first floor east room is pulling away from the wall. This may be an old condition, the floor was reinforced due to sagging.

First floor east room fireplace and mantel. Note the separation at the right side.

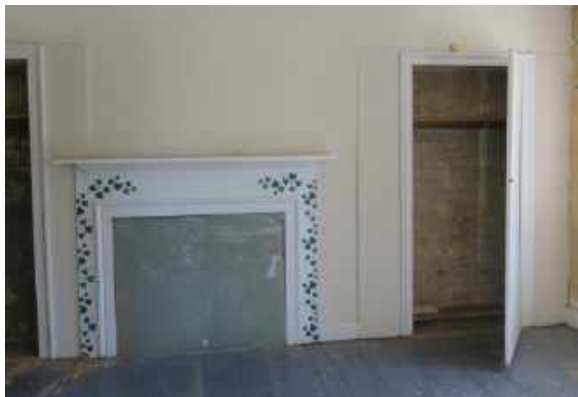
Covered fireplace in second floor east room. Note that the built-ins may have been converted to closets relatively early, as this is a mortis and tenon panel door, not a modern hollow door.

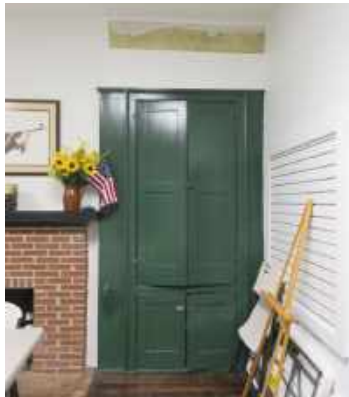
Conference room built-in. Note the paint reveal showing stenciling above the cabinet.

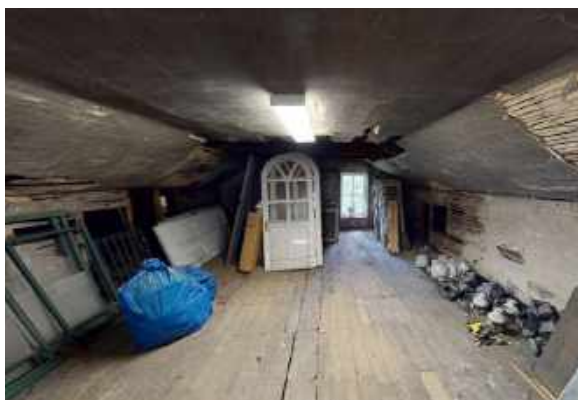
Attic, looking north.

- The attic is in very poor condition. The floor is uneven and there are large sections of damaged and missing plaster. The attic is not currently interpreted by the museum, it is a storage area and contains HVAC equipment.

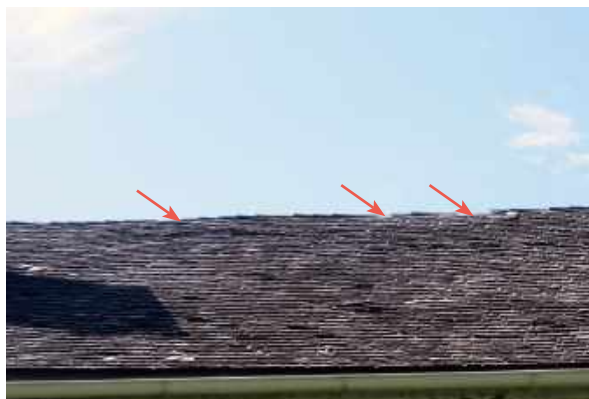
- The roof of the East Building as well as the awnings over the entrances on the east and west elevations are in poor condition, with large areas missing, displaced, and lifting shingles. Many of these areas can be identified from the attic as sunlight streams into the space. Many of the shingles along the ridge beam are missing. There are signs of previous repairs, including the use of plastic sheets instead of shingles in several areas.

Sections of missing shingles at the ridge beam, indicated with red arrows.

- The roof of the building and the awnings should be replaced. At this time, damaged flashing should be repaired or replaced, and all sealant should be replaced. Given the potential

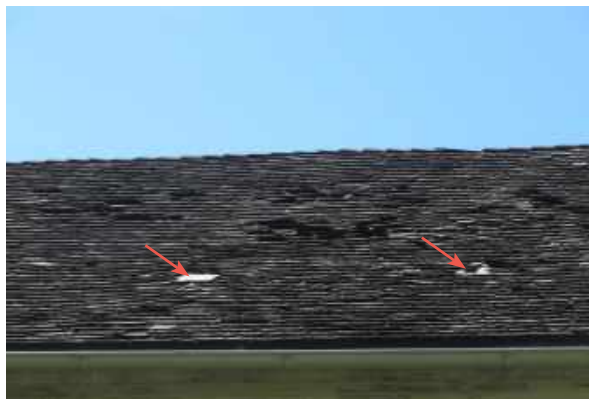
Lifting and curling shingles. Note the plastic sheets used instead of shingles, indicated with red arrows.

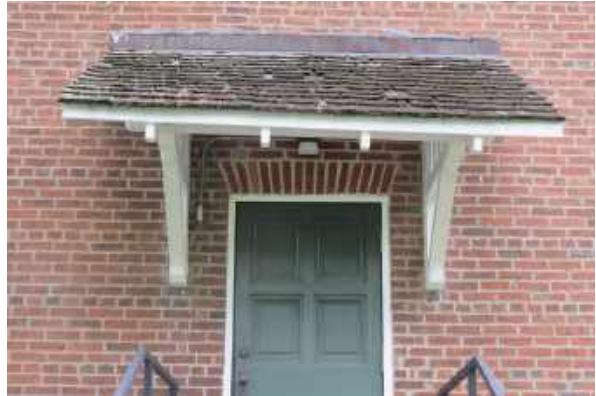
- The awning at the north entrance on the west elevation is sagging to the right side. There are gaps in the seams between wood elements and masonry on the right side.

Sagging awning at the northwest entrance. Note the failed sealant at the flashing above the awning.

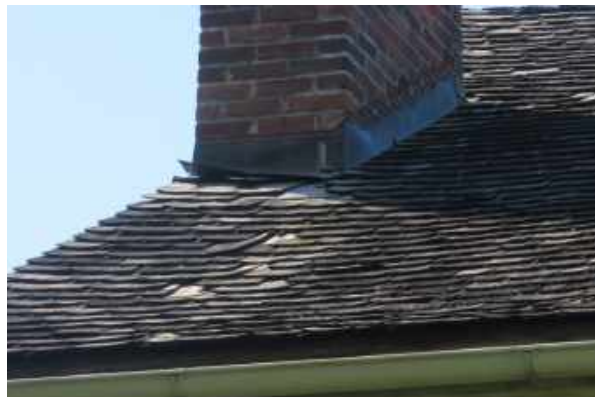
- A section of flashing at the southeast chimney is curling and no longer sits flat with the roof.
- The sealant used to secure the flashing to the chimneys and at the joint between the masonry and the awnings are heavily deteriorated and cracked.

- A section of flashing at the south chimney is curling and no longer sits flat with the roof.

Lifting flashing and deteriorated sealant at southeast chimney.

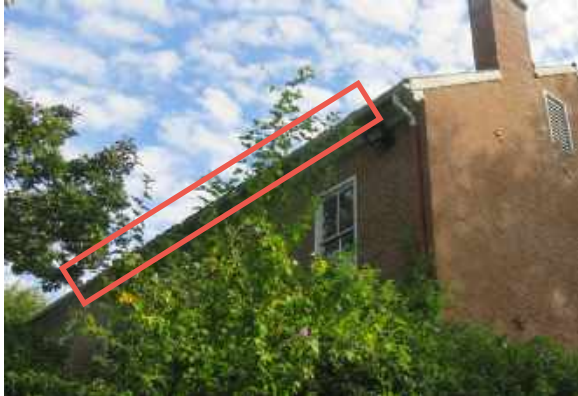
- The north section of gutter on the west elevation is filled with pine needles.
- The south section of the gutter on the west elevation is bent.
- Paint on the soffit panels is heavily deteriorated and weathered. The vents have been painted over to varying degrees, from partially to completely blocked.

Area of damaged gutter outlined in red. Note you one can see the edges of the shingles due to the bent gutter.

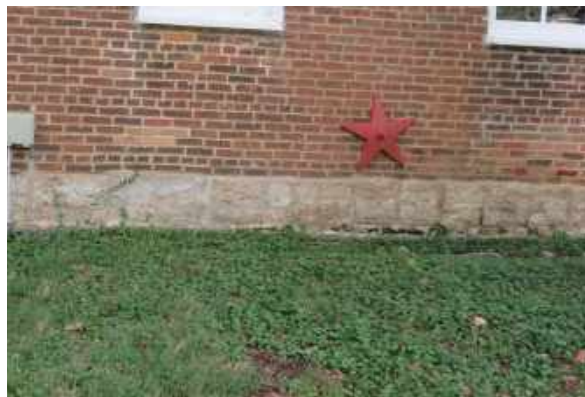
Open joints and plants growing in the gaps of the stone foundation.

- The foundation should be repointed. A mortar analysis should be completed to identify the original mortar. A new repointing mix should match the original in color and should be compatible with the historic masonry.

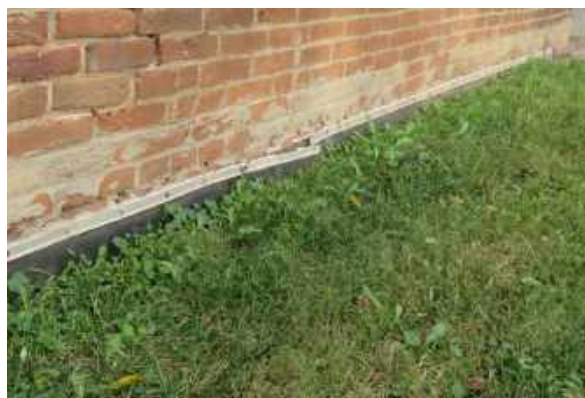
Location of the waterproofing membrane pulling away from the masonry.

- The waterproofing membrane should be reattached to the masonry where it is coming loose.
- The northwest staircase should be repaired. Failed patches should be removed and the railing should be re-set in at the base of the stairs.

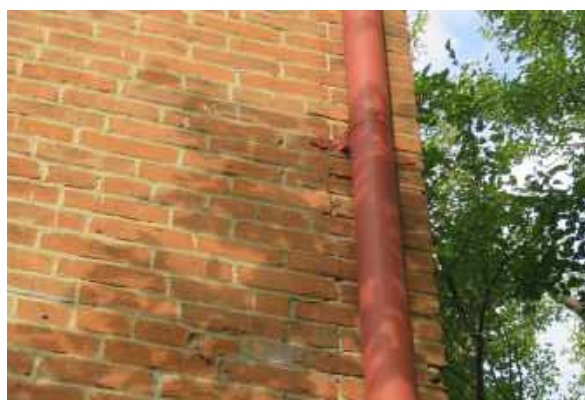
Open joints behind downspout at northeast corner.

- Open joints should be repointed with a mortar compatible with the bricks and uniform in color. A mortar analysis should be completed to identify the original mortar. A new repointing mix should match the original in color and should be compatible with the historic masonry.

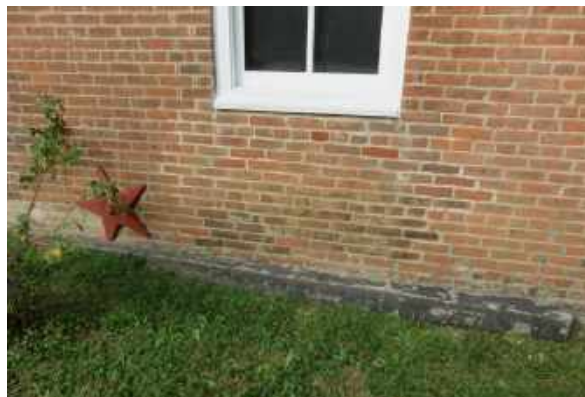
Area of repointing and brick replacement at the east elevation.

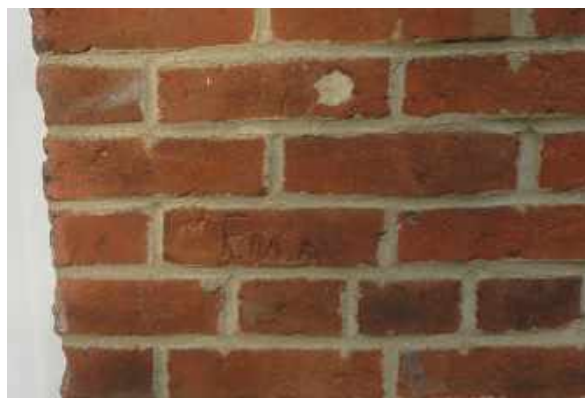
Scratched initials in the brick face. Note the mortar patch a few courses above.

- The scratchiti damage is superficial and can be patched or grouted to match the masonry and discourage further defacing.
- Where possible, the cementitious parging should be removed from the brick and previous anchor holes should be patched.
- The masonry should receive a general cleaning to remove isolated stains.

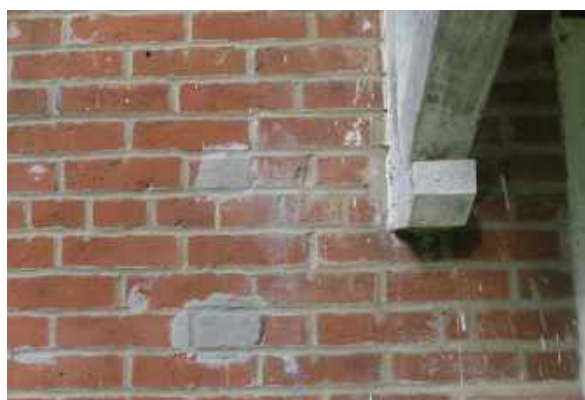
Patch executed in grey mortar.

- Mortar caps on the chimneys should be repaired.
- Spalled bricks should be patched to match the adjacent masonry.
- Non-matching and damaged or deteriorated previous repairs in mortar or cement should be removed and replaced with compatible patching material matching the masonry.

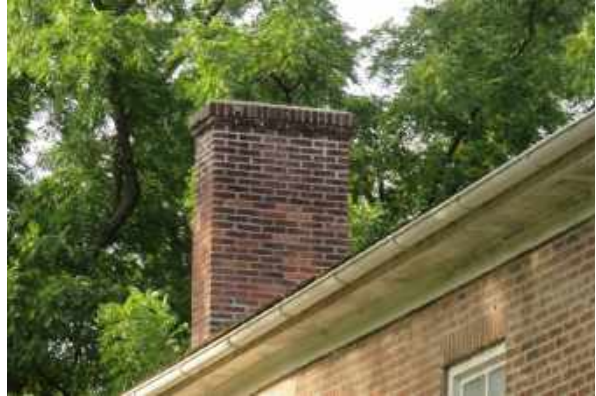
Heavily weathered and cracked mortar cap on the southeast chimney. This condition is typical of the other chimneys as well.

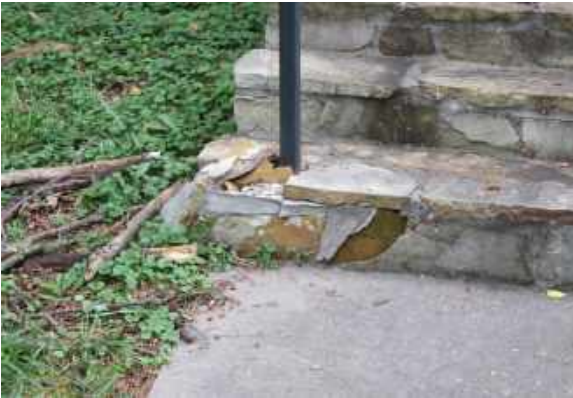
Damaged corner of northwest stair. Note that this area has been repaired, but that repair has failed.

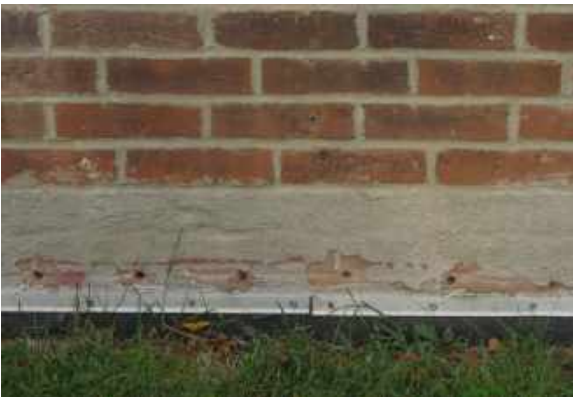
Cement parging and abandoned anchor holes above waterproofing membrane at the east elevation.

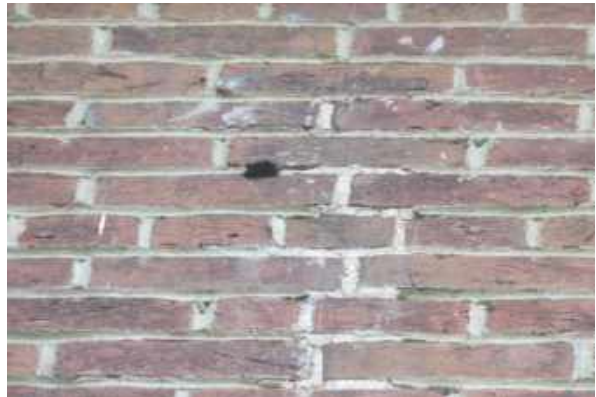
Old anchor and staining from old downspout location.

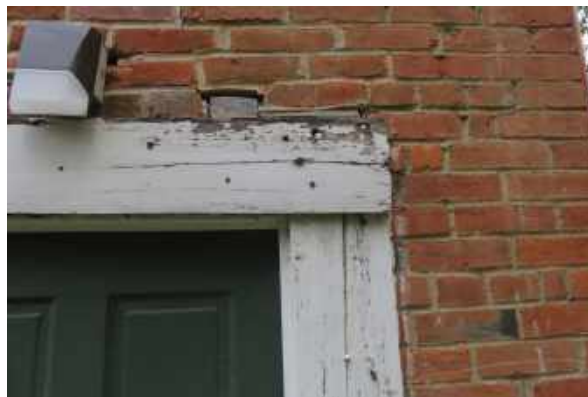
- The door surround to the kitchen on the south elevation is in poor condition, with wood deterioration including checks and rot, paint loss, and displacement at the lintel board.
- The awnings and door surrounds show signs of paint deterioration. There are insect nests and biological growth staining the paint at the undersides.

Wood and paint deterioration at kitchen door.

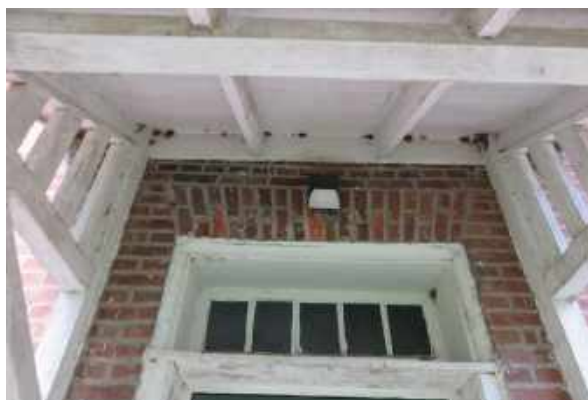
Deteriorated paint and insect nests below awning. Note the overpaint and deteriorated paint at the door surround.

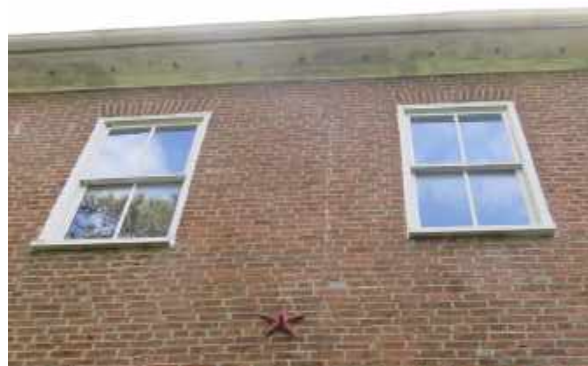
Second floor windows at the west elevation, showing signs of paint deterioration at bottom rail of upper sash.

- The window sashes and frames are generally in good condition, with some windows on the west elevation showing early signs of paint deterioration including staining.
- Most of the windows are not operable, this appears to be for safety reasons as the building often hosts large school groups. Note that the site visit also coincided with high humidity and high temperatures, it is possible the layers of latex paint have swelled and stuck together.
- Sealant was added between the door surrounds and masonry, as well as below window sills at flashing. Particularly below sills and at doors, this sealant is showing signs of deterioration.

- Window and door hardware should be repaired as needed. Ghosting from previous installations should be patched and repaired.
- The window sashes on the west elevation should be cleaned and repainted as needed.
- Perimeter sealant at doors should be replaced. Sealant below window sills should be replaced.

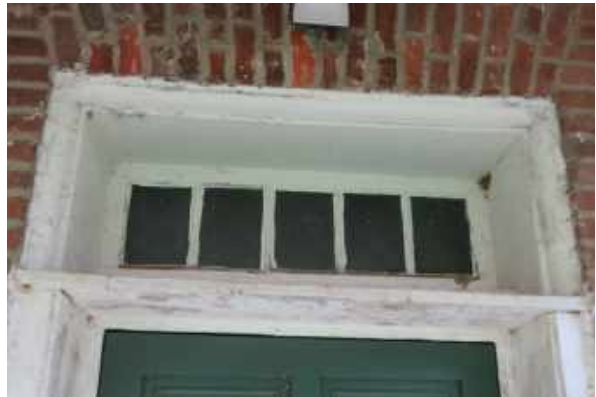
Deteriorated sealant at door surround.

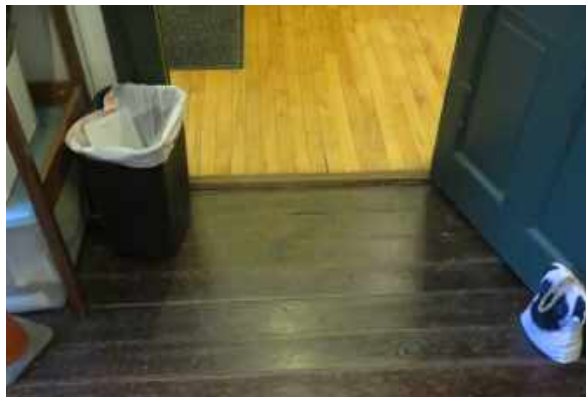
Transition between north foyer (above) and office (below) floors.

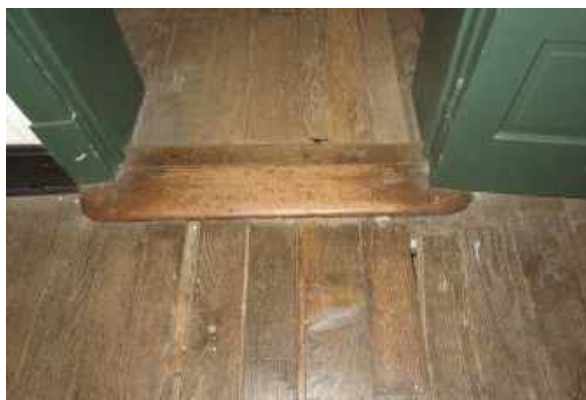
- The condition of the floors varies. They are well maintained but exhibit typical chips and gaps expected with a floor of such an age.
- The floor at the south stair landing slopes strongly to the south.

Large threshold at south door to second floor central room, due to floor slope. Note the broken board to the right.

- The floors should be refinished and repaired as needed. Holes should be filled and heavily damaged boards should be replaced to match the existing.

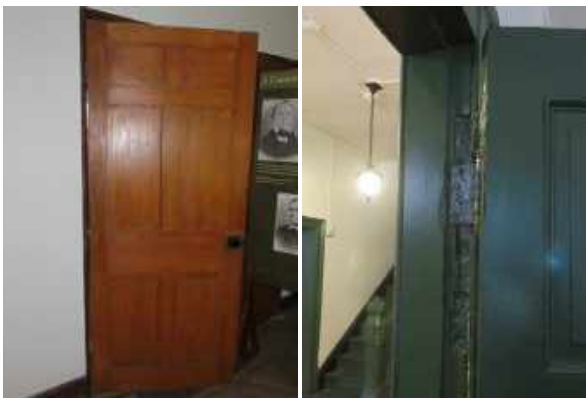
Left: six-panel door in south exhibit rooms, with box lock. Right: ghosting and damage from many different door installations at office door.

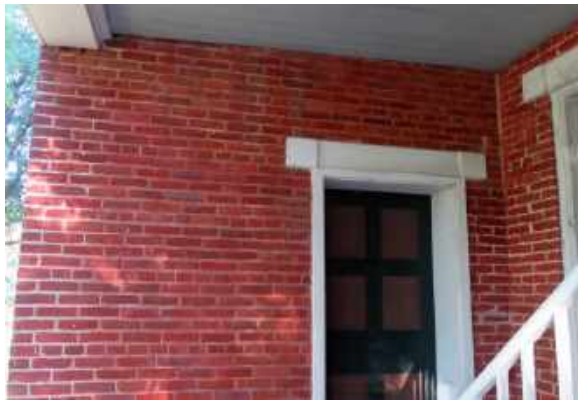
Masonry. Note the red coating on the brick, which has worn off most of the mortar joints.

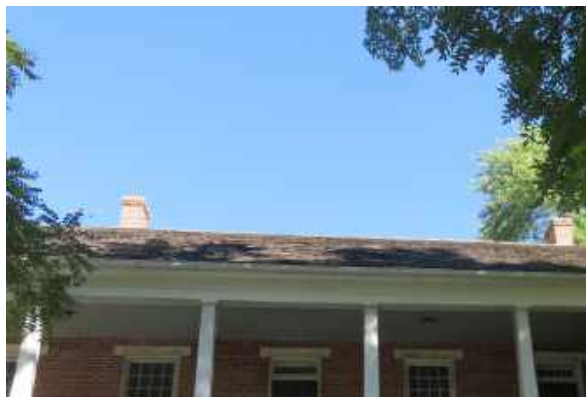
- The roof is in fair to poor condition, with areas of displaced and lifting shingles, and areas where moss is growing in between shingle gaps. From the attic there are several areas where sunlight comes through gaps and areas of missing shingles.
- The sealant used to secure the flashing to the chimneys shows signs of deterioration including cracking.
- A section of the fascia on the east elevation shows significant deterioration and wood rot.

Roof looking south.

- The roof should be replaced.
- The damaged fascia board at the west elevation should be replaced.
- The gutters should be cleaned.
- The soffits and fascia should be repainted to protect the wood, but care should be taken to leave the screens unobstructed.

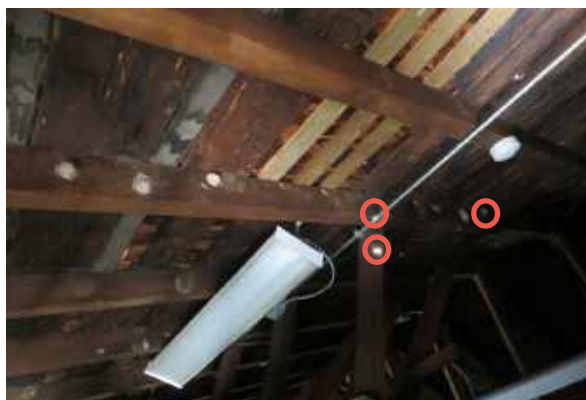
Roof from attic. Note the new sheathing boards. Spots of daylight coming through the roof are circled in red.

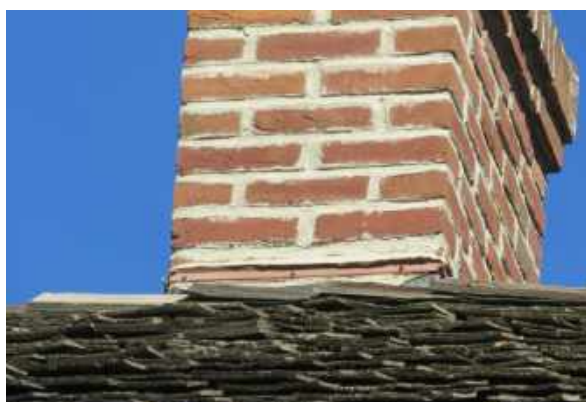
Deteriorating sealant at west chimney.

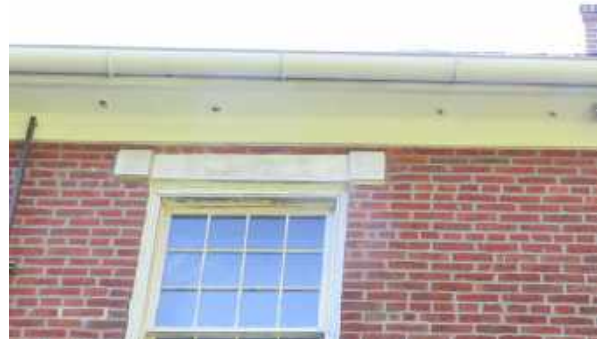
Painted over vents at the soffit underside.

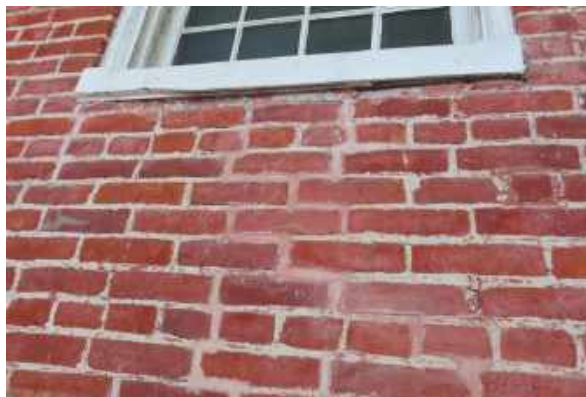
Area of repointing that does not match the rest of the masonry. Note the traces of red coating on the masonry on the right side.

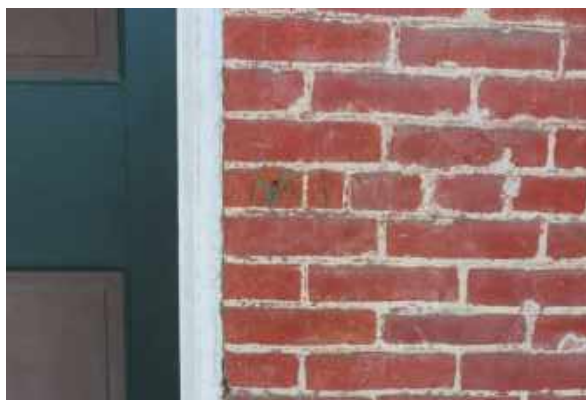
Scratchiti on brick.

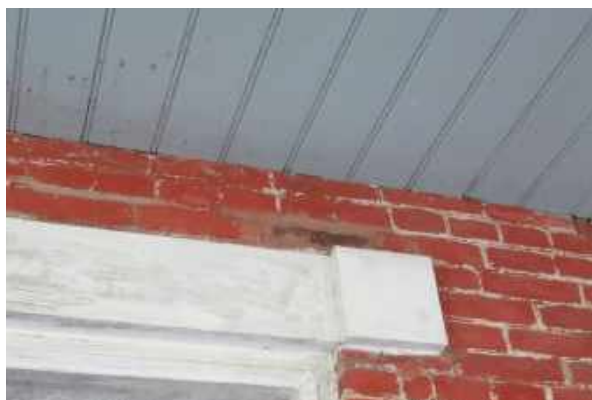
Previous repair that does not match the adjacent masonry.

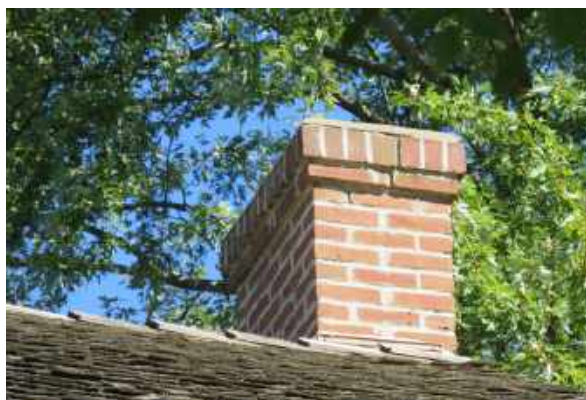
Cracks at mortar cap and open joint at chimney.

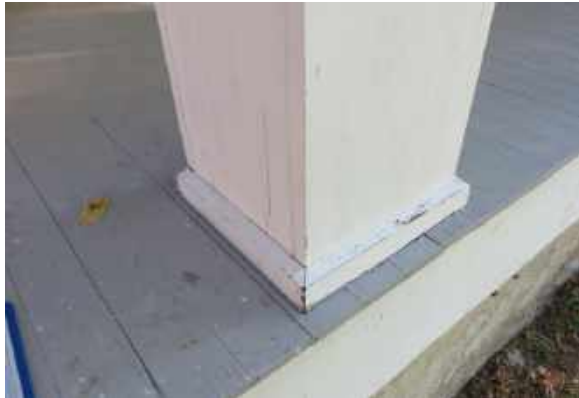
Paint deterioration, checking, and open seams in wood trim at column bases.

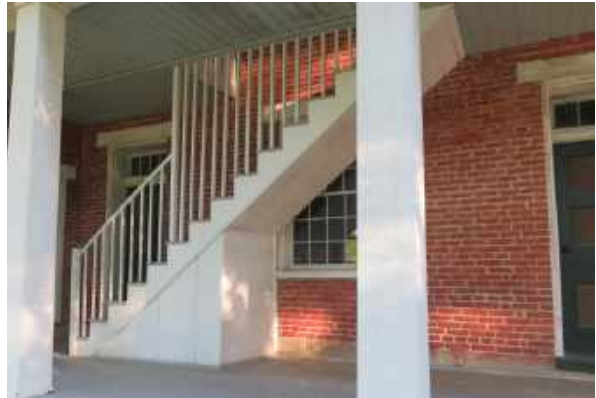
West staircase to the second floor of the porch. This is one of two potentially historic staircases at the porch.

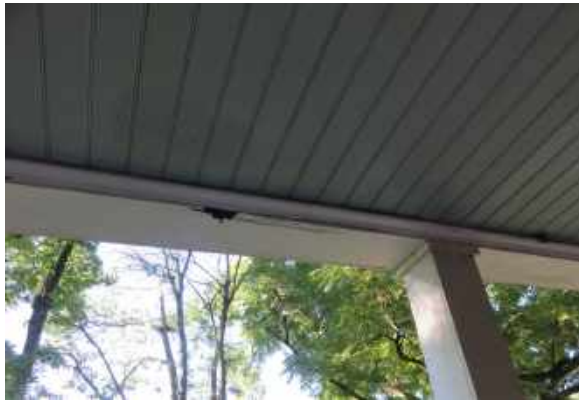
Wood deterioration at porch soffit.

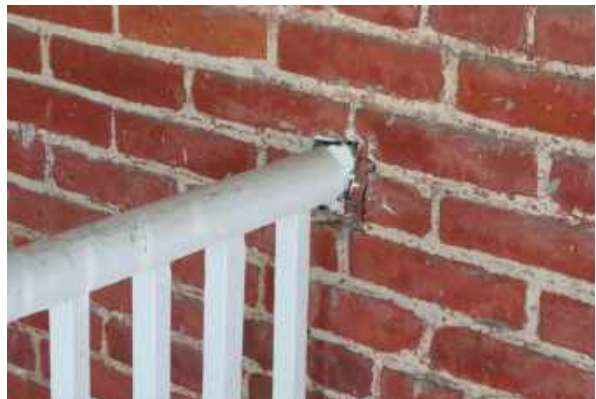
Rail termination at the masonry. Note the wood blocking added to stabilize the railing.

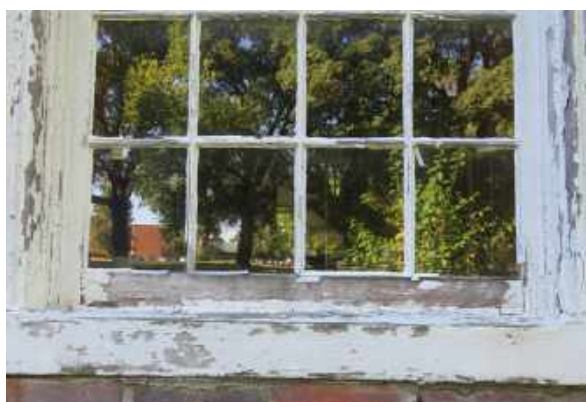
- Many of the window sashes are in poor condition, with heavily deteriorating paint and glazing putty is actively falling away from the sashes. These windows do not appear to have been repaired during the 2016 project.

Paint and glazing putty deterioration at a north elevation window.

- A comprehensive repair and restoration campaign should be scheduled for the windows and include glazing putty replacement and repainting.
- The missing transom lite at the northeast door should be replaced with glass to match the adjacent panes.
- Old repairs including dutchmen should be checked for soundness and replaced as needed.
- Interior sills should be repaired and monitored for water damage following heavy rains.
- Window and door hardware should be repaired as needed. Ghosting from previous installations should be patched and repaired.
- Perimeter sealant at doors and windows should be replaced and painted to match the wood surrounds.

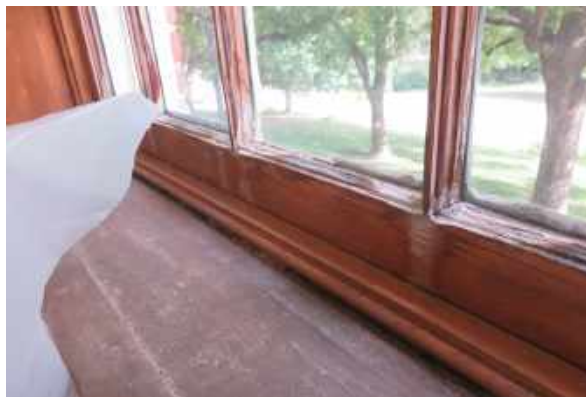
- Some windows show signs of water deterioration at the interior, including at sashes and sills. In most cases these appear to be at windows that were repaired in 2016. Moisture was not observed during the survey despite heavy rains a few days earlier.
- Areas of previous repair including previous dutchman repairs are visible below the paint.
- Some of the windows are painted shut, especially at the porch.
- The transom above the northwest door has an opaque replacement pane of glass that does not match the rest of the glass.
- The lintels and raised wood blocks were selectively treated in 2016 and many of those that were not repaired are in poor condition, with wood checks and deteriorated paint.
- Sealant was added between the window frames and door surrounds and masonry. In some areas, this sealant is not painted, and the grey color stands out from the red brick and white trim,

Water damage at new sash, deteriorating finish at window sill.

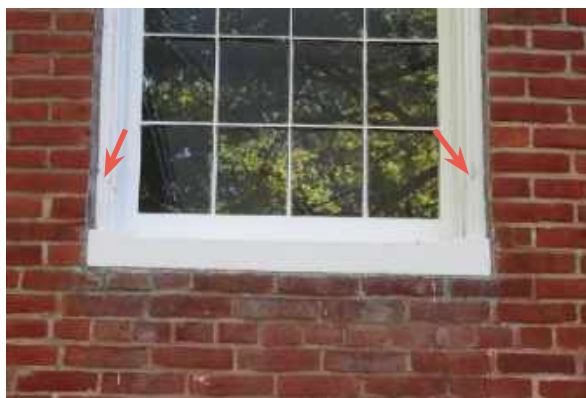
Repaired window where seams from dutchman repairs are visible through the paint. Note the unpainted grey sealant at the edges of the window frame.

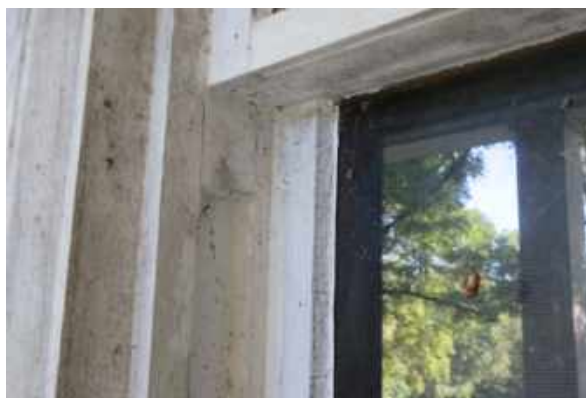
Window at the porch that is painted closed.

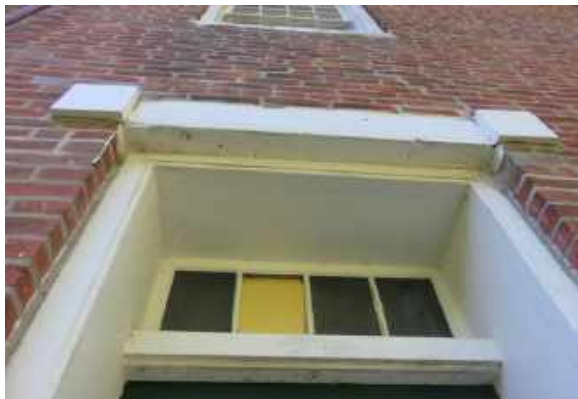
Transom with opaque replacement glass at the northwest door.

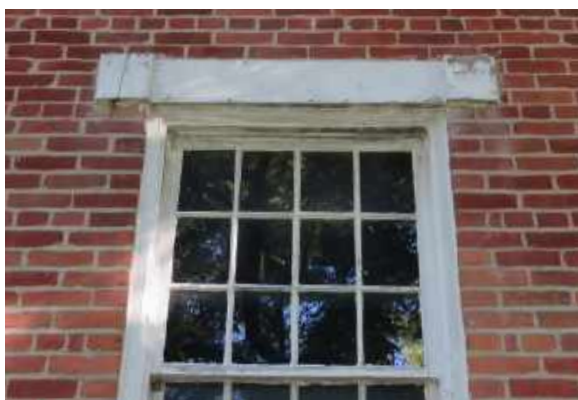
Both the doors and windows are topped with Federal Style flat wood lintels with raised wood corner blocks. Some of these show signs of repair and replacement, but others are in poor condition.

Paint and wood deterioration at flat lintel and raised wood block detail.

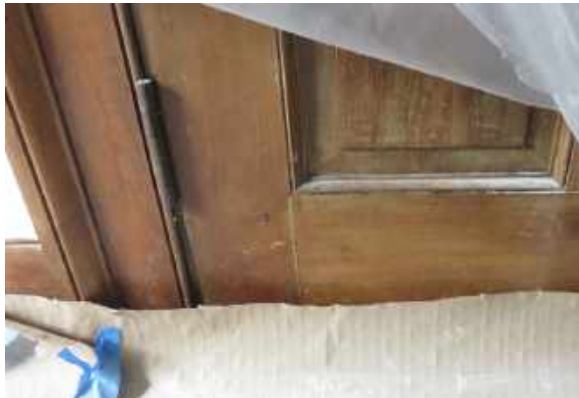
- The interior doors are generally in good condition. The operability of the hardware varies. Some doors show signs of water damaged finishes, but are otherwise in good condition.

Water damaged finish at door to the north elevation in the first floor west room.

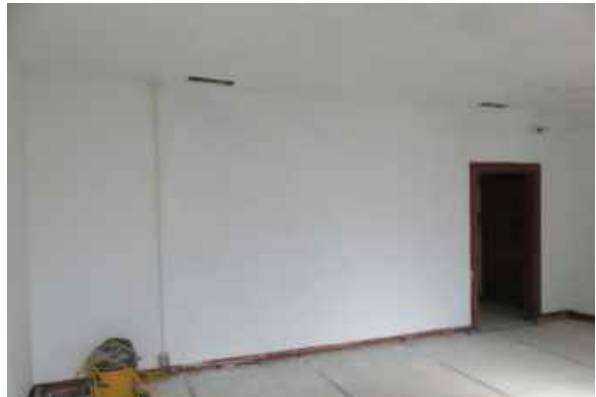
- The condition of the floors varies. They are well maintained but exhibit typical chips and gaps expected with a floor of such an age.
- The floor in the second floor west room slopes to the middle. It is unclear if this condition is the result of the repaired leak or a pre-existing condition and should be investigated further.

New wall at second floor west room. Note that this floor slopes to the center of the room.

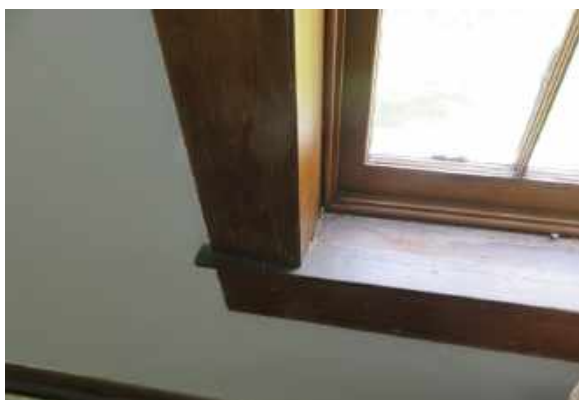
- The windows are generally in fair condition from the interior. There is very little overpaint on the sashes, consistent with replacement units. Some windows show signs of water infiltration, but most of these coincide with windows that were repaired in 2016 based on their exterior conditions.

Water damaged finish at window sill from previous water infiltration issue.
