CONDITIONS ASSESSMENT REPORT

Shawnee Indian Manual Labor Boarding School

Shawnee Tribe Cultural and Historical Preservation Committee | December 6, 2021

Architectural
Resources Group

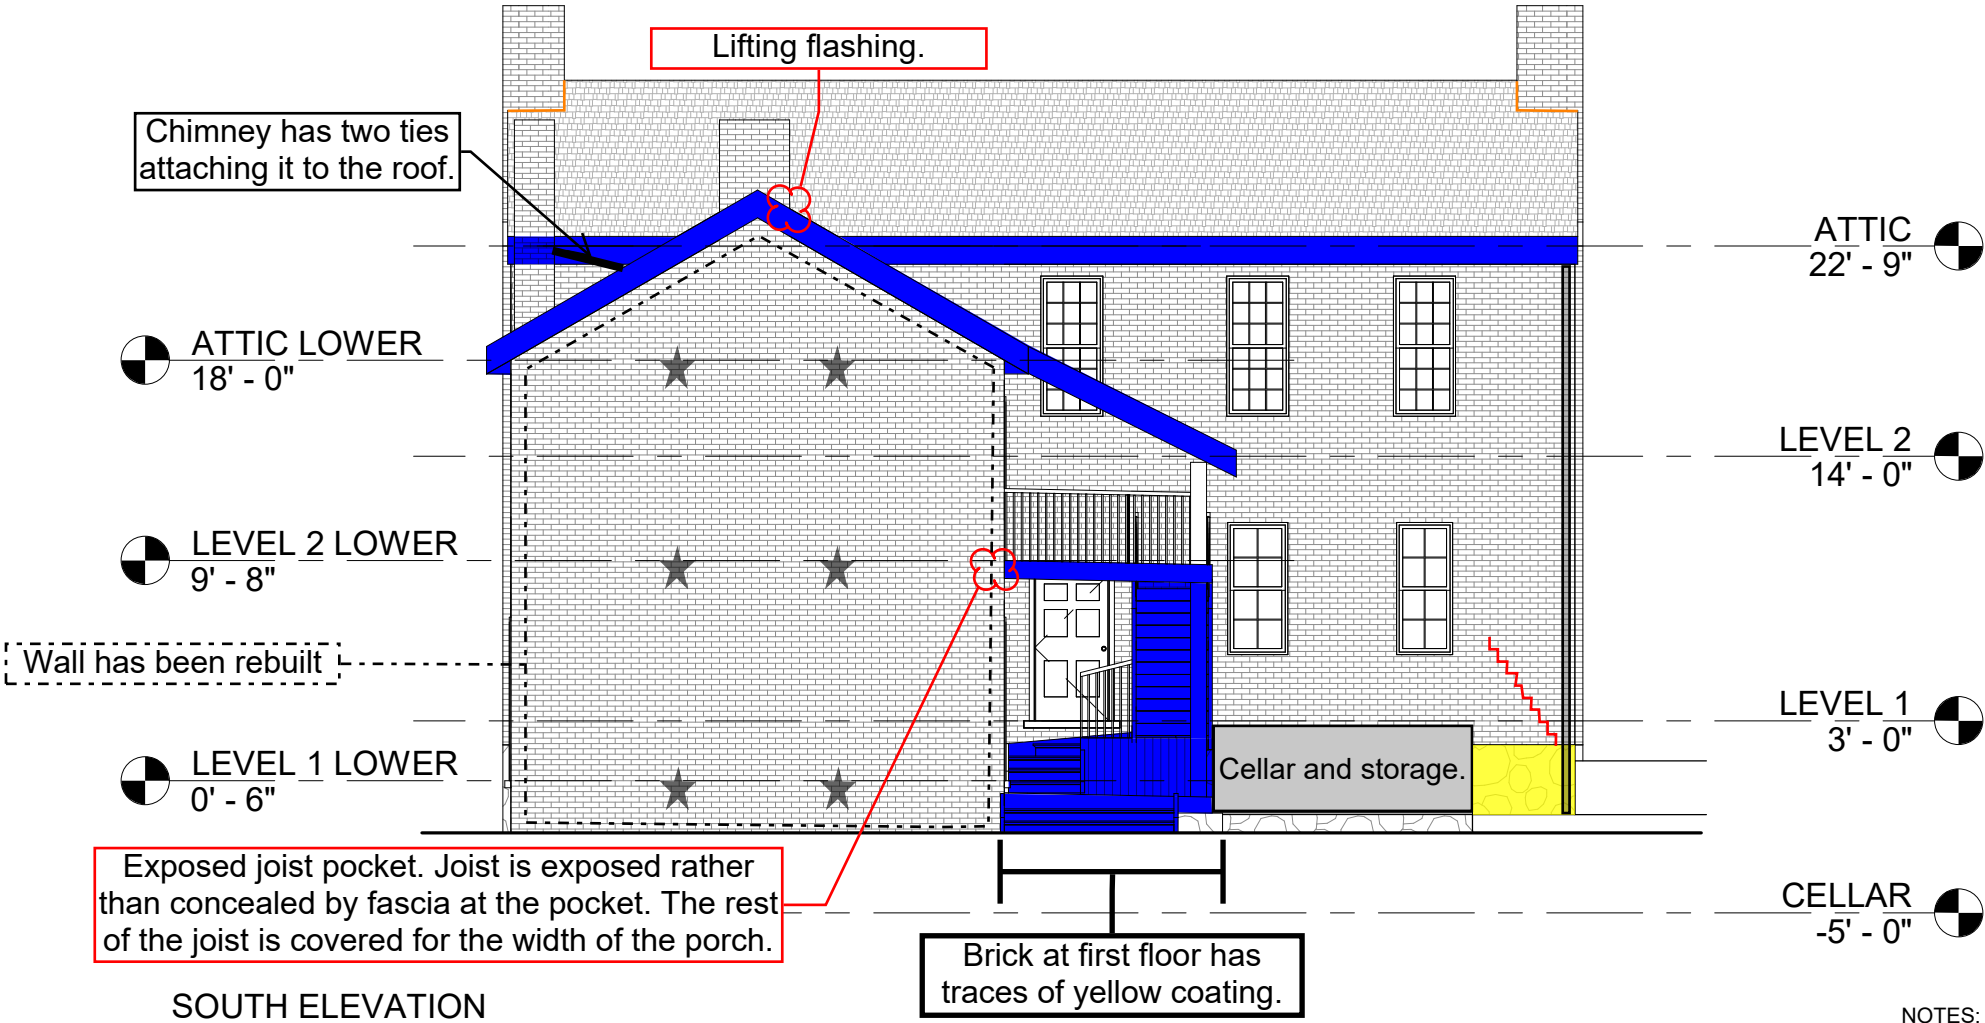
- Paint on soffit is very deteriorated.
- There are multiple areas of brick infill that vary in size from single bricks to larger sections of walls and corners. The brick is a fair match for the existing brick, that is slightly darker in color and with more color variation than the original.
- Sealant around windows and doors appears to be in serviceable condition, date of previous repair or replacement is unknown.
- The roof shingles shows early signs of curling but is overall in good to fair condition. Sealant at chimney flashing shows signs of cracking and should be replaced.
- Wood and paint deterioration at edges of floorboards at the first level of the porch.
- General paint deterioration and wear on porch floor.
- Open joints in the limestone foundation vary and can be very large in size.
- Mortar caps on chimneys are in poor condition and should be replaced during repointing.

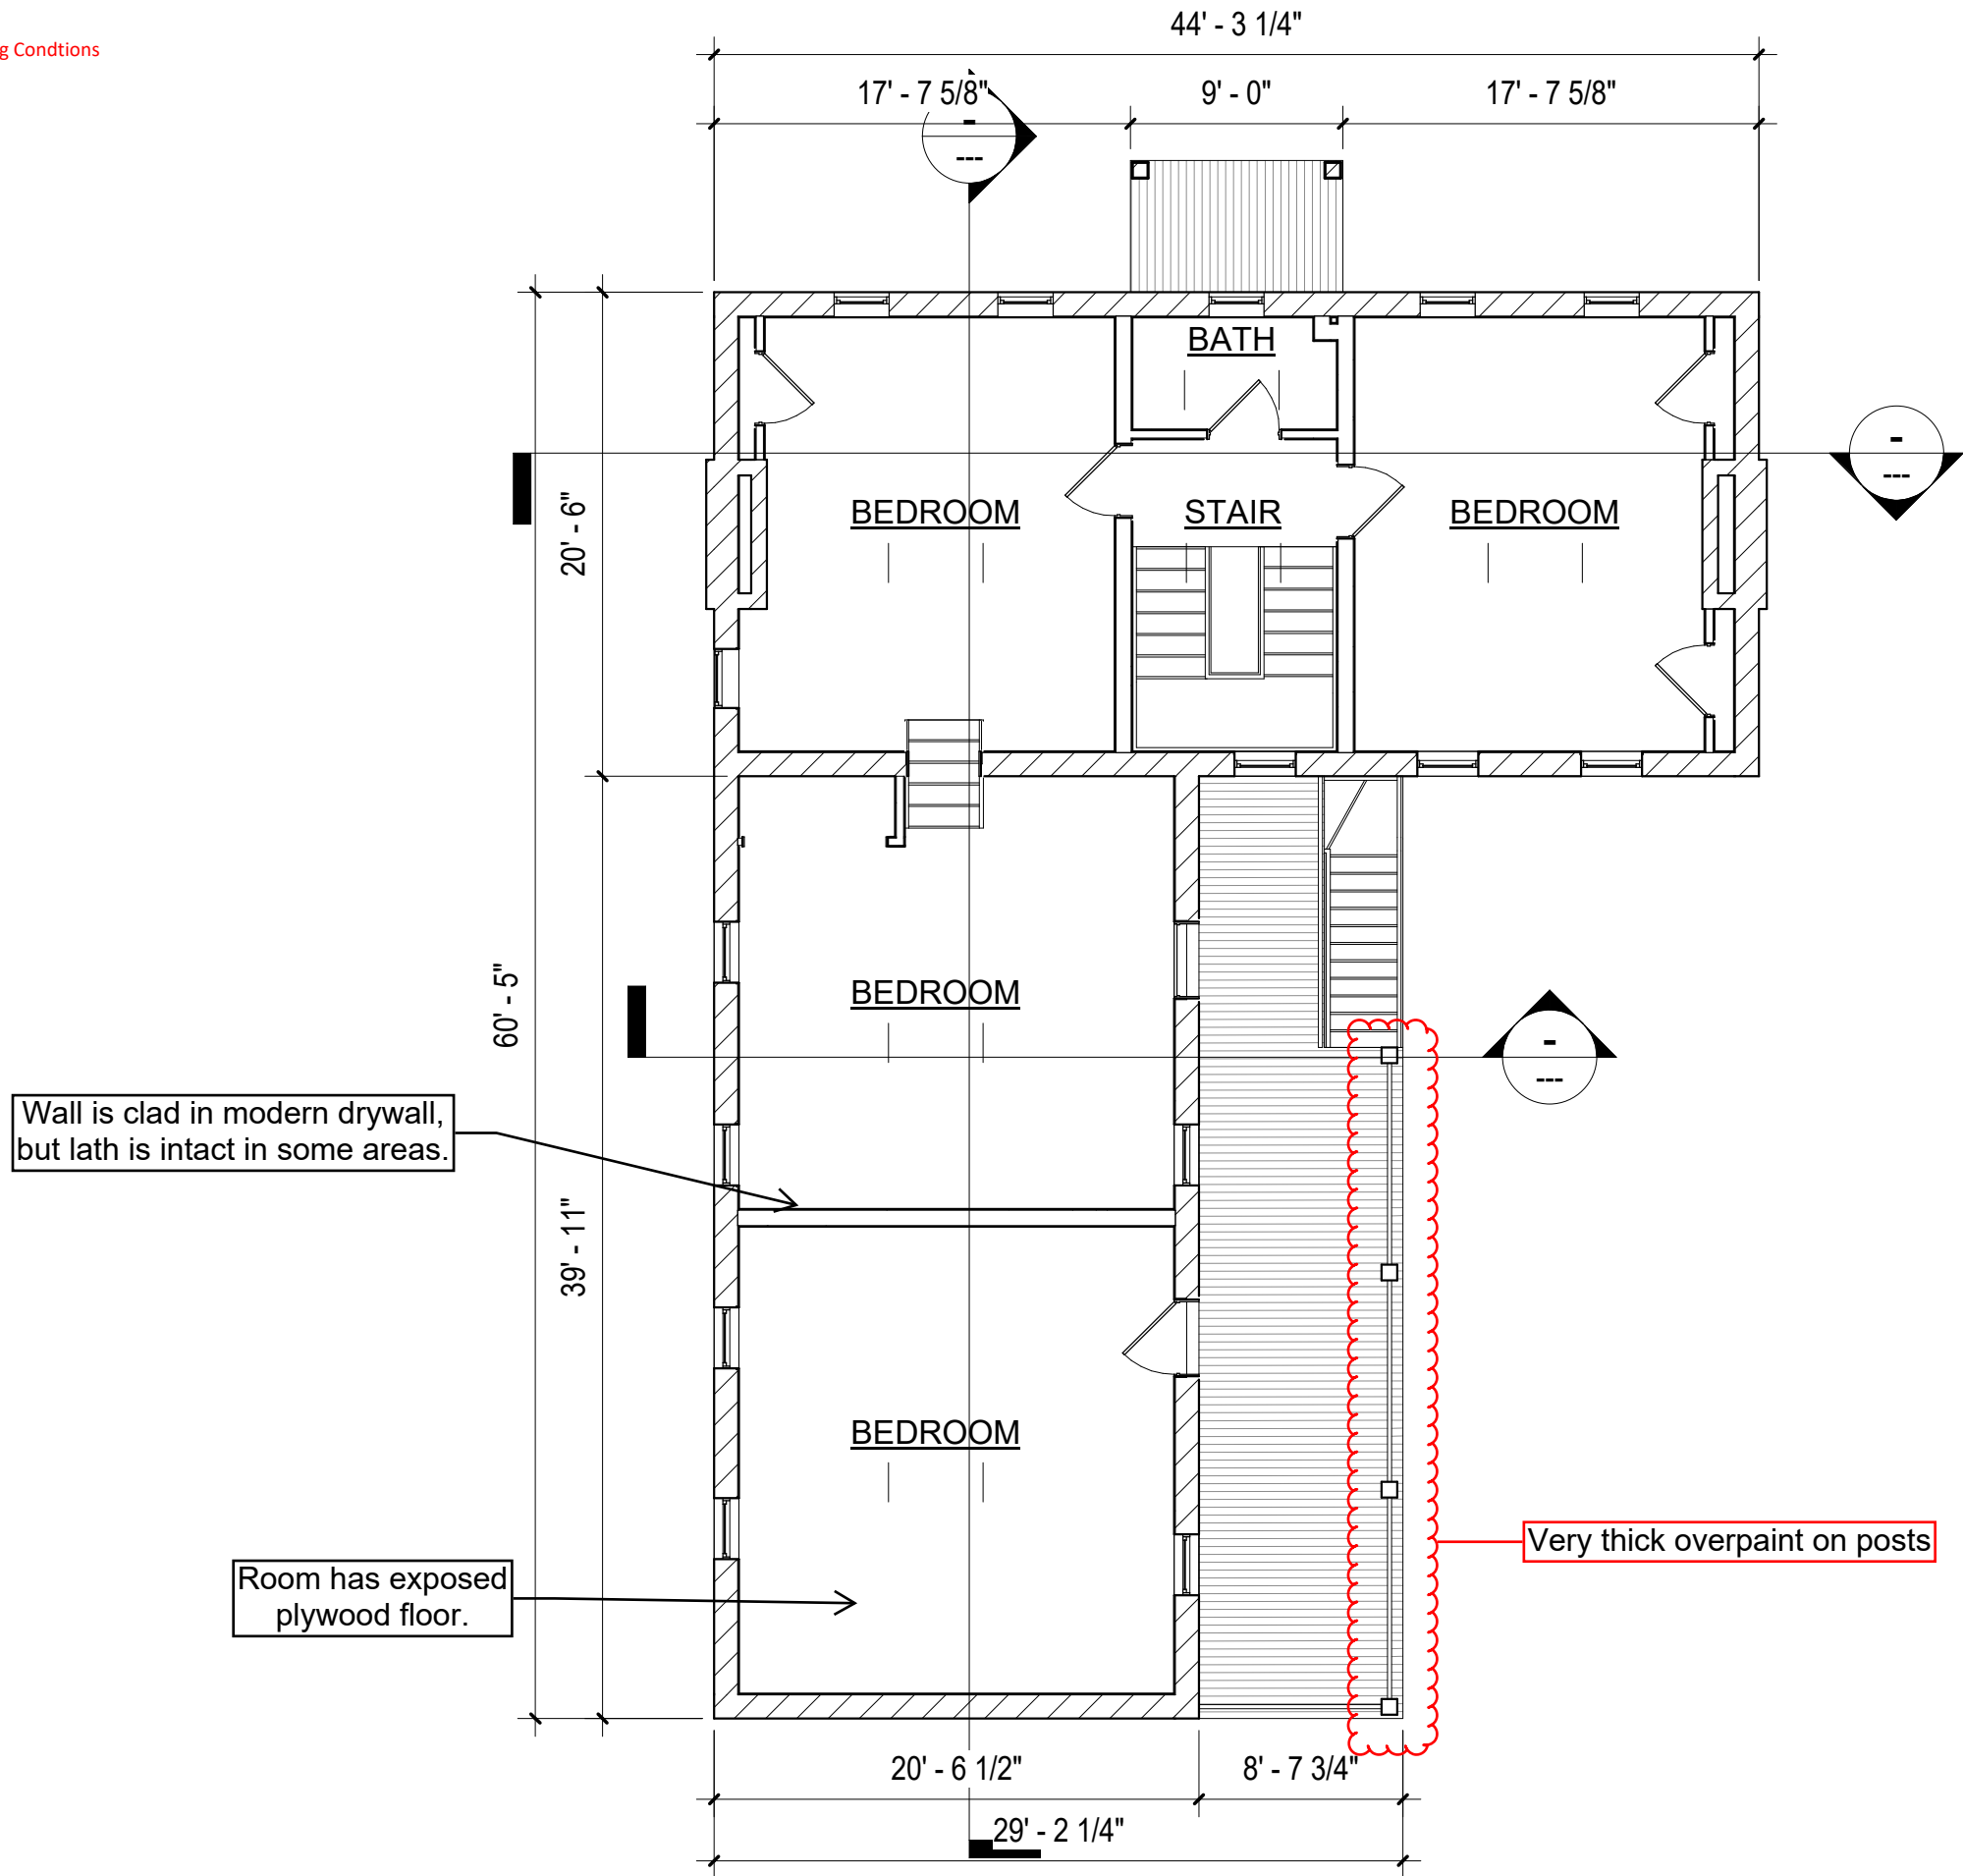
LEVEL 2 FLOOR PLAN

- Floors are painted. Finish is heavily worn.
- There are patches on the floors where holes or penetrations are covered with sheet metal nailed in place.
- Very few intact finishes. Wallpaper was removed and plaster stripped to lath in some places, likely from the remediation of the water leak in 2013.
- There are multiple repairs to the plaster around the windows and mantles in all rooms.
- Sections of second floor railing were replaced at the south end due to damage caused by "teenagers".

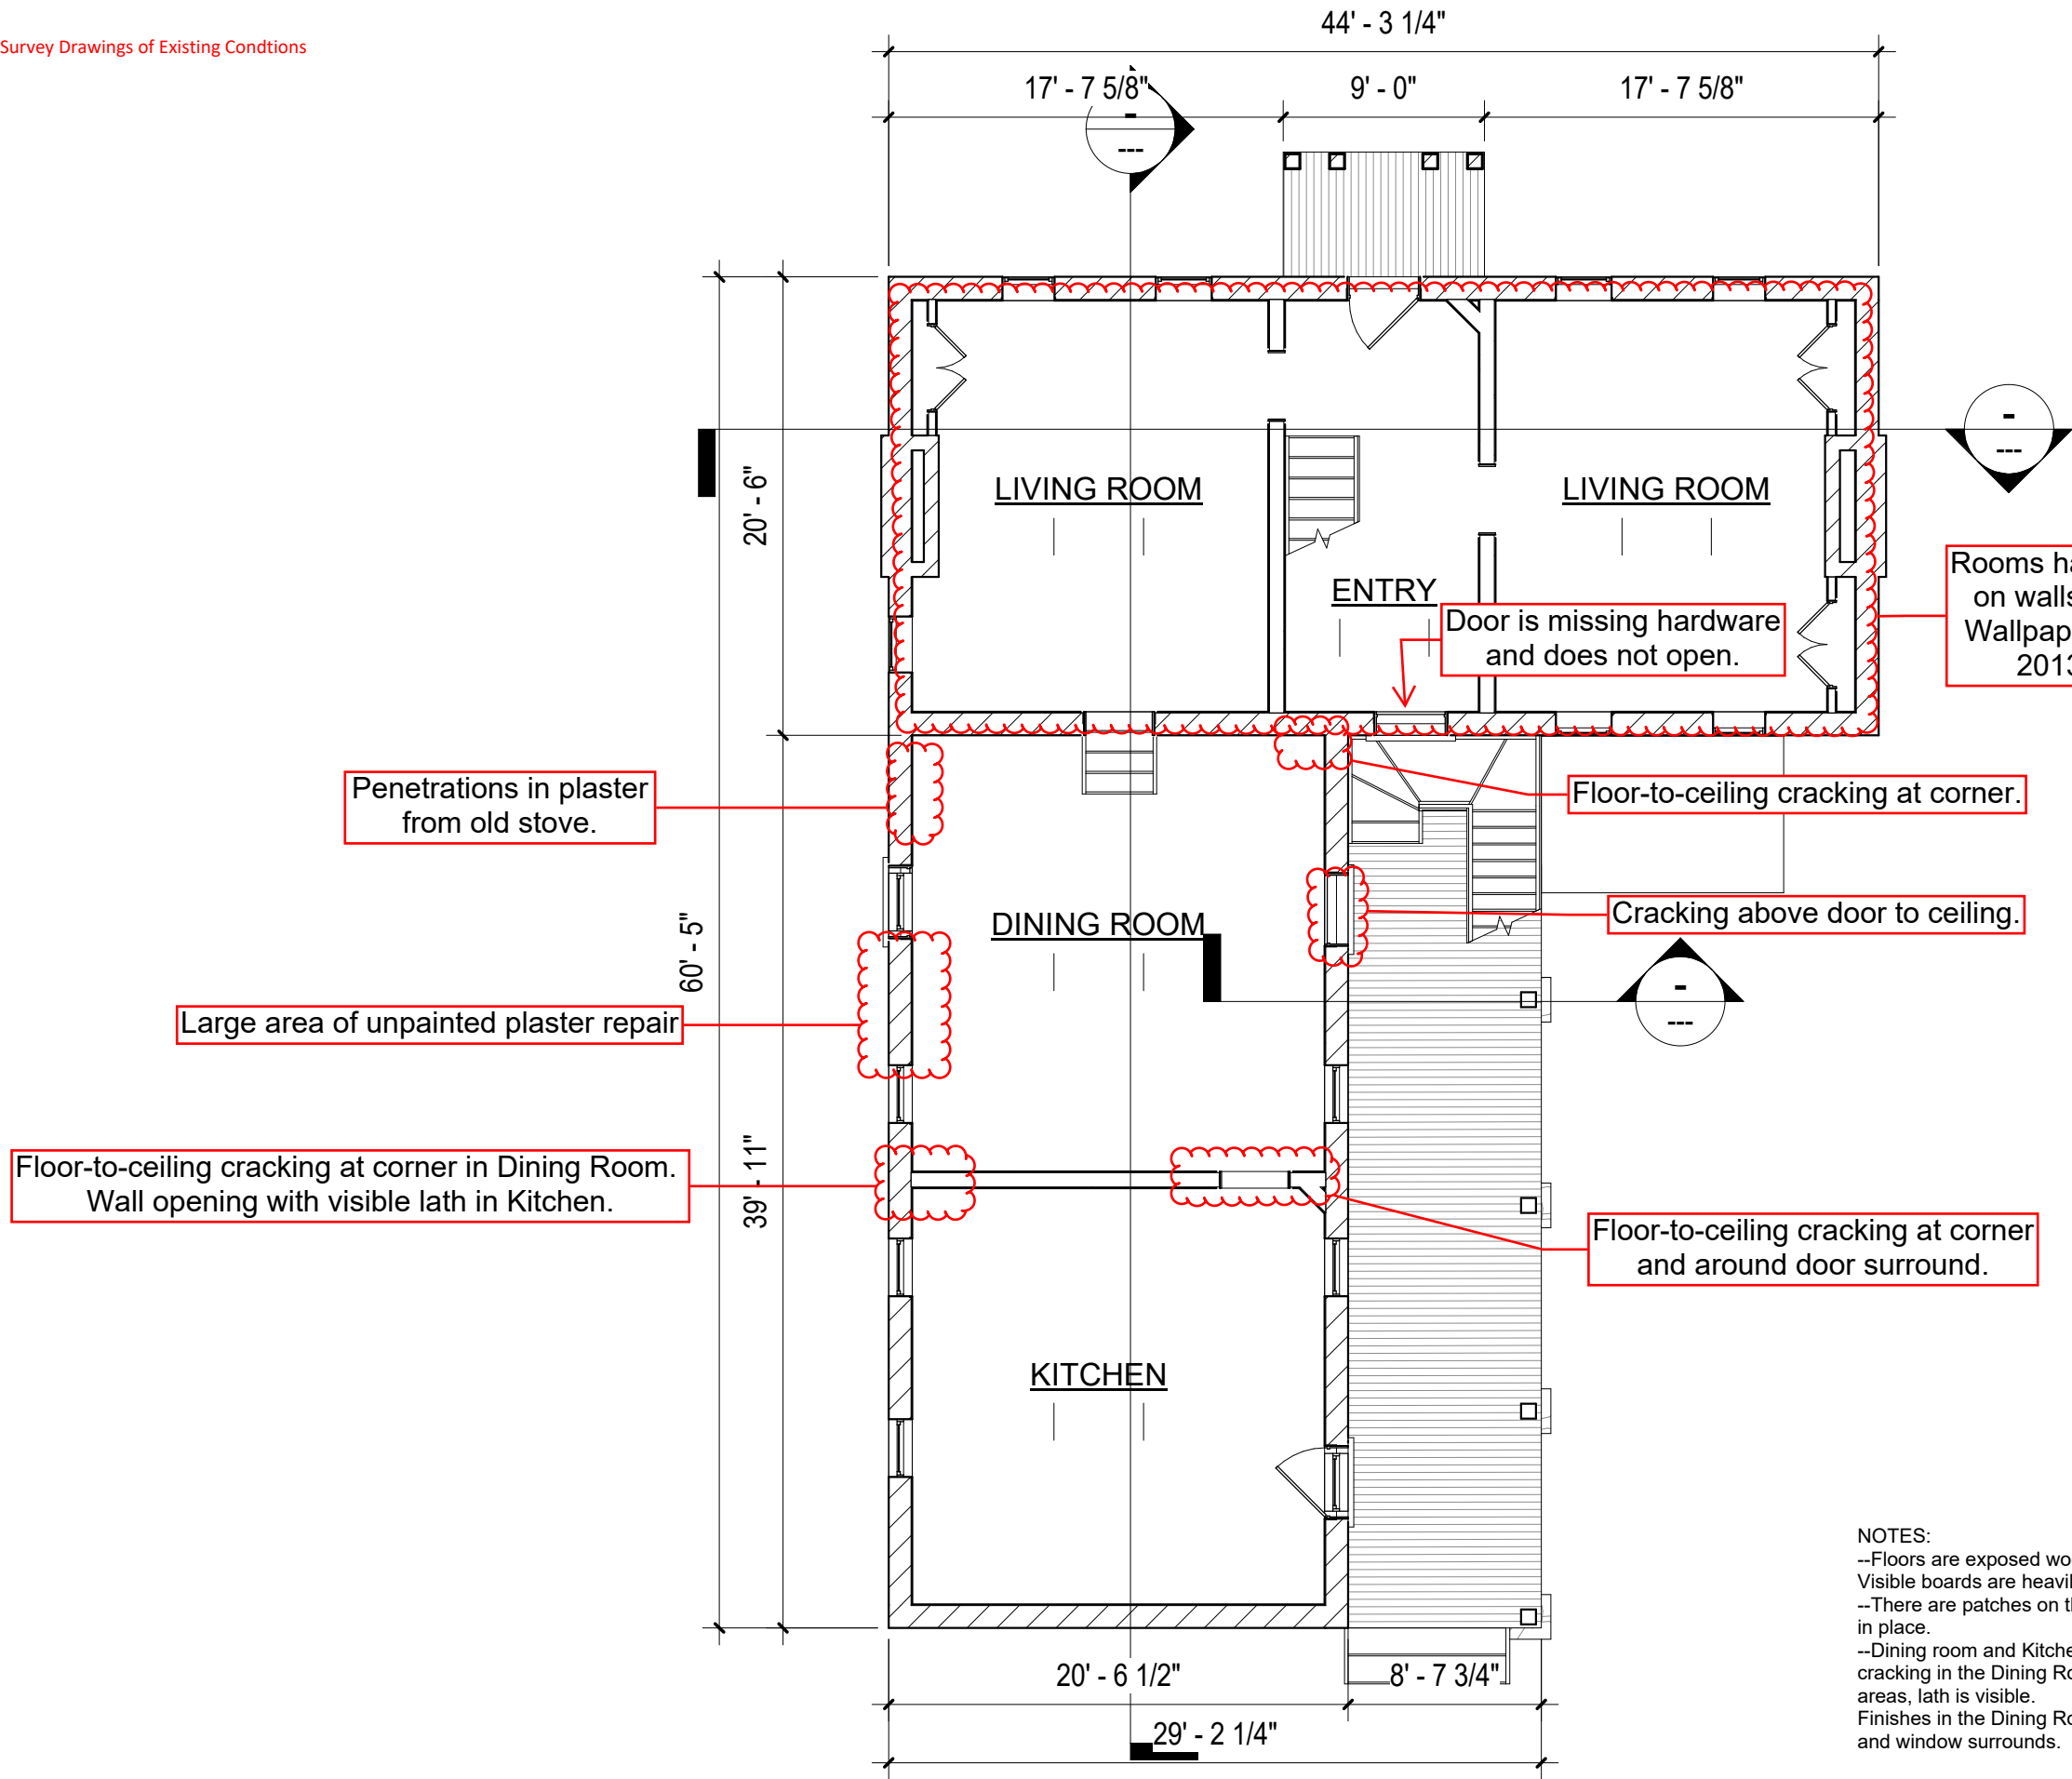
LEVEL 1 FLOOR PLAN

NOTES:
--Floors are exposed wood, with previous flooring finishes removed during 2013 remediation. Visible boards are heavily worn.
--There are patches on the floors where holes or penetrations are covered with sheet metal nailed in place.
--Dining room and Kitchen have intact wallboard ceilings and plaster walls. There is significant cracking in the Dining Room and isolated areas of damage due to investigative openings. In some areas, lath is visible.
Finishes in the Dining Room are heavily deteriorated. Plaster has cracks in corners, and at door and window surrounds.

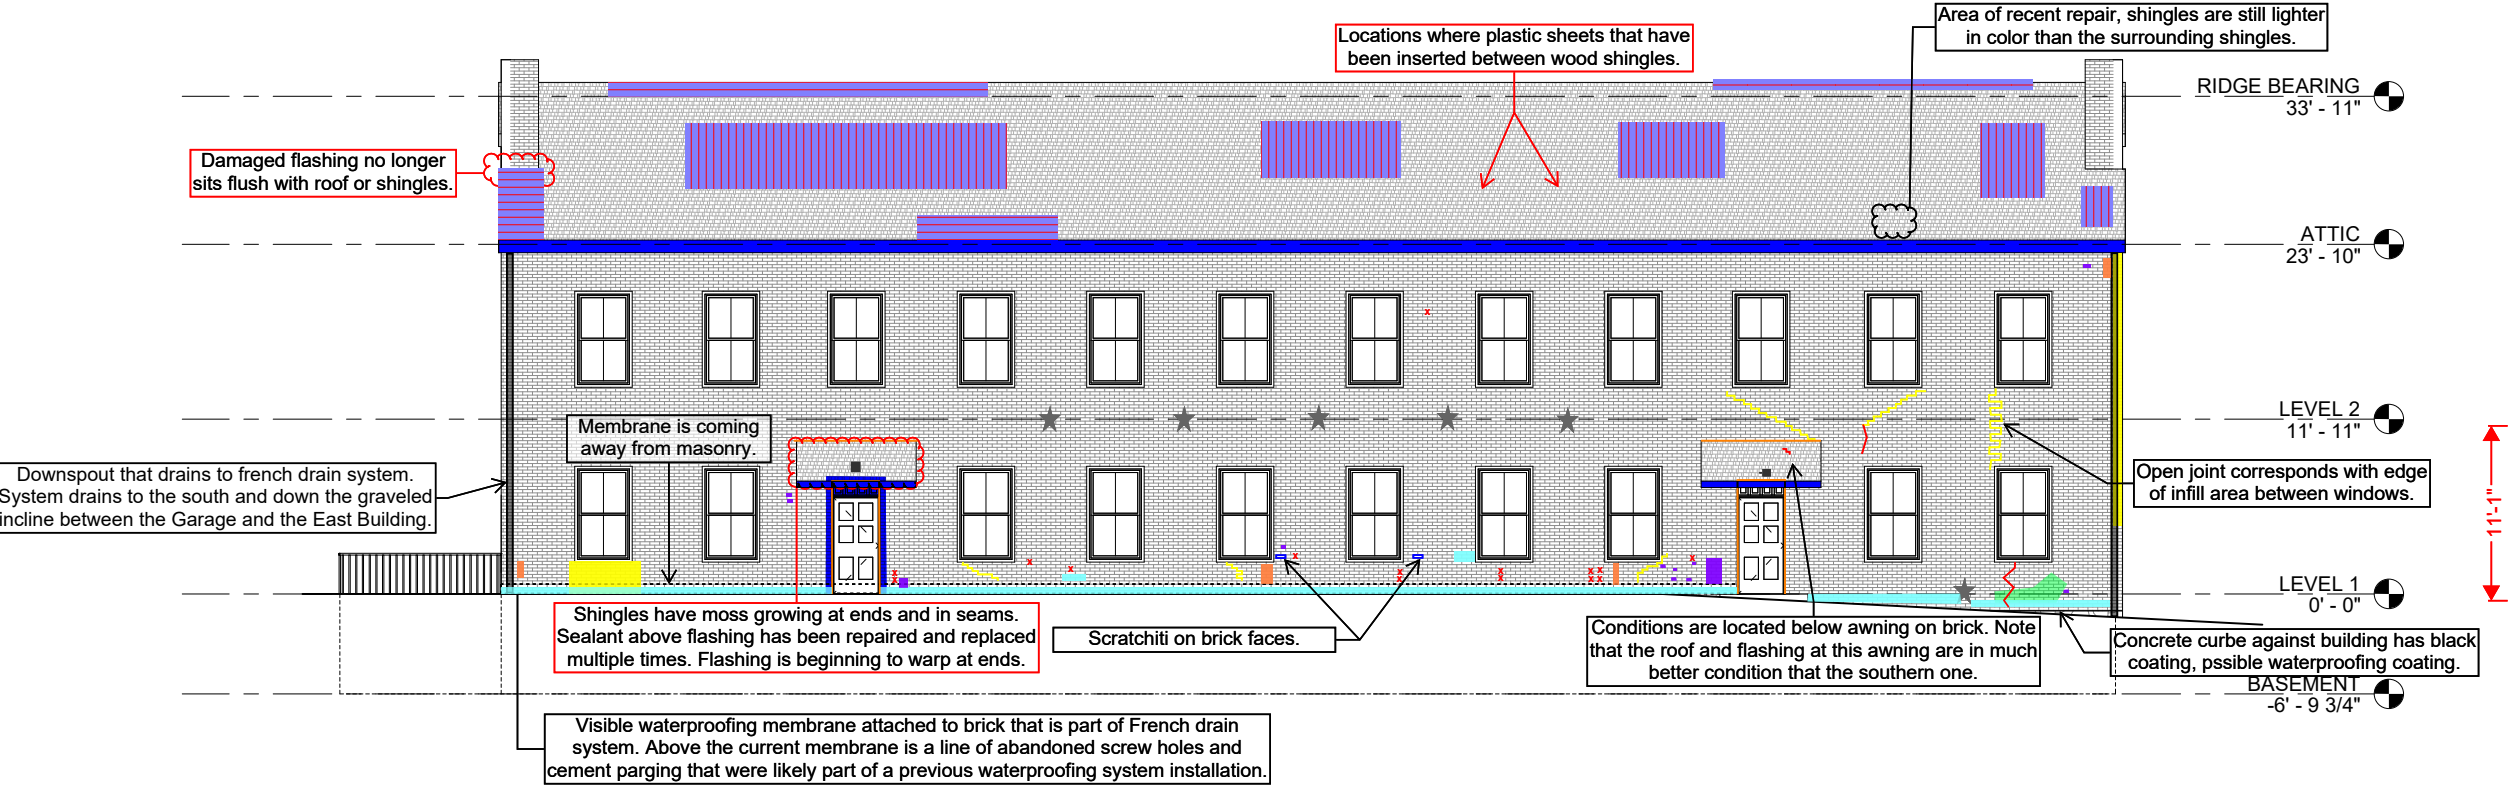
EAST ELEVATION

- The roof has large areas of warped shingles.
- There is heavy paint build-up on window frames, door frames, as well as door surrounds and transom windows. There is less paint build-up on awnings and fascia trim, but this paint is heavily deteriorated.

- Mortar caps on chimneys are in fair condition and should be replaced during repointing.
- Windows are later replacements and are not original.
- There are screened vents on the soffit behind the gutter. Many of these screens are partially blocked from being painted over.

- The roof shingles show signs of lifting, curling, and heavy weathering.
- Flashing is visible below sills.

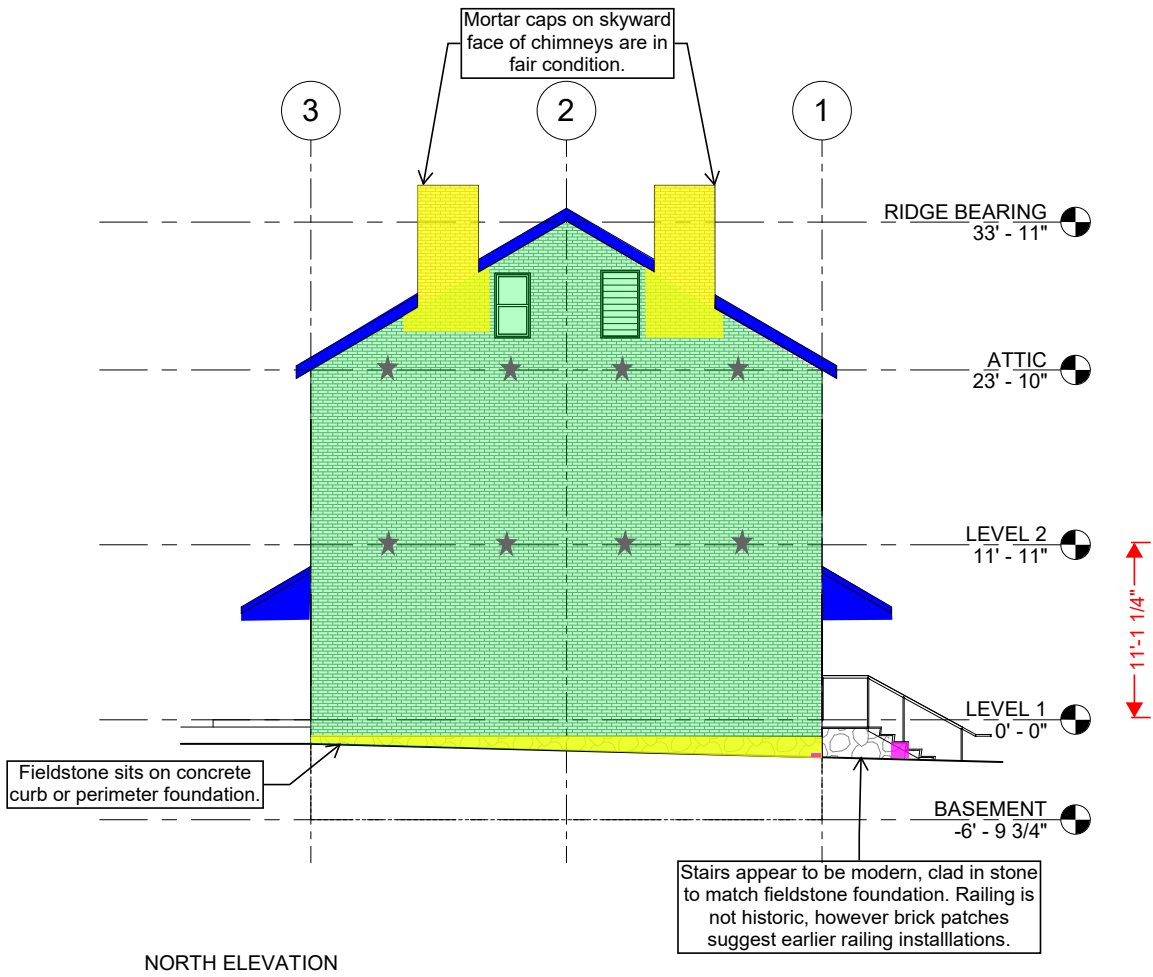
- There are multiple areas of brick infill that vary in size from single bricks to the spandrels between windows. The brick is a good match for the existing brick, with slightly more color variation and flash marks than the original.
- Mortar caps on chimneys are in fair condition and should be replaced during repointing.
- Open joints in the fieldstone vary and can be very large in size.
- There is a general film of biological growth on the brick due to the shade and debris from a nearby tree. General cleaning is recommended.
- Foundation is non-dimensional limestone.

Note that right chimney was rebuilt in the 1970s

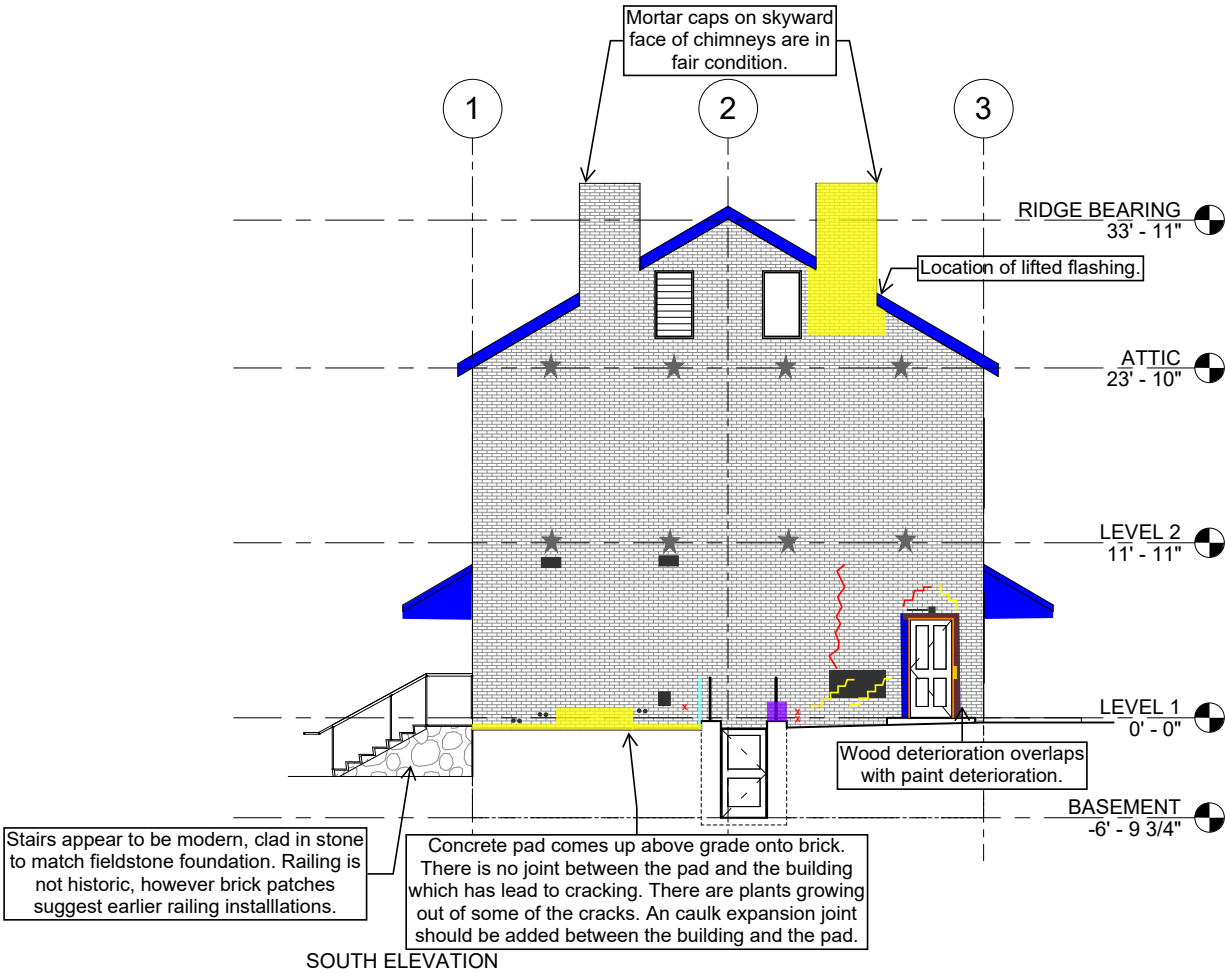
- There are multiple areas of brick infill that vary in size from single bricks to the spandrels between windows. The brick is a good match for the existing brick, with slightly more color variation and flash marks than the original. most of these areas of infill occur below windows.
- Mortar caps on chimneys are in fair condition and should be replaced during repointing.
- Open joints in the fieldstone vary and can be very large in size.
- This elevation includes most of the exterior mounted utilities.
- Kitchen door and exterior door surround appear to be modern replacements.
- Pipe protrusions from the brick are set in cement or mortar, and many have cracks.

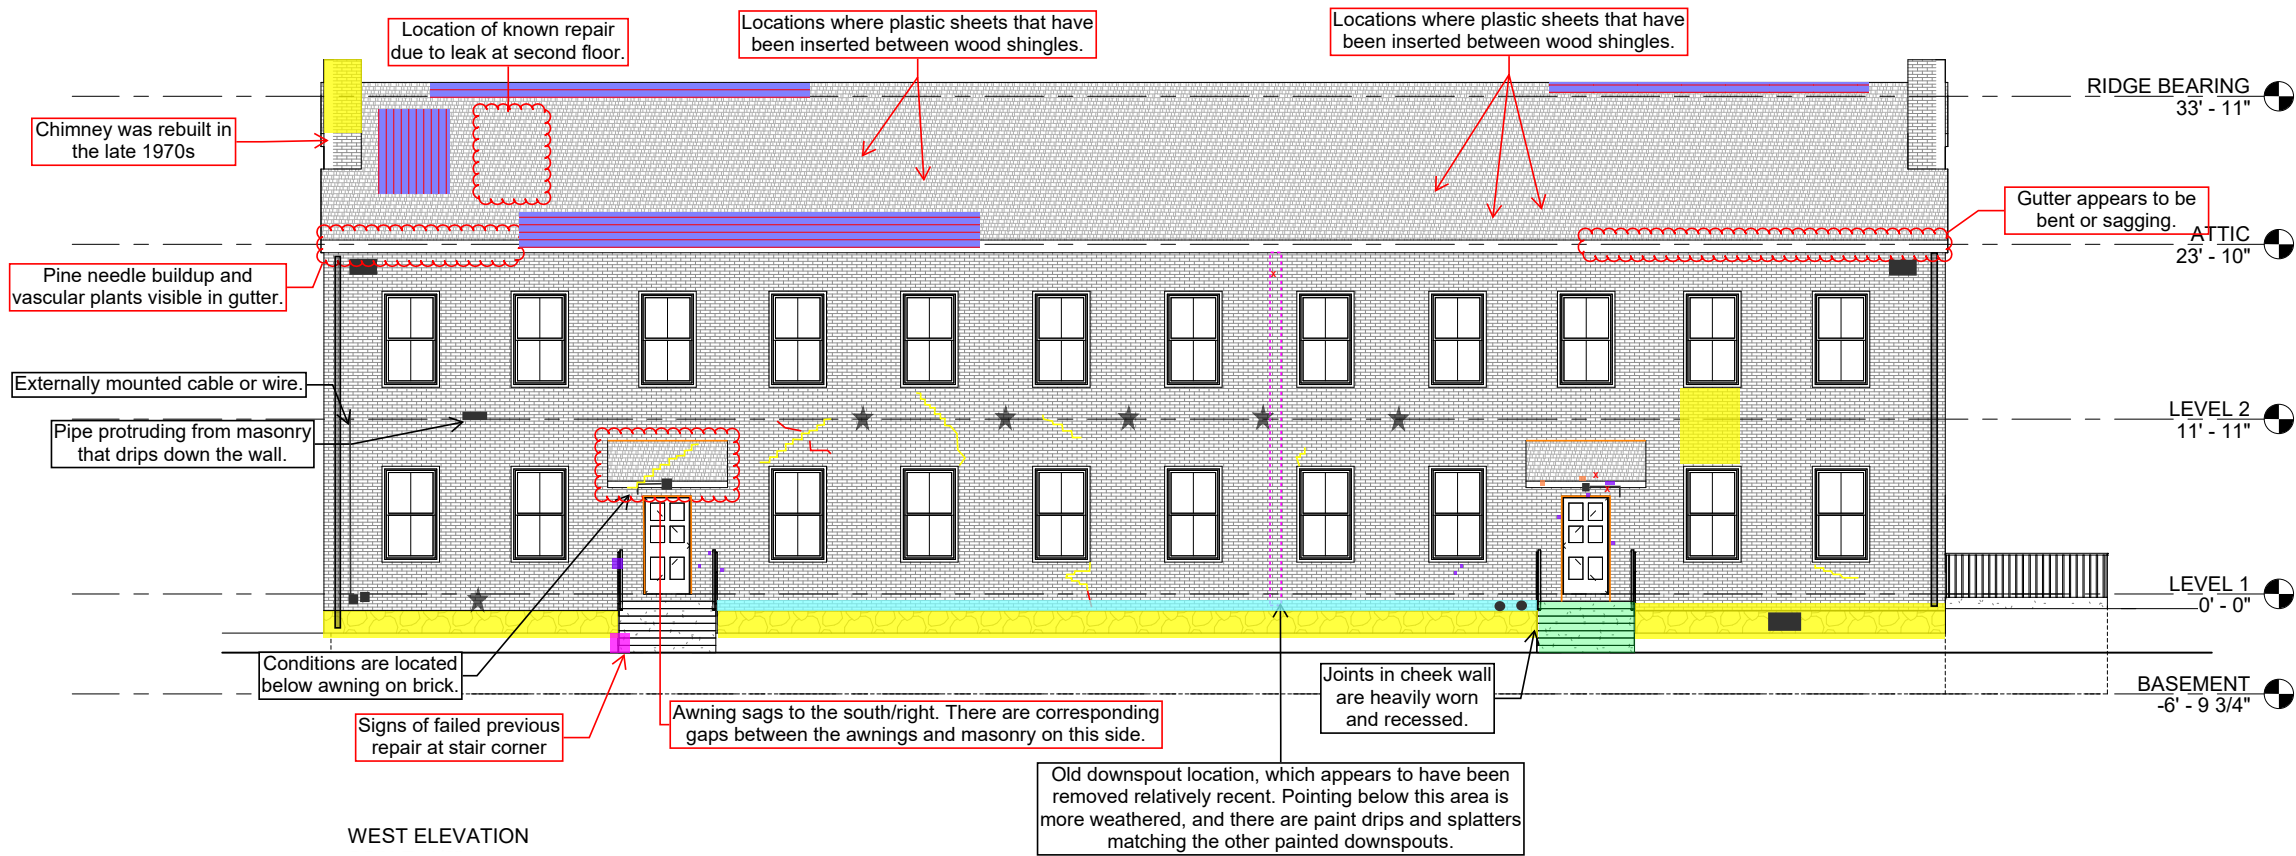
- The roof has large areas of warped shingles.
- There is heavy paint build-up on window frames, door frames, as well as door surrounds and transom windows. There is less paint build-up on awnings and fascia trim, but this paint is heavily deteriorated.

- There are drips and splatter from white paint, likely from repainting the window frames and trim on the building.
- Mortar caps on chimneys are in fair condition and should be replaced during repointing.

- Open joints in the fieldstone vary and can be very large in size.
- Windows are later replacements and are not original.
- There are screened vents on the soffit behind the gutter. Many of these screens are partially blocked from being painted over.

- The roof shingles show signs of lifting, curling, and heavy weathering.

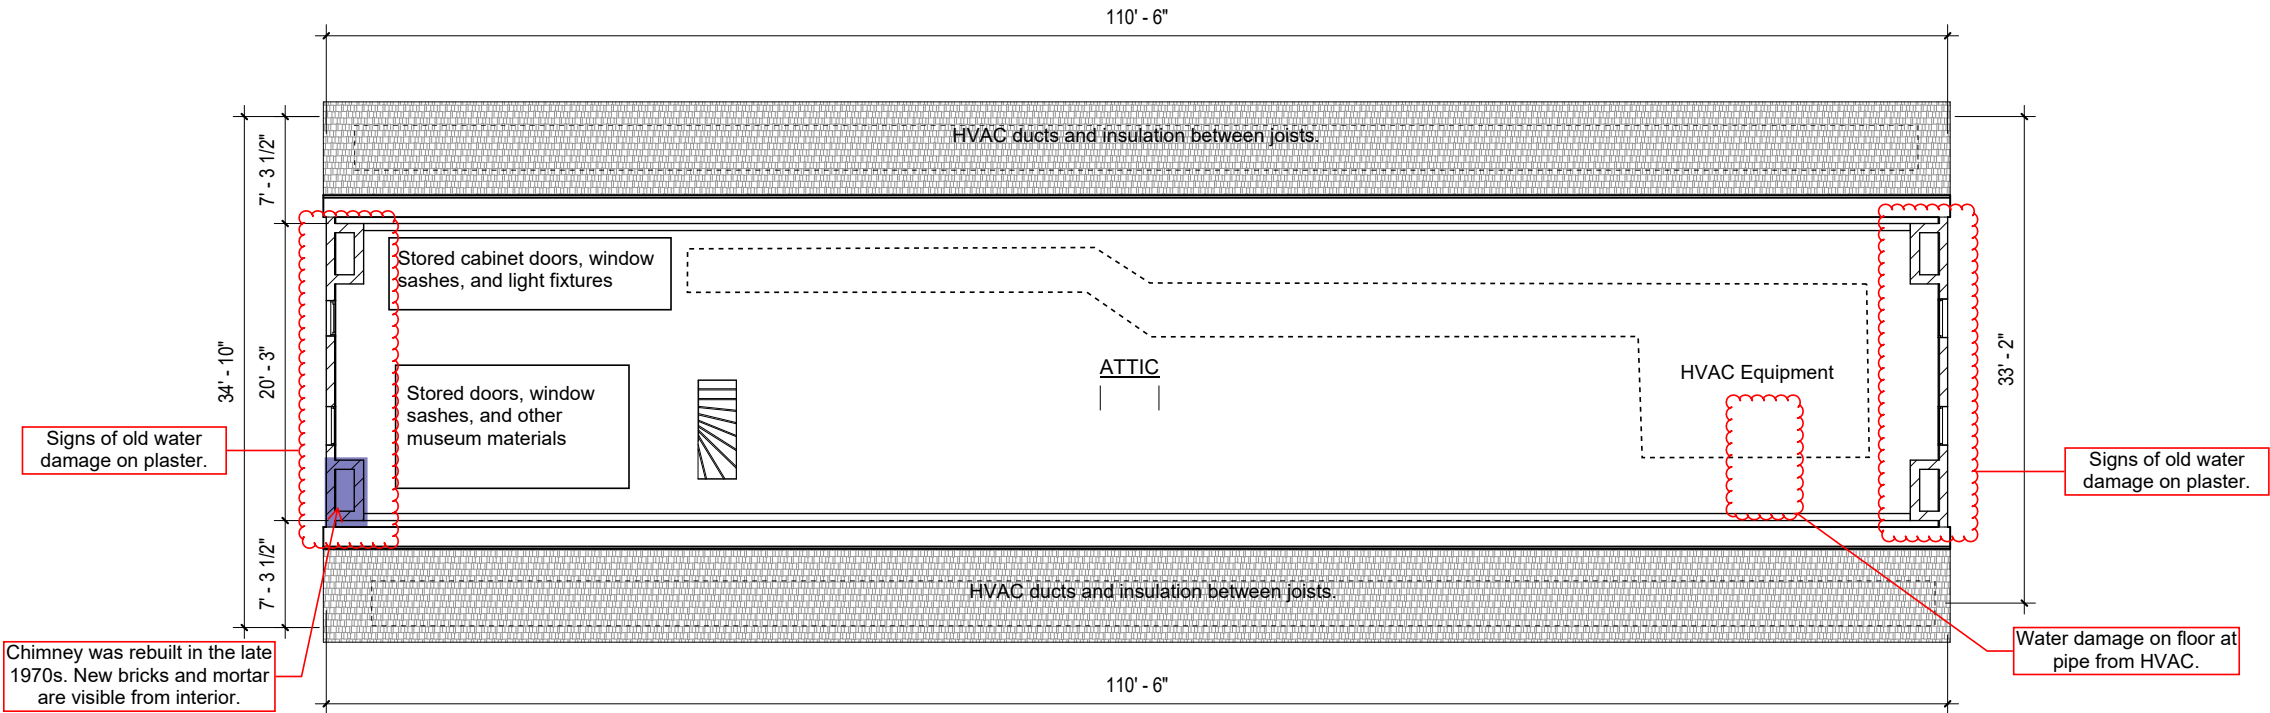
ATTIC FLOOR PLAN

- Plaster finishes in the attic area are very poor. there are large areas if exposed lath, and sections of sagging plaster.
- There are multiple areas of visible water damage. While most do not appear active, daylight could be seen through shingles in several areas behind plaster and lath walls.

- There is graffiti written on and scratched into the plaster in many locations. Some are dated and may correspond with renovation and restoration campaigns, but this should be investigated further.

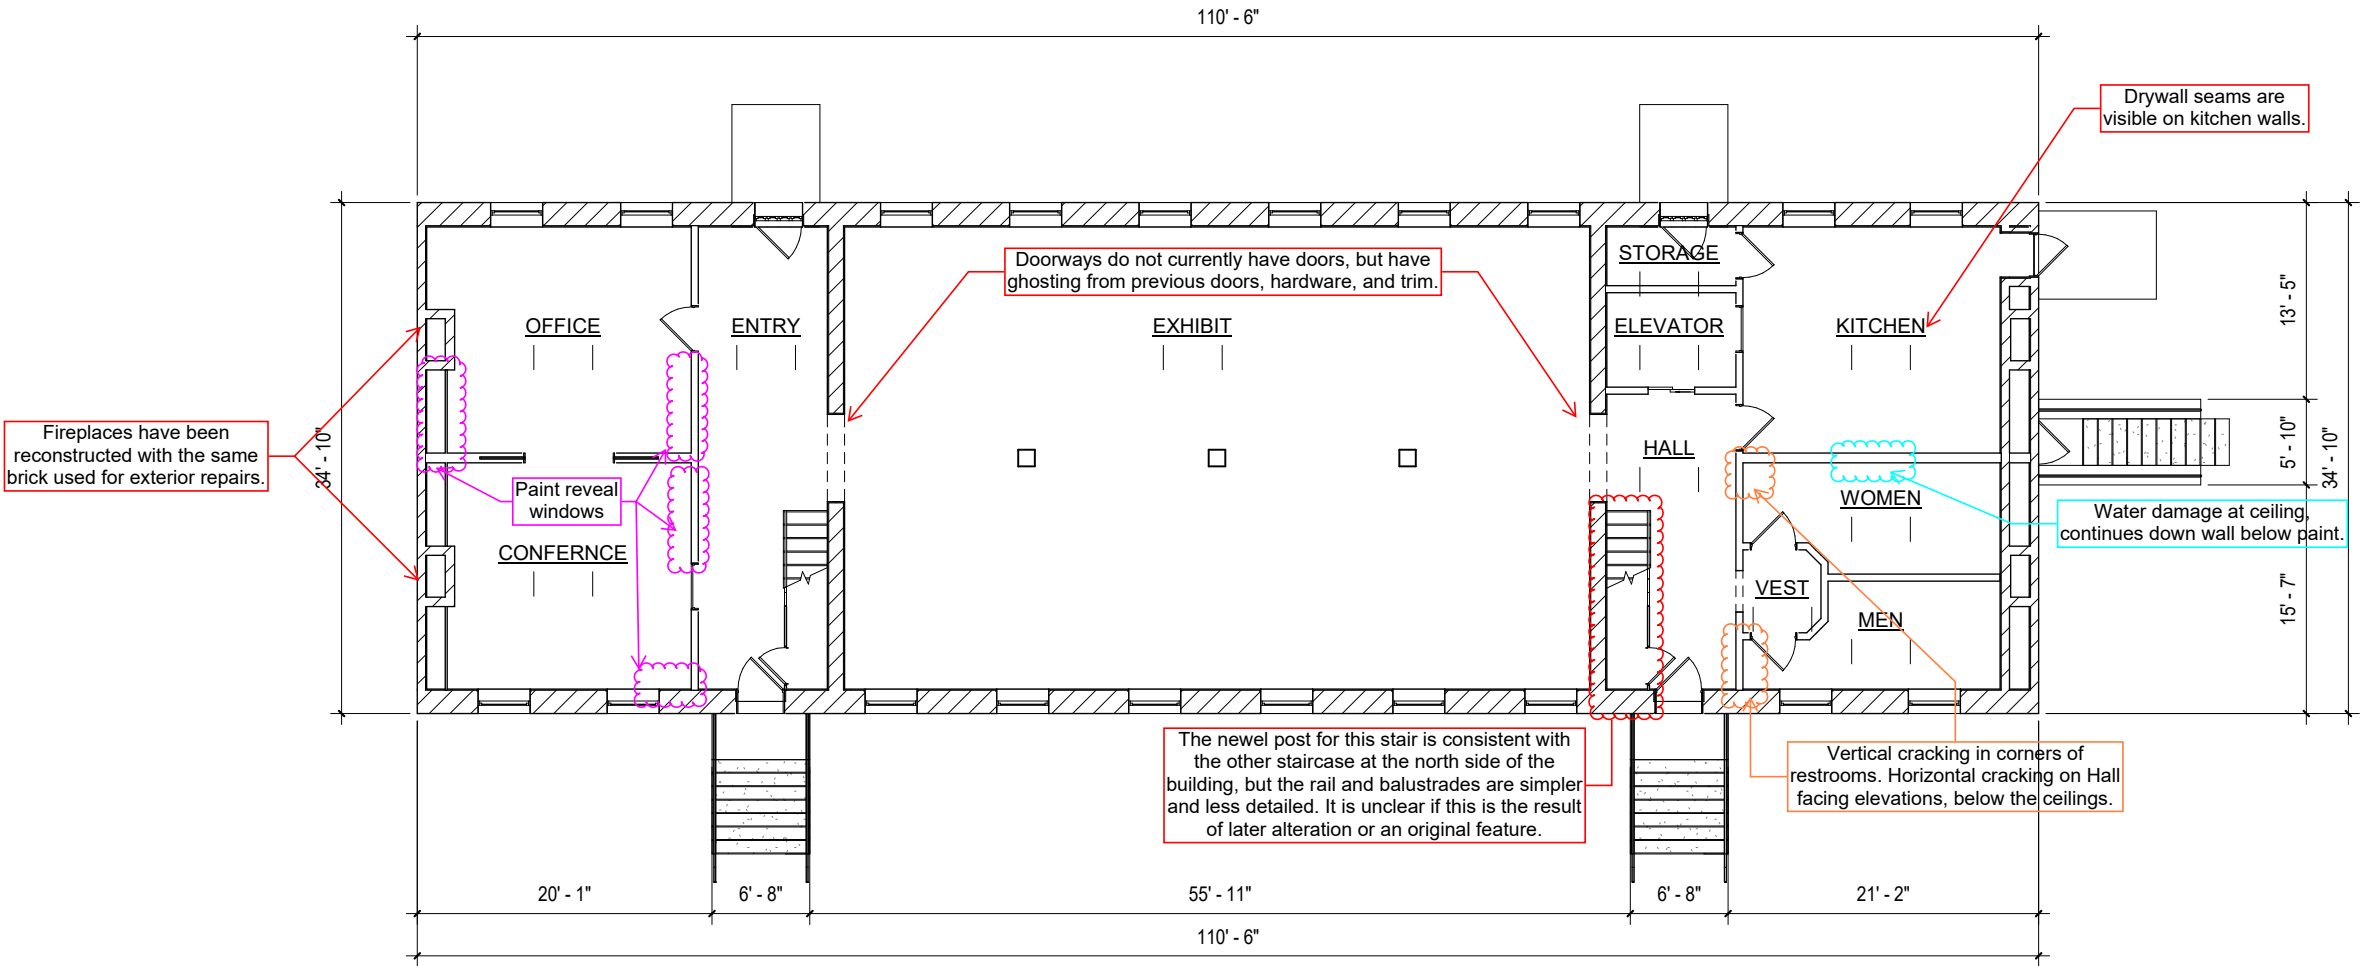
LEVEL 1 FLOOR PLAN

- Office and conference room include paint reveal windows showing early stencil finishes. These were completed prior to 2003 where they were called out to be left unpainted when the rest of the interior was painted.
- Hardware on built-ins in conference room is heavily overpainted and does not operate smoothly.
- Conduit is often surface mounted on walls because they appear to be solid masonry with plaster applied directly to the masonry.
- Kitchen has drywall, the seams are visible in some areas.
- East and west walls of central room have a chair rail at the sill level.
