CONDITIONS ASSESSMENT REPORT

Shawnee Indian Manual Labor Boarding School

Shawnee Tribe Cultural and Historical Preservation Committee | December 6, 2021

Architectural
Resources Group

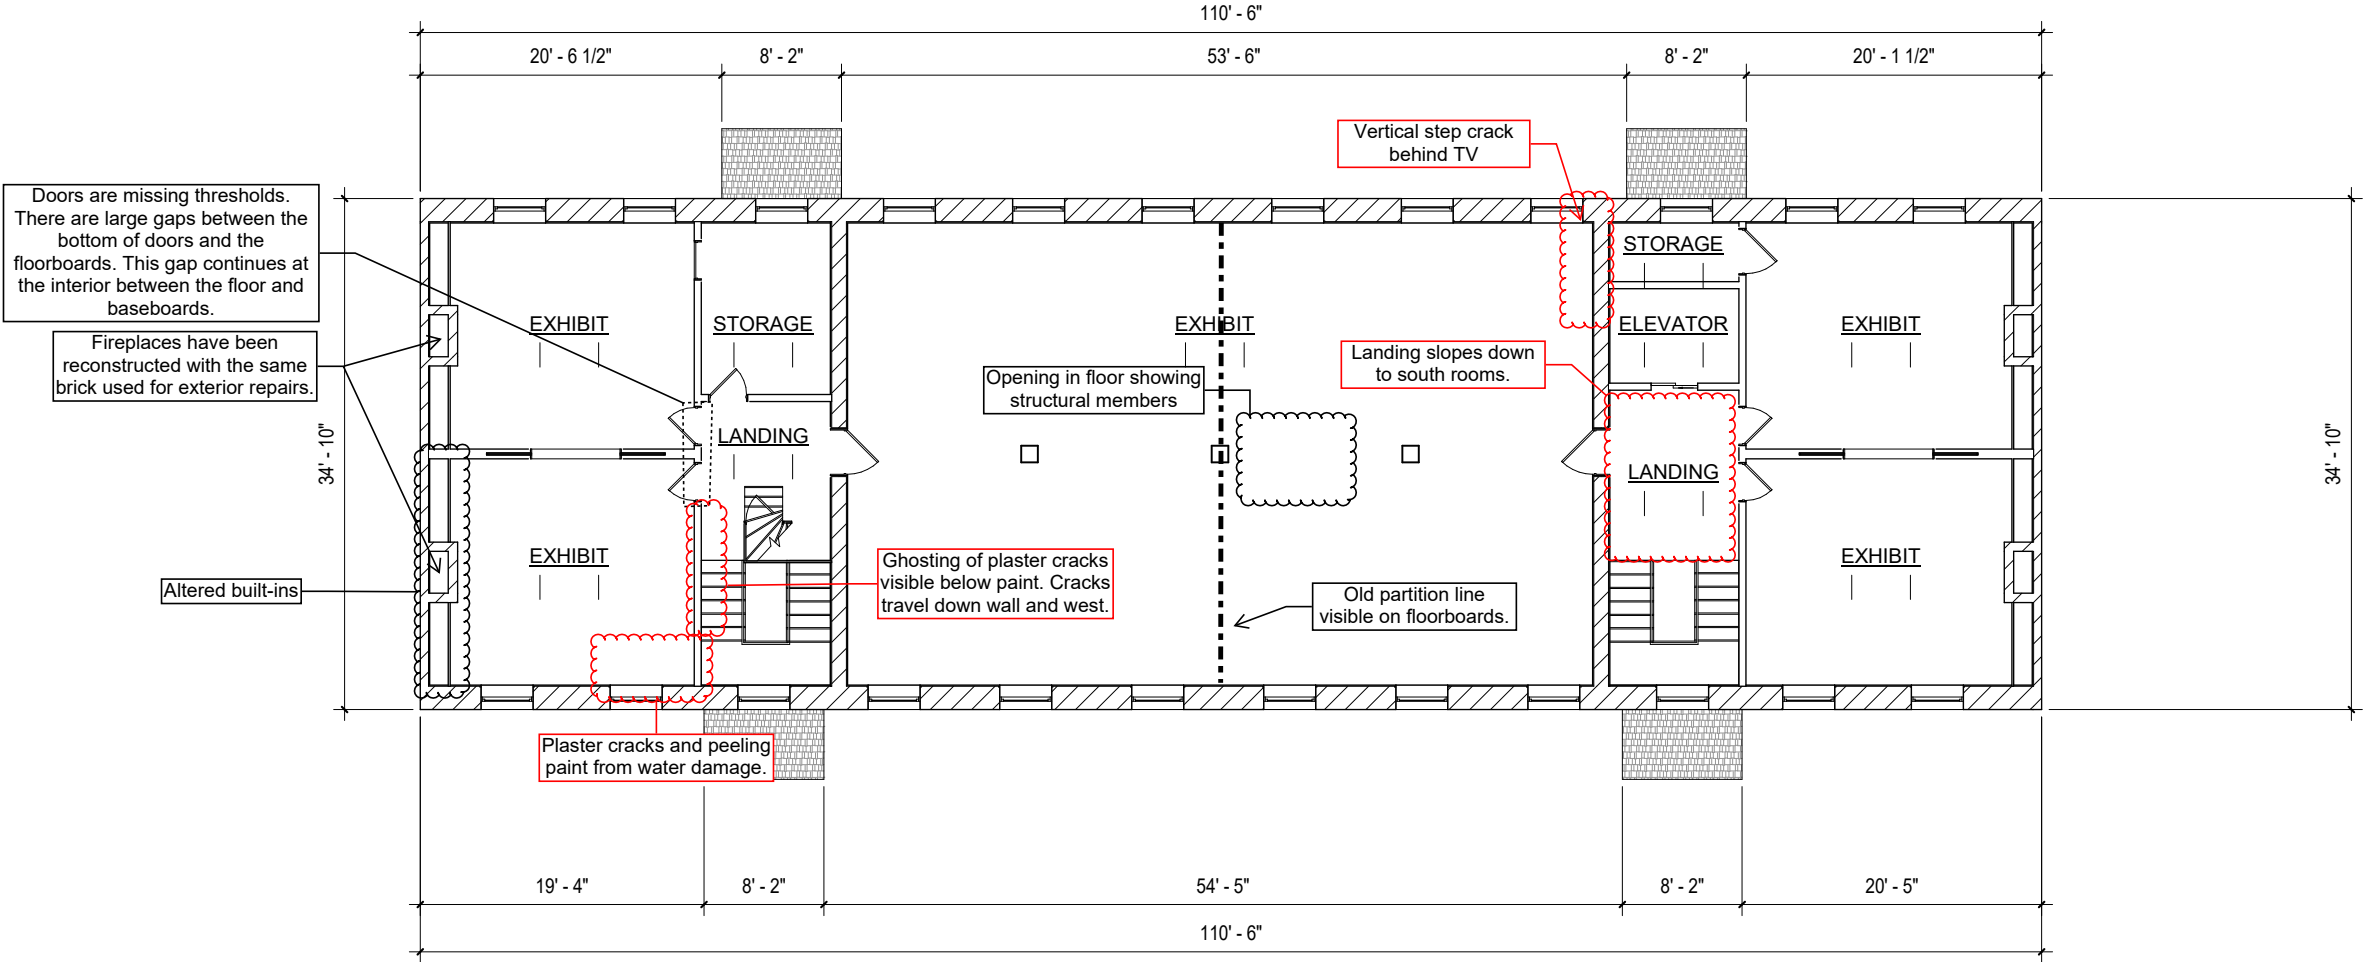
LEVEL 2 FLOOR PLAN

- Built-ins in northwest exhibit room appear to have been altered for installed exhibit. This room is displayed as a civil war barrack.
- Hardware on built-ins in conference room is heavily overpainted and does not operate smoothly.
- Conduit is often surface mounted on walls because they appear to be solid masonry with plaster applied directly to the masonry.
- East and west walls of central room have a chair rail at the sill level. These chair rails are not found on the rooms at the north and south.

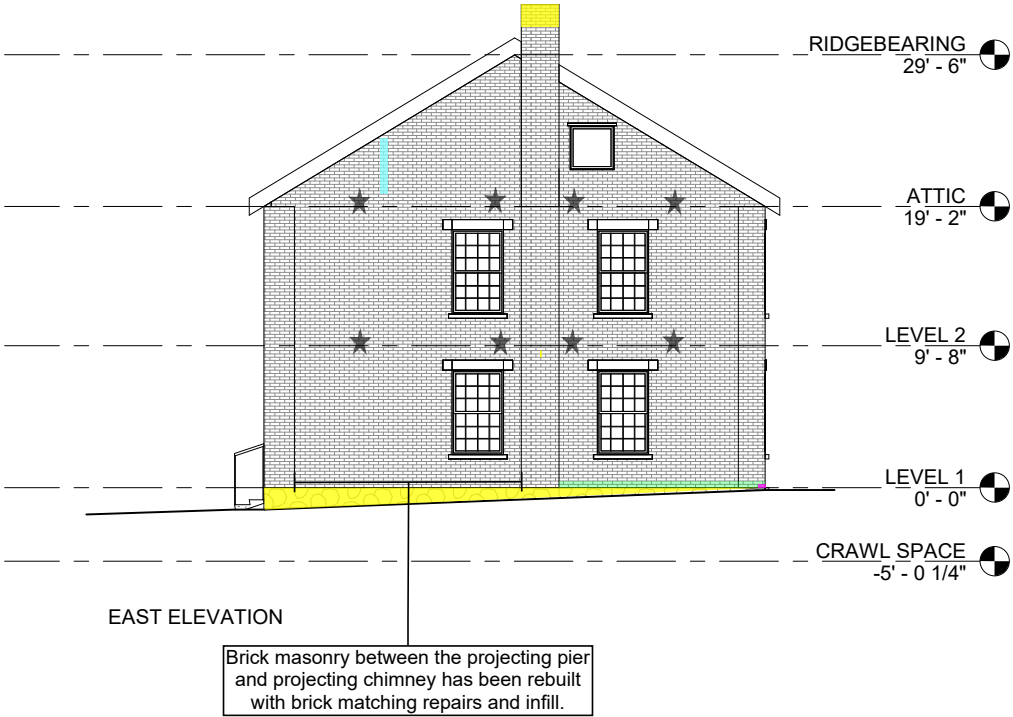
--Mortar caps on chimneys are in poor condition and should be replaced during repointing.

--Window sashes and surrounds including lintels and sills are new.

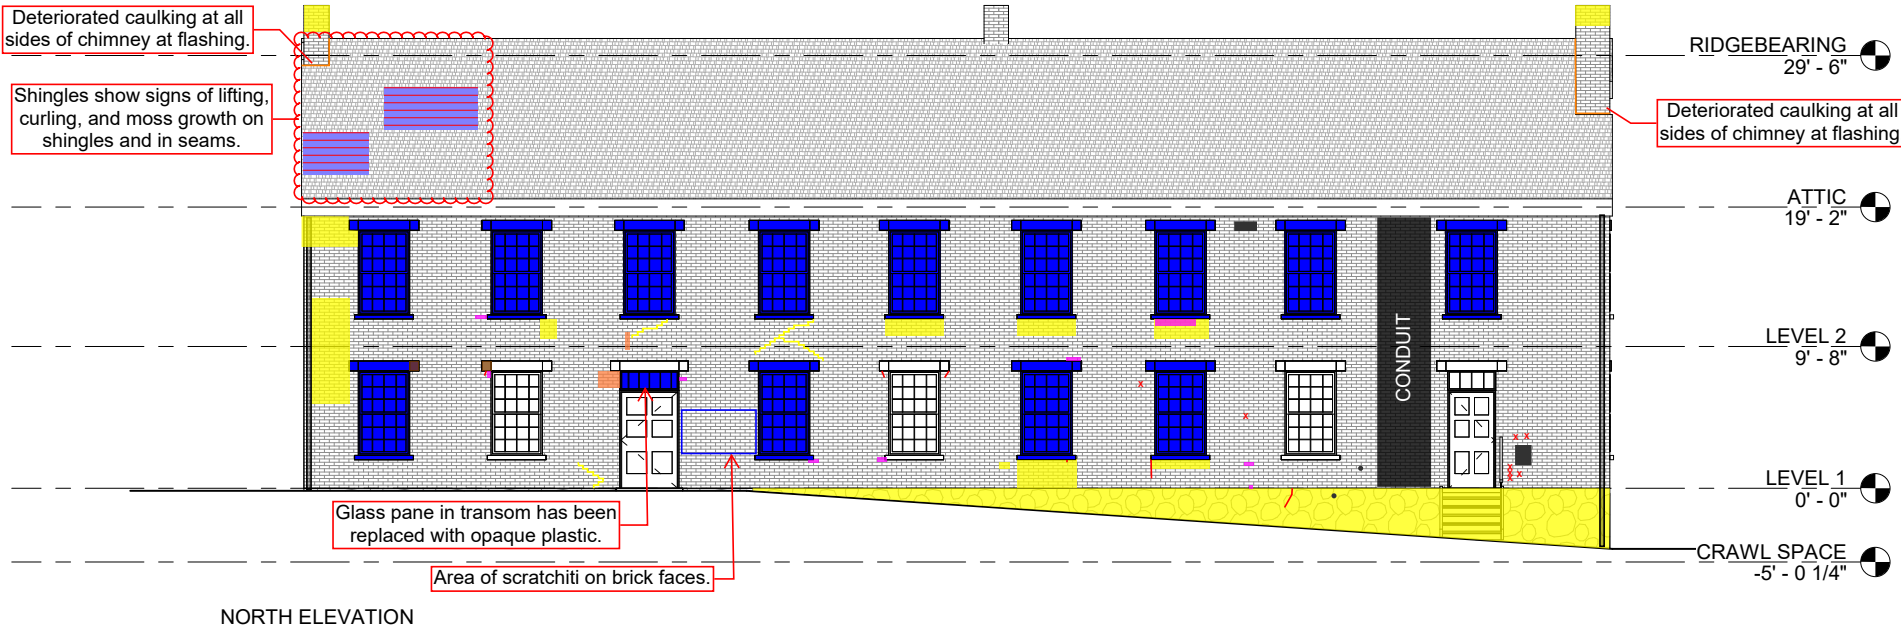
- There is heavy paint build-up on window frames, door frames, as well as door surrounds and transom windows. There is less paint build-up on the porch and trim, but this paint is heavily deteriorated. Note that windows with no paint deterioration consist of replacement sashes and surrounds including lintels and sills.

- Mortar caps on chimneys are in poor condition and should be replaced during repointing.
- The roof shingles show signs of lifting, curling, and heavy weathering.

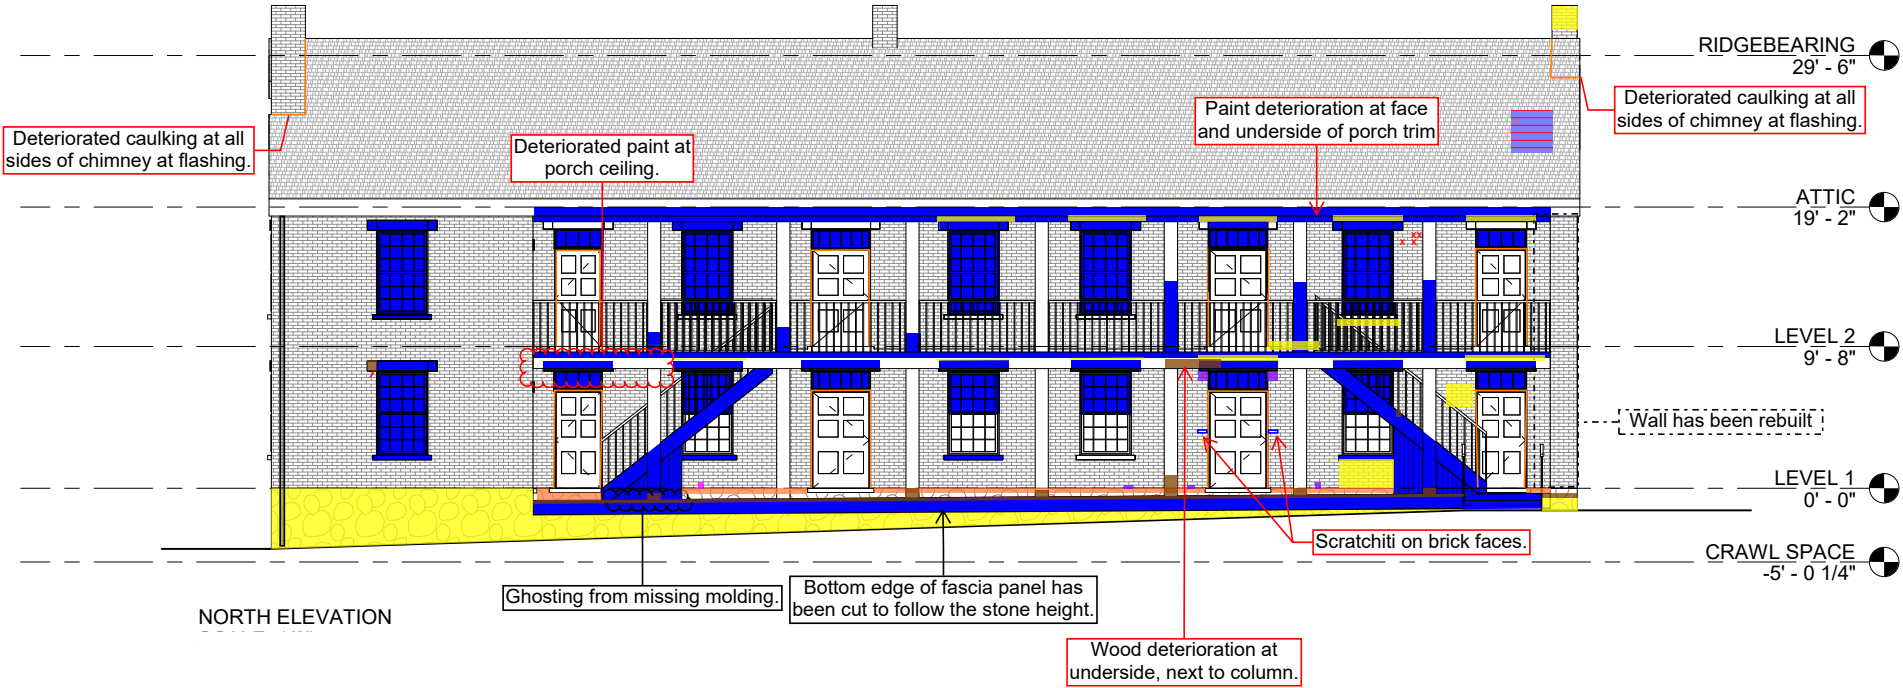
- Door frames have hinge ghosting from screen doors.
- There are multiple areas of brick infill.
- Areas of masonry at the back and west walls of the porch retain a red paint that was applied on the brick and mortar. There are still traces of the paint on the mortar, but most has worn off over time. The east wall was rebuilt and does not show signs of paint.

- There are screened vents on the soffit behind the gutter. Many of these screens are partially blocked from being painted over.
- The roof shingles show signs of lifting, curling, and heavy weathering.

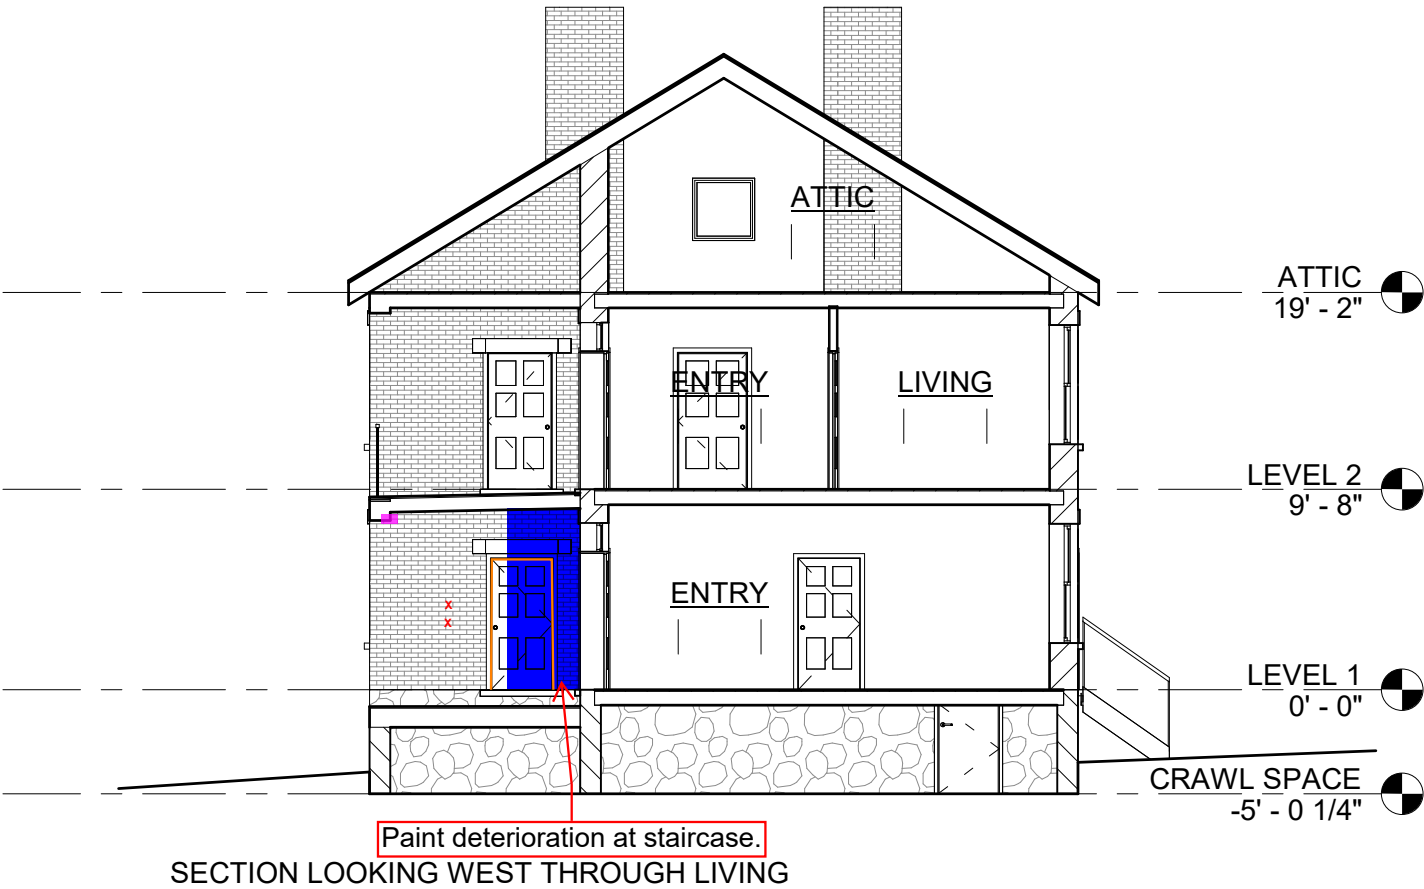
- There are multiple areas of brick infill.
- The field stone of this elevation is dressed rectangular stone.
- There is heavy paint build-up on window frames, door frames, as well as door surrounds and transom windows. There is less paint build-up on the porch and trim, but this paint is heavily deteriorated.
- Multiple repointing campaigns can be seen on the brick.
- Mortar caps on chimneys are in poor condition and should be replaced during repointing.
- Stone foundation shows signs of several repointing campaigns.
- Sealant at windows on this elevation is grey and unpainted.
- Locations of dutchman repairs on sashes are visible through paint.

NOTES:
--The masonry retains more red paint than other areas. There are still traces of the paint on the mortar, but most has worn off over time.
--The east wall is rebuilt and does not show signs of paint.
--Open joints in the fieldstone vary and can be very large in size. The field stone of this elevation is dressed rectangular stone.
--There is heavy paint build-up on window frames, door frames, as well as door surrounds and transom windows. There is less paint build-up on the porch and trim, but this paint is heavily deteriorated.

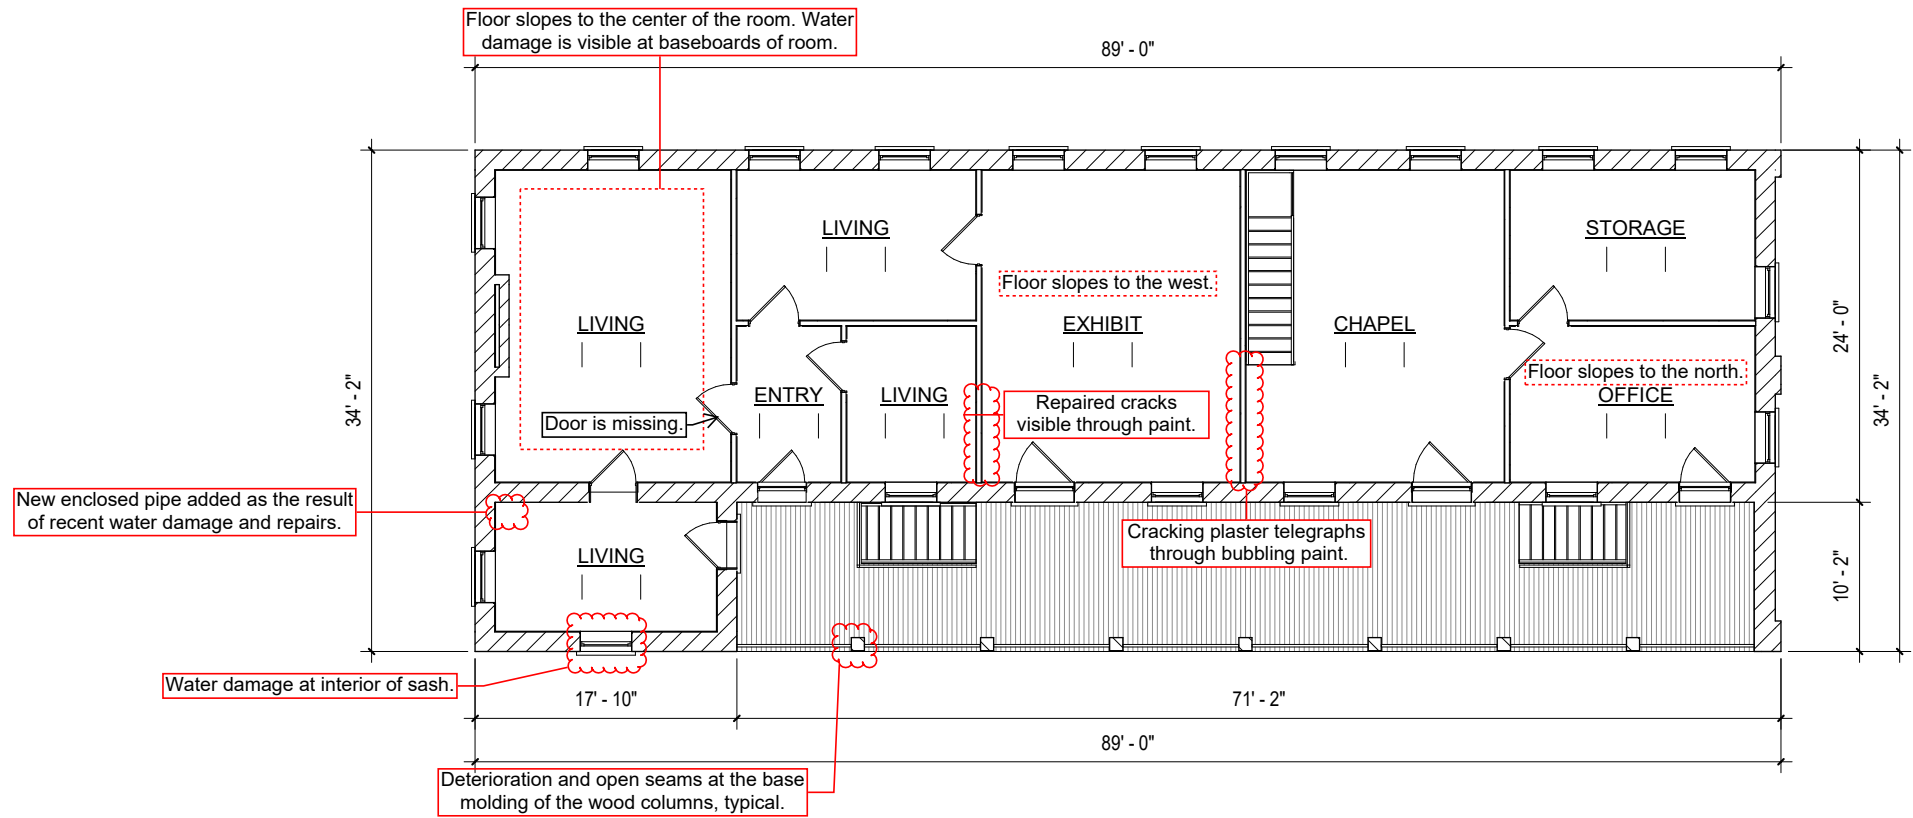
LEVEL 2 FLOOR PLAN

NOTES:
--Mantel on north wall was covered during the survey. This room has a new ceiling and east wall due to recent water damage from AC in the attic.
--Water damage to window sills in all rooms is typical.
--Most interior doors have ghosting from missing hardware such as box locks.
