**KIRKLAND & ELLIS LLP**  
AND AFFILIATED PARTNERSHIPS

July 26, 2019

As you requested, this is a letter report on the vegetation management field inspections (“VM inspections”) the Monitor team is conducting pursuant to the Court’s April 3, 2019 Order (“April 3 Order”). This submission includes: (1) background information on the VM inspections; (2) an explanation of the VM inspections process; (3) the Monitor team’s preliminary observations; (4) PG&E’s feedback based on the Monitor team’s preliminary findings; (5) the Monitor team’s preliminary suggestions to PG&E, as shared with the Company on July 17, 2019; and (6) concluding thoughts.

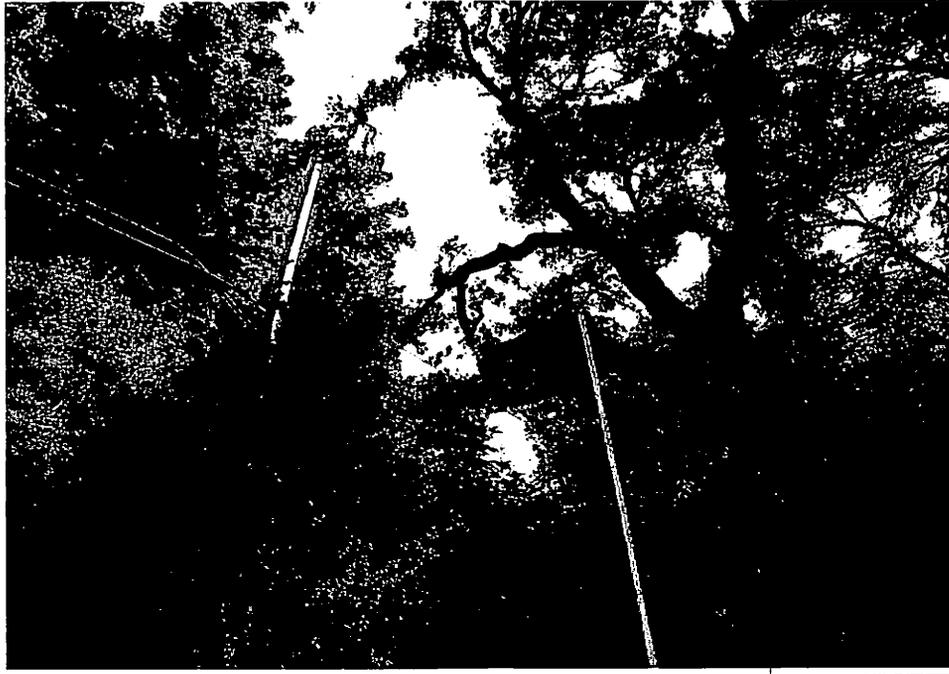
<b>PG&amp;E ArcCollector Project Status</b>	No Work Required Under EVM	
<b>Monitor Team Observed Tree Work in Immediate Vicinity of Subject Tree</b>	Yes	
<b>Species</b>	Coastal Live Oak	
<b>GPS Coordinates</b>	38.410948, -122.947381	
<b>Approx. Distance from Primary Conductor</b>	Trunk of tree 23 feet south	
<b>Approx. Height</b>	56 feet	
<b>Veg Type</b>	Potential Hazard Tree	
<b>Monitor Arborist Comment</b>	Observations of the tree include (a) cavity in trunk displays evidence of decay. (b) guy wire embedded in trunk, and (c) tree leaning toward primary conductor

***Figure 8: Photos included in a sample report. Here, the photos substantiate the observations that (1) there is a cavity in the trunk, (2) the tree is leaning towards the primary conductor, and (3) guy wire is embedded in the tree's trunk.***

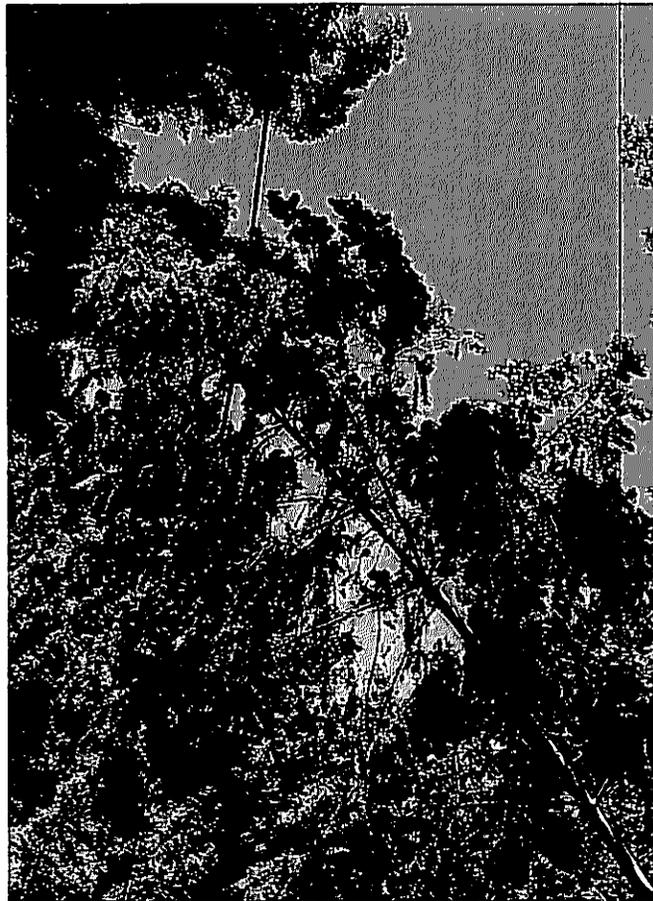
Second, on July 11, 2019, the Monitor team informed PG&E of a tree that was in contact with a primary conductor near the driveway of a private residence (see Figure 10 below). The Monitor team stayed in the area until a PG&E-dispatched pre-inspector arrived. The pre-inspector remained on the scene until a tree crew arrived to address the issue later that day.

***Figure 10: Tree found by Monitor team on July 11, 2019 that was in contact with a primary conductor.***

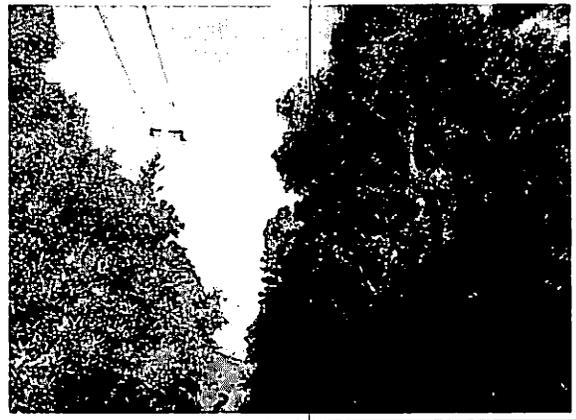
tree exceptions the Monitor team found were not properly documented in Arc Collector or marked for removal with tree paint, as they should be. Further, in some instances, potential hazard trees were marked with a yellow dot for pruning only (that is, not removal), despite the fact that decay, rot, or other defects were observable in the area near the paint dot at the base of the tree, which suggests that removal is appropriate. Additionally, in many instances, the overall health of the tree—along with the EVM scope—suggested that removal may have been the appropriate prescription. The Monitor team’s observation is that pre-inspectors may not be fully assessing the trunk of the tree, which is often where many of the defects are present.

*Figure 12: Example of a potential hazard tree exception.*

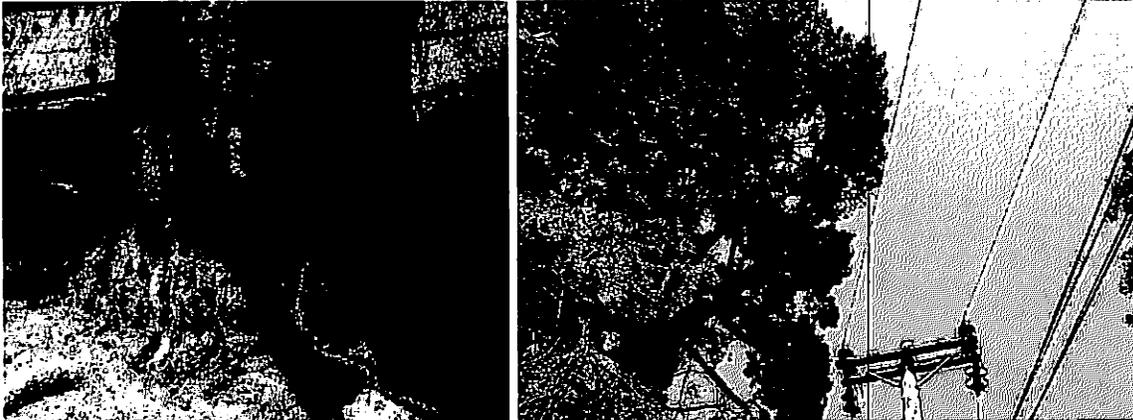
The Monitor team found 524 potential overhang exceptions in 53.49 miles inspected, or 9.80 potential overhang exceptions per mile. The Monitor team noted multiple instances where potential overhangs were not properly cleared to the sky (that is, the tree was pruned up to a certain height, but the higher portions of the tree, which would readily fall on the line if displaced, were not pruned). If there were reasons for not pruning the additional overhanging vegetation (for example, it was unsafe to do so, or it would have compromised the health of the tree), those reasons were not documented in Arc Collector to reflect any reasoned analysis by PG&E.

*Figure 13: Example of a potential overhang tree that was partially—but not fully—trimmed.*

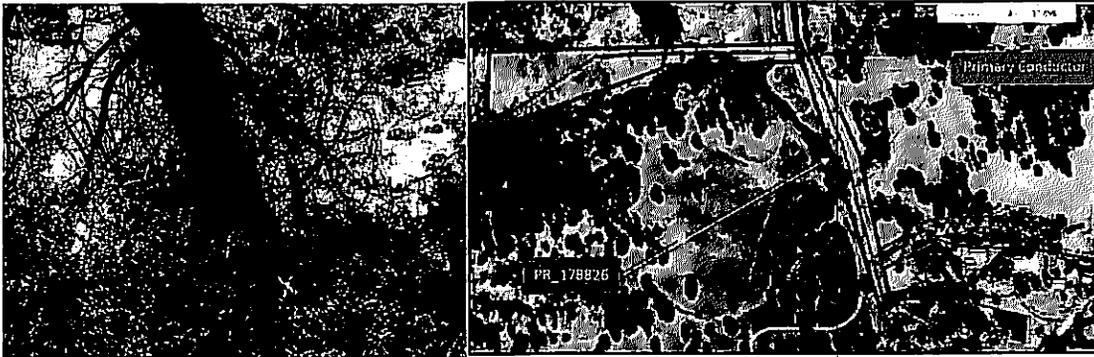
Some workers are simply not entering data into Arc Collector. Trees identified as requiring work under the EVM scope are supposed to be (1) physically marked with yellow paint or flagging, and (2) entered into Arc Collector. This is often not occurring—the Monitor team has identified numerous instances where trees that were physically marked for work were not included in Arc Collector, and vice versa. Either failure materially reduces the chance that proper remediation will occur.

*Figure 14: Example of a potential hazard tree that was marked with an X for removal (left photo) but did not appear in Arc Collector (right photo; trees prescribed for work are supposed to appear in Arc Collector as green triangles).*

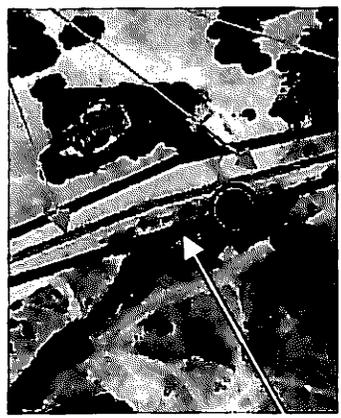
- The Monitor team has often observed trees that were marked with tree paint by a pre-inspector but were not entered into Arc Collector (*left example below*). The Monitor team has also observed the inverse issue, where the tree was included in Arc Collector but not marked with paint or flagging (*right example below: confirmed that stake in photo is not associated with tree work*).

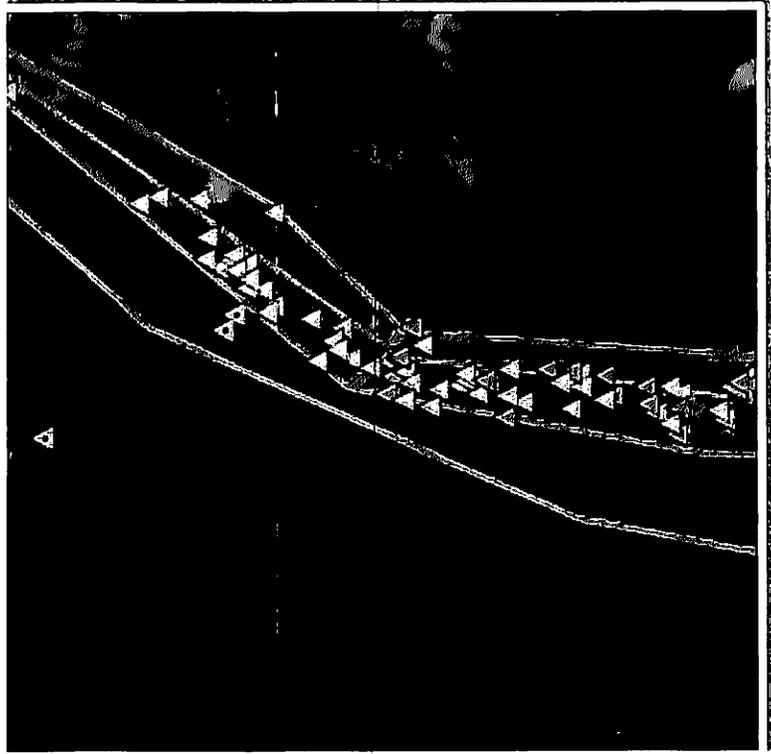
- Re-inspection after post-work verification is not recorded consistently. The Monitor team observed that inspectors came to an area and marked trees that needed to be remediated with yellow paint, but only added some of those trees into Arc Collector (*left photo, dark green triangles*). In other areas, pre-inspectors appeared to have re-inspected an area, with paint on trees needing remediation, but they made no additions on Arc Collector (*right photo*).

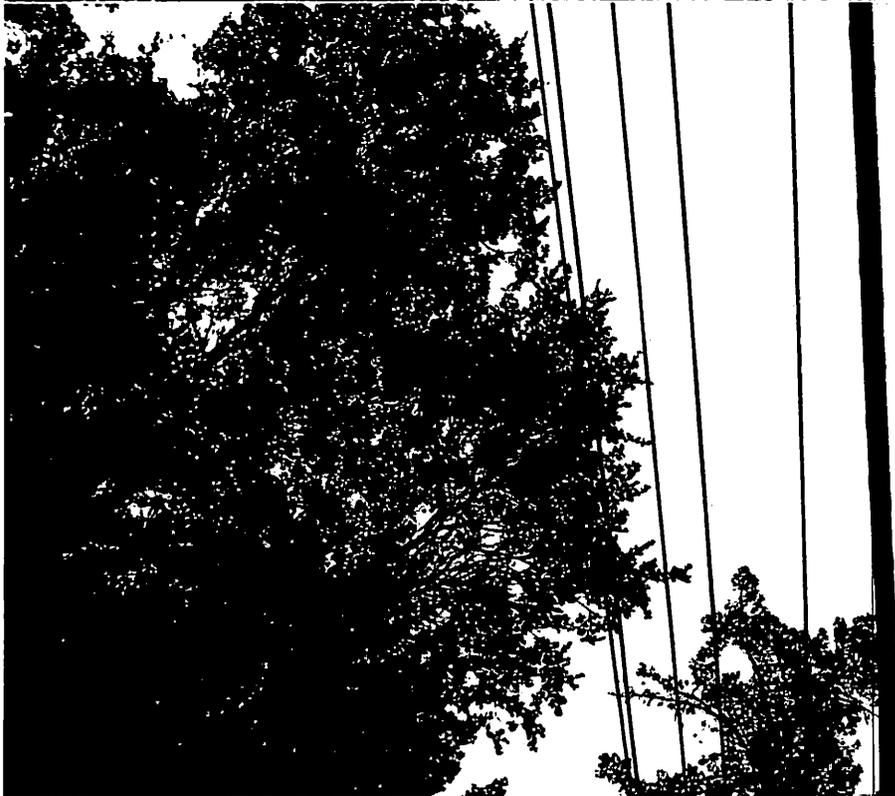
A potential hazard tree was found during a Monitor Inspection on July 9, 2019 of Project *PR\_037553* on Circuit *Silverado 2104*. In general terms, this circuit is located on the outskirts of the city of St. Helena, CA, running approximately 15 miles to the north of the city. This circuit is located in/near a Tier 3 fire threat area pursuant to the ArcCollector database. The approximate position of the tree is denoted as the red circle in the second graphic below.

PG&E ArcCollector Project Status	Wood Mgmt Complete
Monitor Team Observed Tree Work in Immediate Vicinity of Subject Tree	Yes
Monitor Team Observed Recent Tree Work on Subject Tree	No
Tree Paint or Other Markings Observed	None
Species	Coastal Live Oak
GPS Coordinates	38.543353, -122.477124
Approx. Distance from Primary Conductor	Trunk of tree 3 feet east
Approx. Height	55 feet
Veg Type	Potential Hazard Tree
Monitor Arborist Comment	Observations of the tree include (a) located on uphill slope from primary line, (b) tree is overhanging the line, and (c) roots are exposed due to erosion, causing potential instability in the tree.

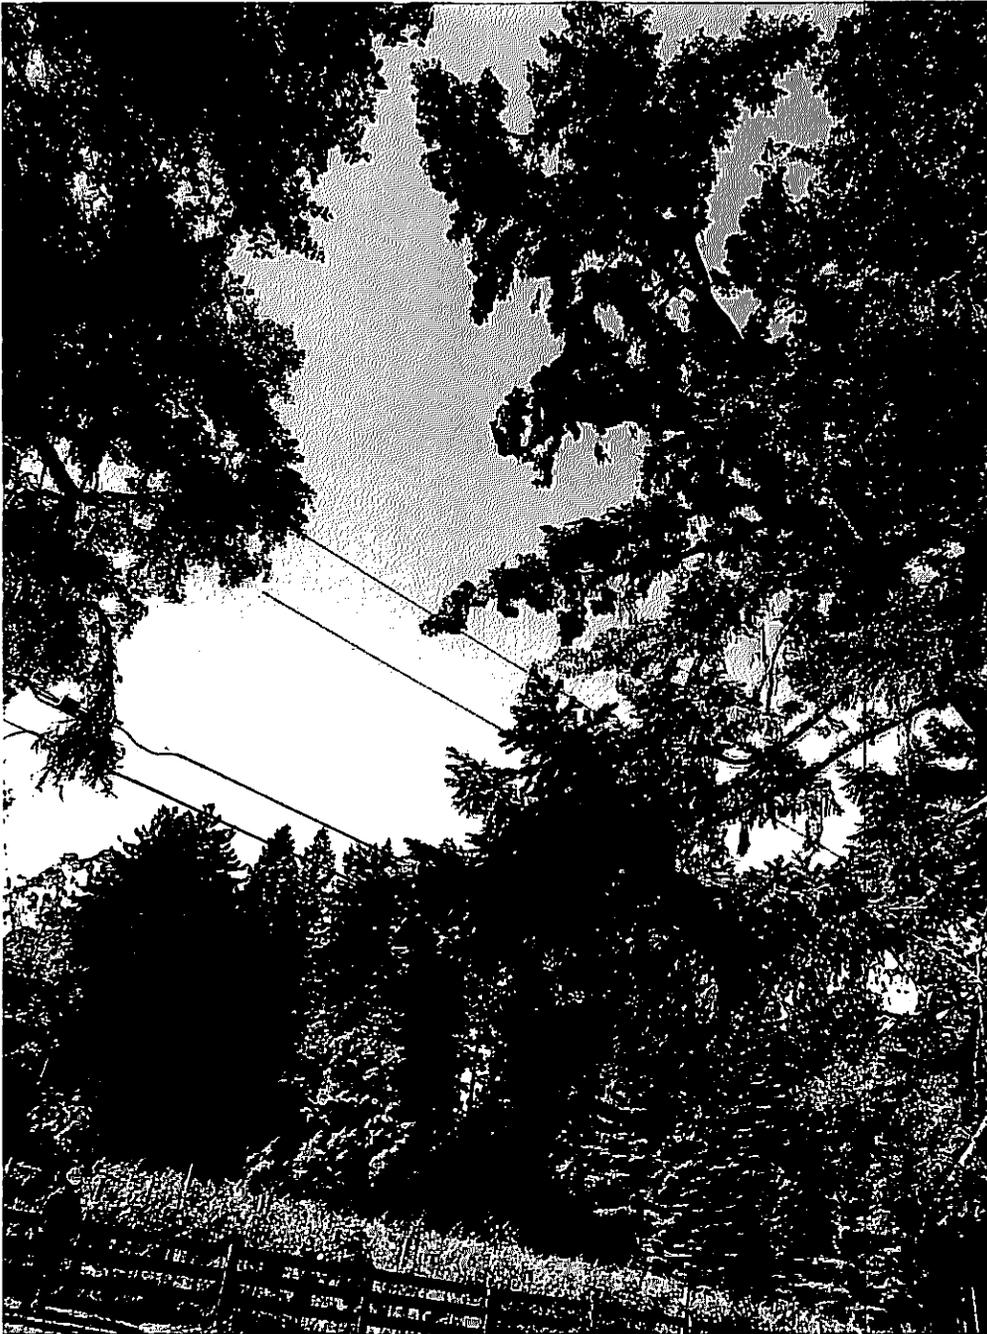
A potential hazard tree was found during a Monitor Inspection on July 8, 2019 of Project PR\_187518 on Circuit Molino 1102. In general terms, this circuit is located on the outskirts of the city of Sebastopol, CA, running approximately 10 miles to the west of the city. This circuit is located in/near a Tier 3 fire threat area pursuant to the ArcCollector database. The approximate position of the tree is denoted as the red circle in the second graphic below.

PG&E ArcCollector Project Status	Work Identified	
Monitor Team Observed Tree Work in Immediate Vicinity of Subject Tree	No	
Monitor Team Observed Recent Tree Work on Subject Tree	No	
Tree Paint or Other Markings Observed	No paint observed	
Species	Douglas Fir	
GPS Coordinates	38.4074348, -122.9278607	
Approx. Distance from Primary Conductor	Trunk of tree 50 feet southeast	
Approx. Height	100 feet	
Veg Type	Potential Hazard Tree	
Monitor Arborist Comment	Observations of the tree include (a) tree leaning 40 degrees towards the primary conductor, (b) failure would strike the primary conductor, and (c) no apparent lifting of the roots.

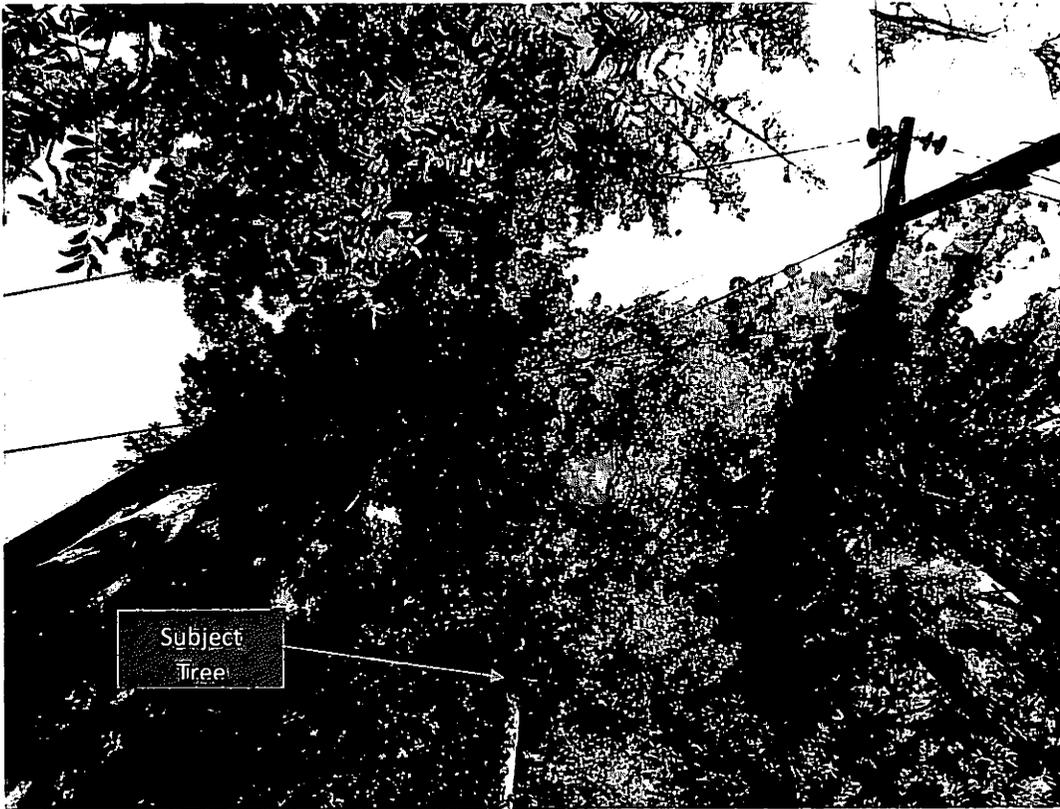
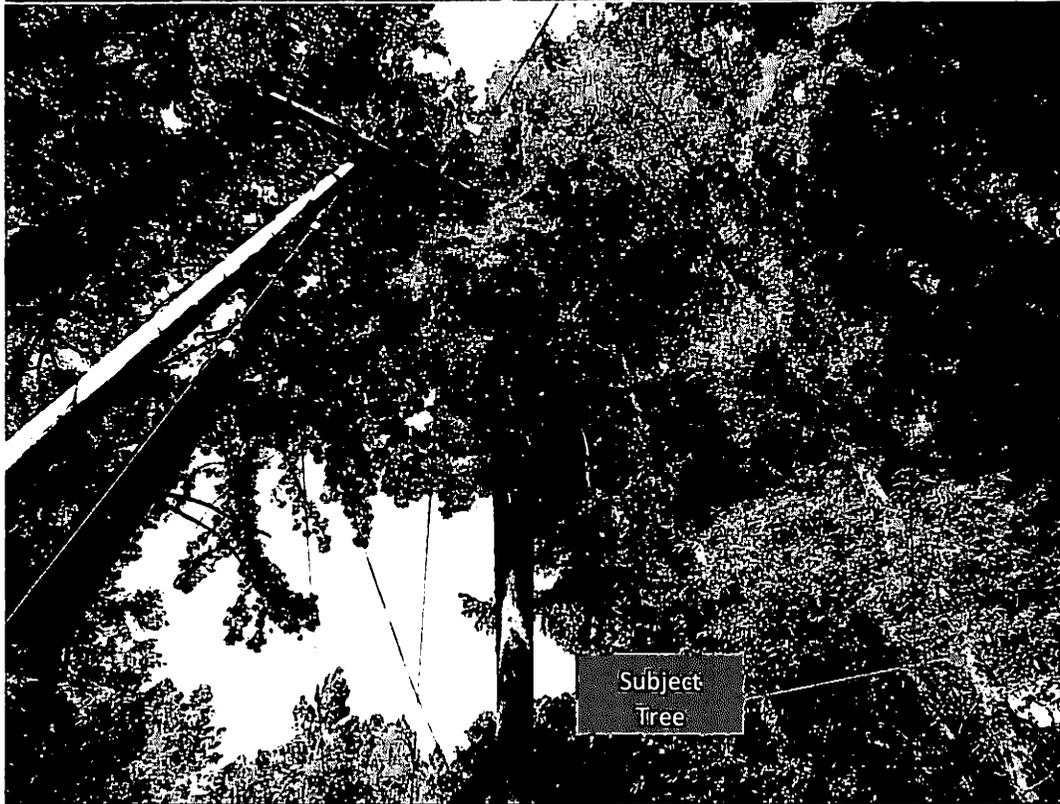
A potential hazard tree was found during a Monitor Inspection on July 11, 2019 of Project *PR\_187761* on Circuit *Molino 1102*. In general terms, this circuit is located on the outskirts of the city of Sebastopol, CA, running approximately 10 miles to the west of the city. This circuit is located in/near a Tier 3 fire threat area pursuant to the ArcCollector database. The approximate position of the tree is denoted as the red circle in the second graphic below.

PG&E ArcCollector Project Status	Work Identified
Monitor Team Observed Tree Work in Immediate Vicinity of Subject Tree	No
Monitor Team Observed Recent Tree Work on Subject Tree	No
Tree Paint or Other Markings Observed	No
Species	California Bay
GPS Coordinates	38.399828, -122.940605
Approx. Distance from Primary Conductor	Trunk of tree 14 feet northwest
Approx. Height	70 feet
Veg Type	Potential Hazard Tree
Monitor Arborist Comment	Observations of the tree include (a) weak multi-stemmed tree structure, (b) soil eroded around roots leading to poor anchorage, and (c) tree is overhanging line at 15 ft.

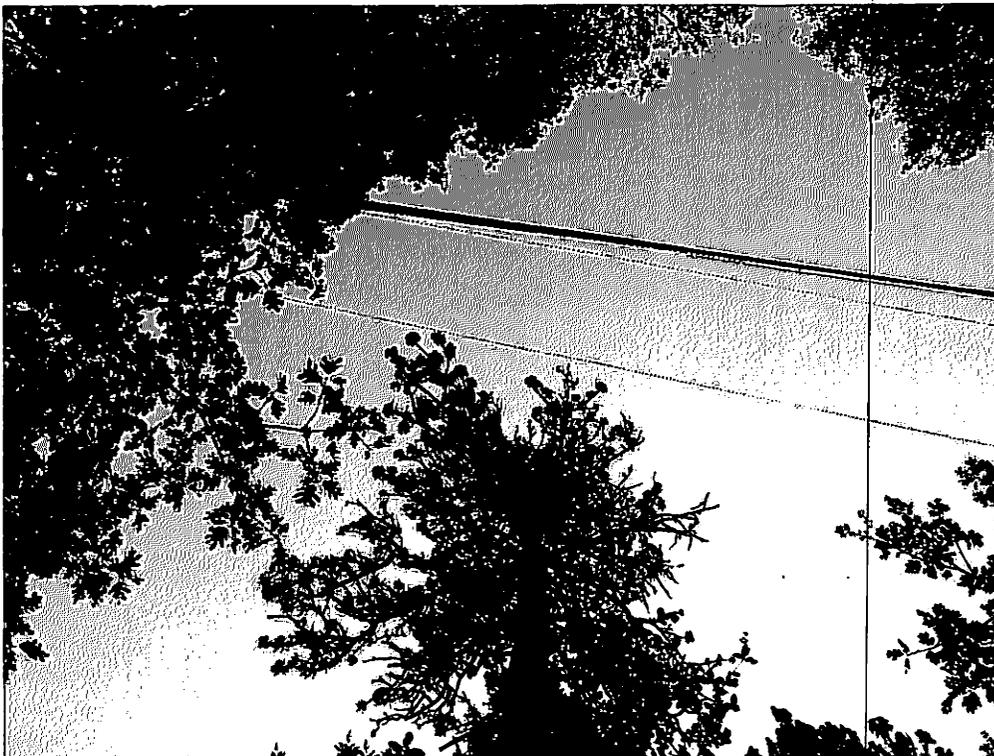
A potential overhang tree was found during a Monitor Inspection on July 3, 2019 of Project *PR\_000053* on Circuit *Silverado 2104*. In general terms, this circuit is located on the outskirts of the city of St. Helena, CA, running approximately 15 miles to the north of the city. This circuit is located in/near a Tier 3 fire threat area pursuant to the ArcCollector database. The approximate position of the tree is denoted as the red circle in the second graphic below.

PG&E ArcCollector Project Status	Tree Work Complete
Monitor Team Observed Tree Work in Immediate Vicinity of Subject Tree	Yes
Monitor Team Observed Recent Tree Work on Subject Tree	Yes
Tree Paint or Other Markings Observed	Red dot
Species	Ponderosa Pine
GPS Coordinates	38.55916545, -122.45531080
Approx. Distance from Primary Conductor	Trunk of tree 18 feet east
Approx. Height	102 feet
Veg Type	Potential Overhang Tree
Monitor Arborist Comment	Vegetation observed currently overhanging the 4 foot vertical plane.

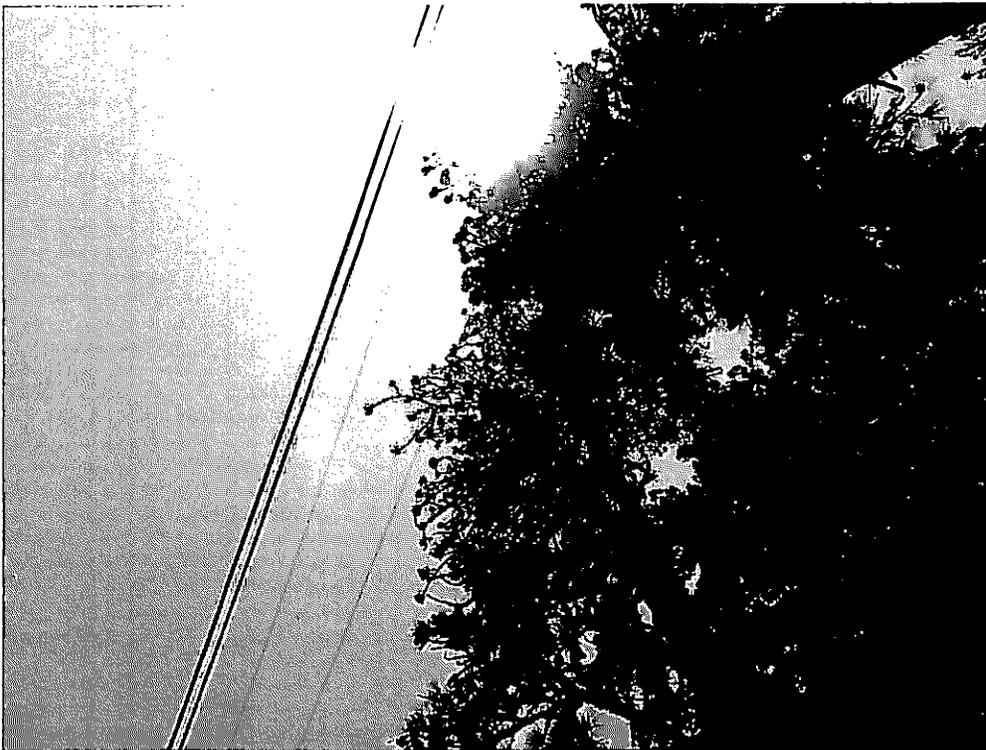
A potential overhang tree was found during a Monitor Inspection on July 3, 2019 of Project *PR\_000340* on Circuit *Silverado 2104*. In general terms, this circuit is located on the outskirts of the city of St. Helena, CA, running approximately 15 miles to the north of the city. This circuit is located in/near a Tier 3 fire threat area pursuant to the ArcCollector database. The approximate position of the tree is denoted as the red circle in the second graphic below.

PG&E ArcCollector Project Status	Work Identified	
Monitor Team Observed Tree Work in Immediate Vicinity of Subject Tree	No	
Monitor Team Observed Recent Tree Work on Subject Tree	No	
Tree Paint or Other Markings Observed	No paint observed	
Species	Ponderosa Pine	
GPS Coordinates	38.55996885, -122.45295820	
Approx. Distance from Primary Conductor	Trunk of tree 8 feet east	
Approx. Height	115 feet	
Veg Type	Potential Overhang Tree	
Monitor Arborist Comment	Vegetation observed currently overhanging the 4 foot vertical plane, and tree not visibly marked for pruning.

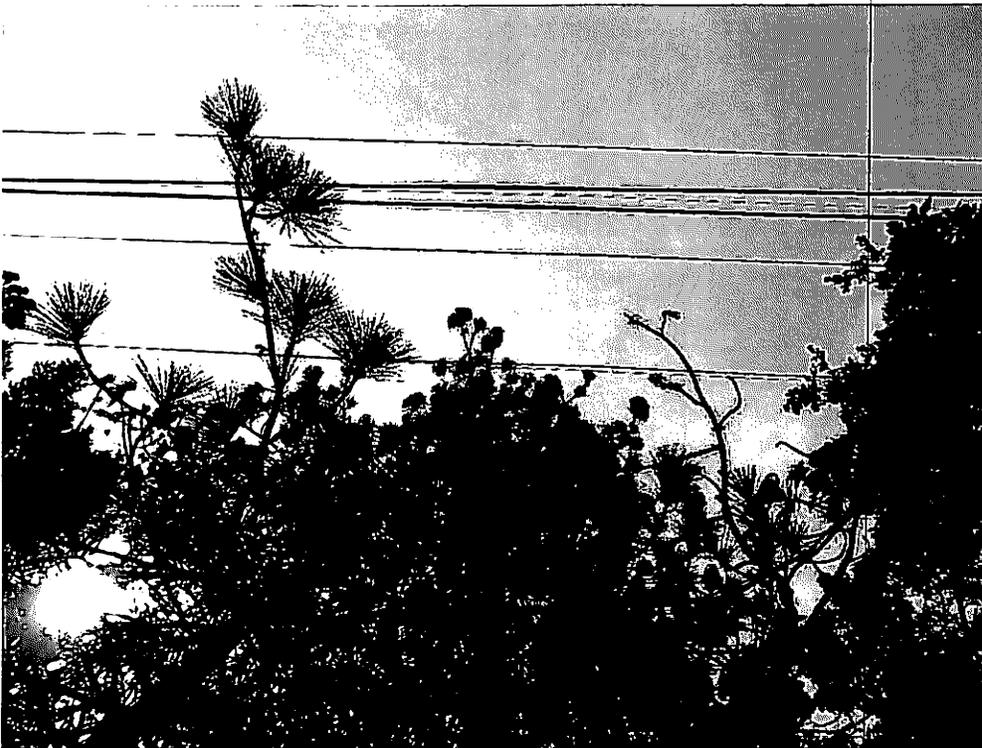
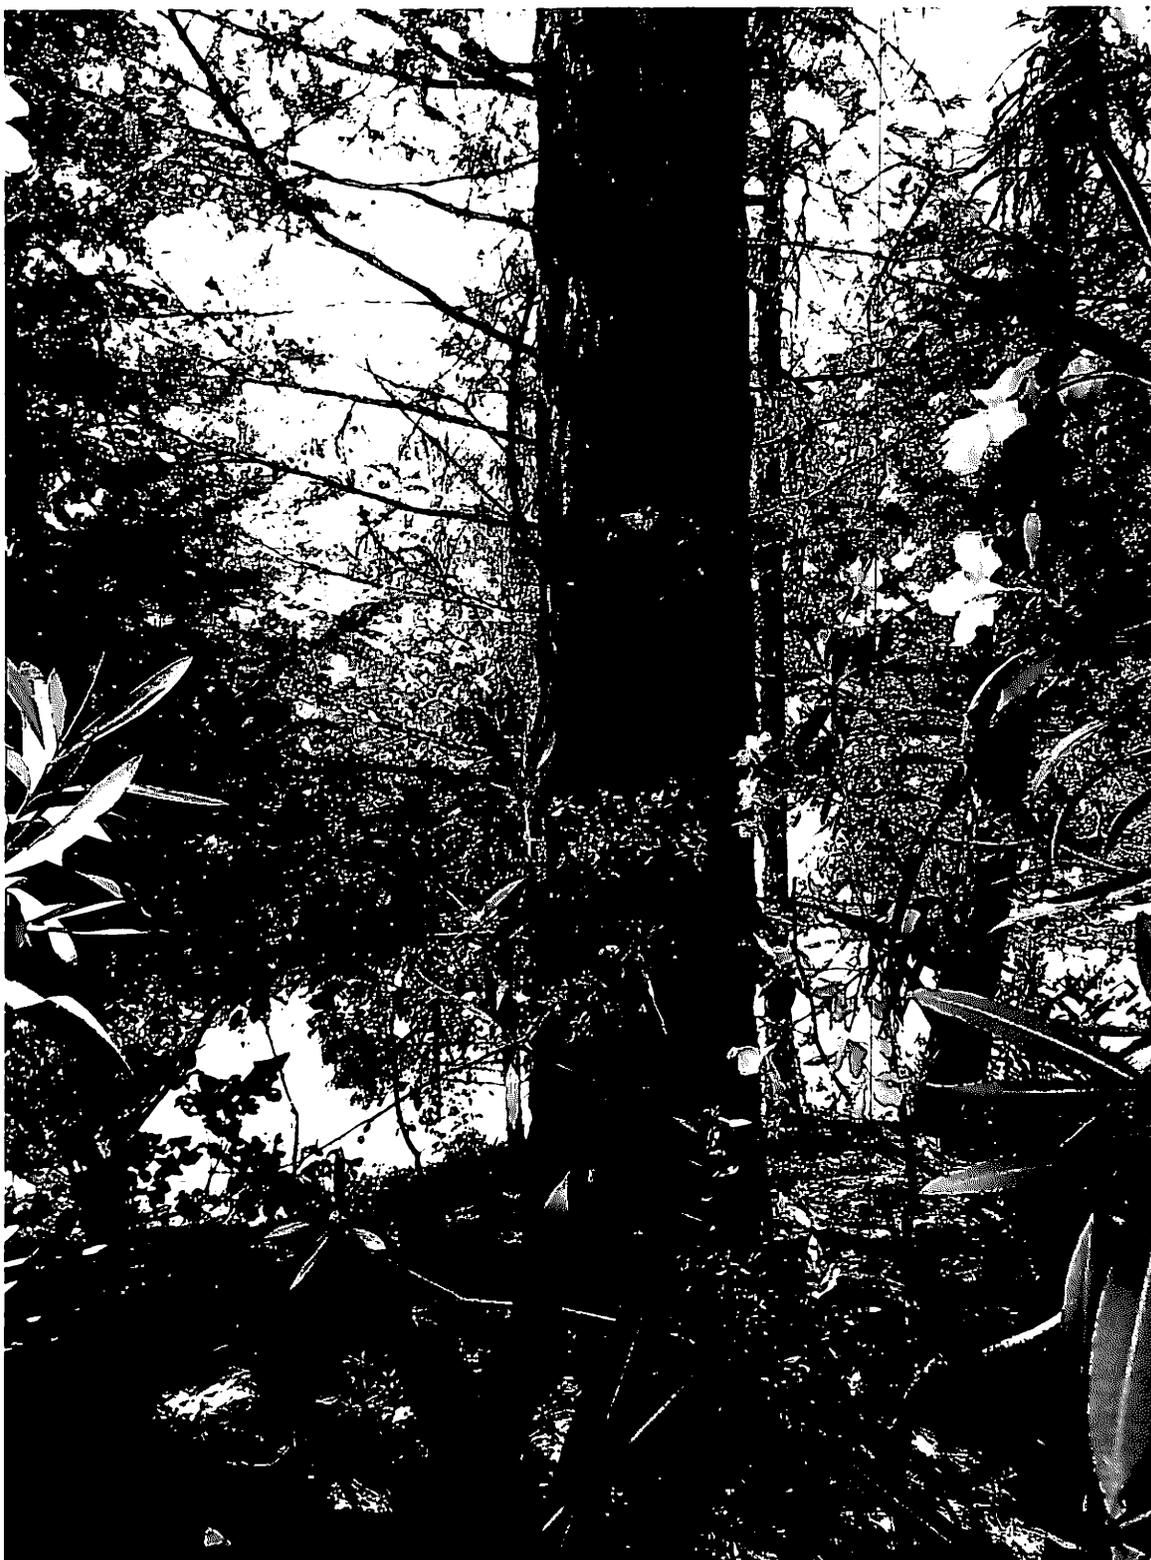
A potential overhang tree was found during a Monitor Inspection on July 1, 2019 of Project *PR\_177220* on Circuit *Silverado 2104*. In general terms, this circuit is located on the outskirts of the city of St. Helena, CA, running approximately 15 miles to the north of the city. This circuit is located in/near a Tier 3 fire threat area pursuant to the ArcCollector database. The approximate position of the tree is denoted as the red circle in the second graphic below.

PG&E ArcCollector Project Status	In-Progress
Monitor Team Observed Tree Work in Immediate Vicinity of Subject Tree	No
Monitor Team Observed Recent Tree Work on Subject Tree	No
Tree Paint or Other Markings Observed	No paint observed
Species	Ponderosa Pine
GPS Coordinates	38.5584645, -122.4610075
Approx. Distance from Primary Conductor	Trunk of tree 20 feet northwest
Approx. Height	90 feet
Veg Type	Potential Overhang Tree
Monitor Arborist Comment	Vegetation observed currently overhanging the 4 foot vertical plane, and tree not visibly marked for pruning.

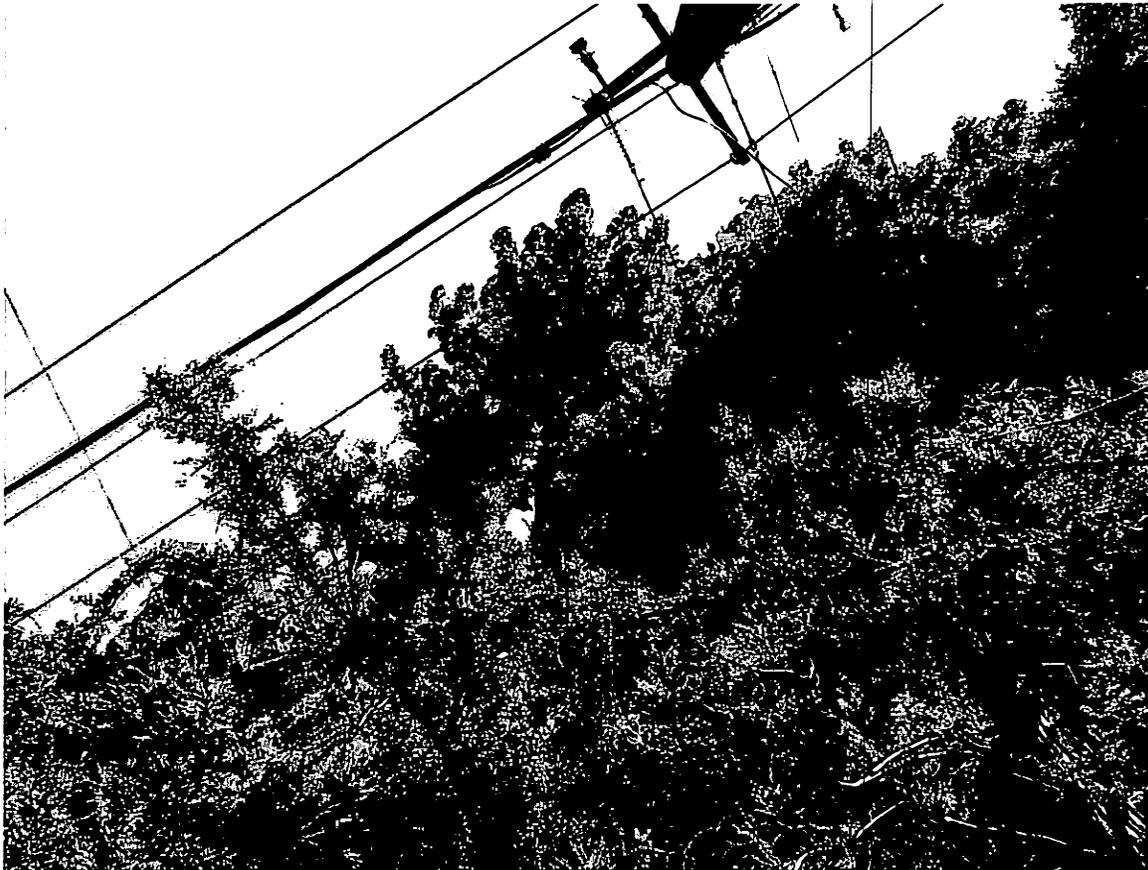
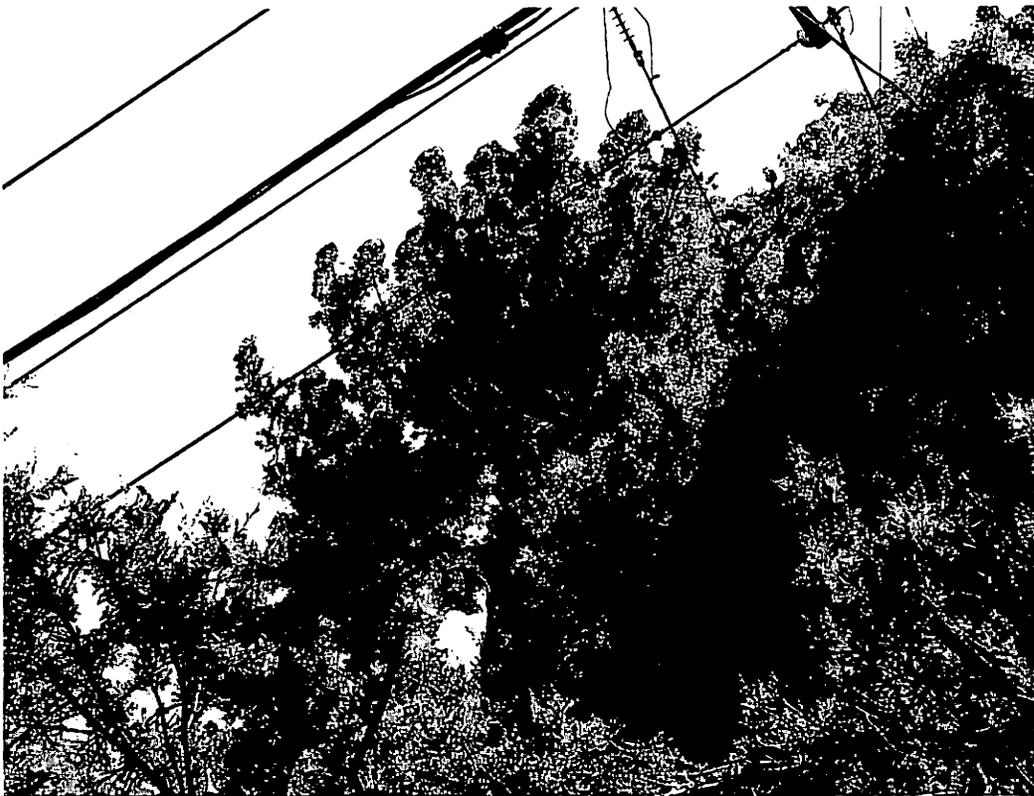
A potential overhang tree was found during a Monitor Inspection on July 2, 2019 of Project *PR\_187602* on Circuit *Molino 1102*. In general terms, this circuit is located on the outskirts of the city of Sebastopol, CA, running approximately 10 miles to the west of the city. This circuit is located in/near a Tier 3 fire threat area pursuant to the ArcCollector database. The approximate position of the tree is denoted as the red circle in the second graphic below.

PG&E ArcCollector Project Status	No Work Required Under EVM
Monitor Team Observed Tree Work in Immediate Vicinity of Subject Tree	No
Species	Coastal Redwood
GPS Coordinates	38.402852, -122.922316
Approx. Distance from Primary Conductor	Trunk of tree 5 feet north
Approx. Height	115 feet
Veg Type	Potential Overhang Tree
Monitor Arborist Comment	Vegetation observed currently overhanging the 4 foot vertical plane

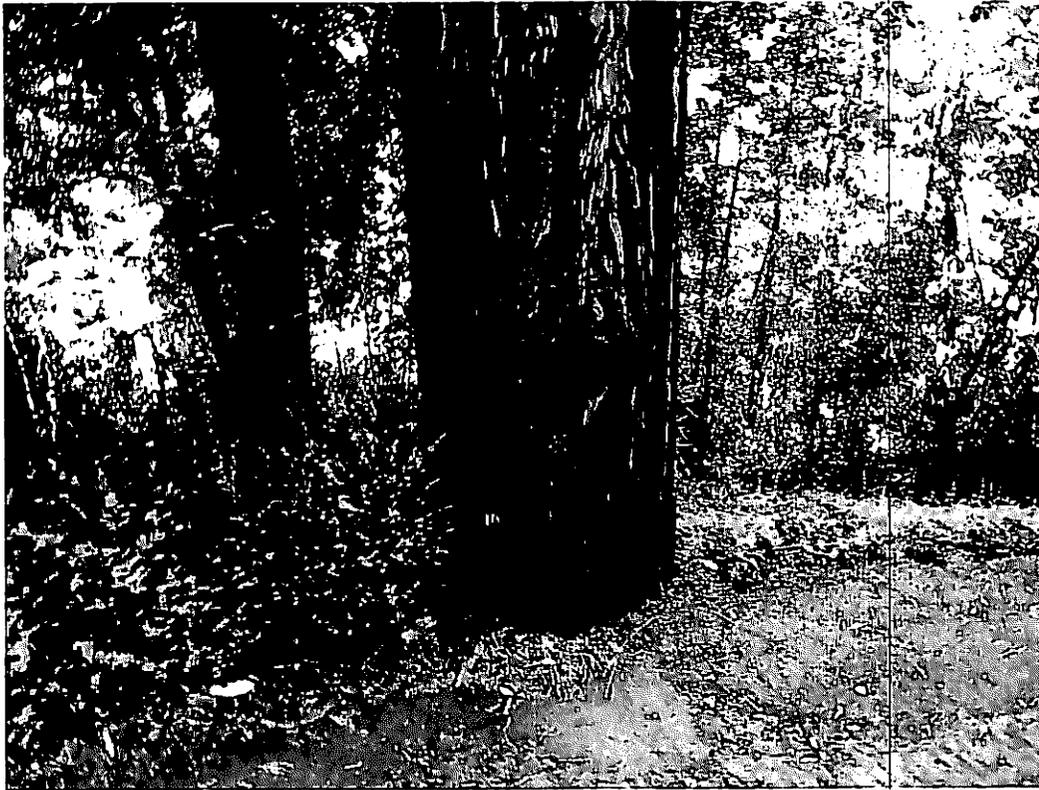
A potential overhang tree was found during a Monitor Inspection on July 1, 2019 of Project *PR\_187996* on Circuit *Molino 1102*. In general terms, this circuit is located on the outskirts of the city of Sebastopol, CA, running approximately 10 miles to the west of the city. This circuit is located in/near a Tier 3 fire threat area pursuant to the ArcCollector database. The approximate position of the tree is denoted as the red circle in the second graphic below.

PG&E ArcCollector Project Status	Work Identified
Monitor Team Observed Tree Work in Immediate Vicinity of Subject Tree	No
Monitor Team Observed Recent Tree Work on Subject Tree	No
Tree Paint or Other Markings Observed	No paint observed
Species	Coastal Redwood
GPS Coordinates	38.4076087, -122.9726341
Approx. Distance from Primary Conductor	Trunk of tree 3 feet north
Approx. Height	120 feet
Veg Type	Potential Overhang Tree
Monitor Arborist Comment	Vegetation observed currently overhanging the 4 foot vertical plane, and tree not visibly marked for pruning.

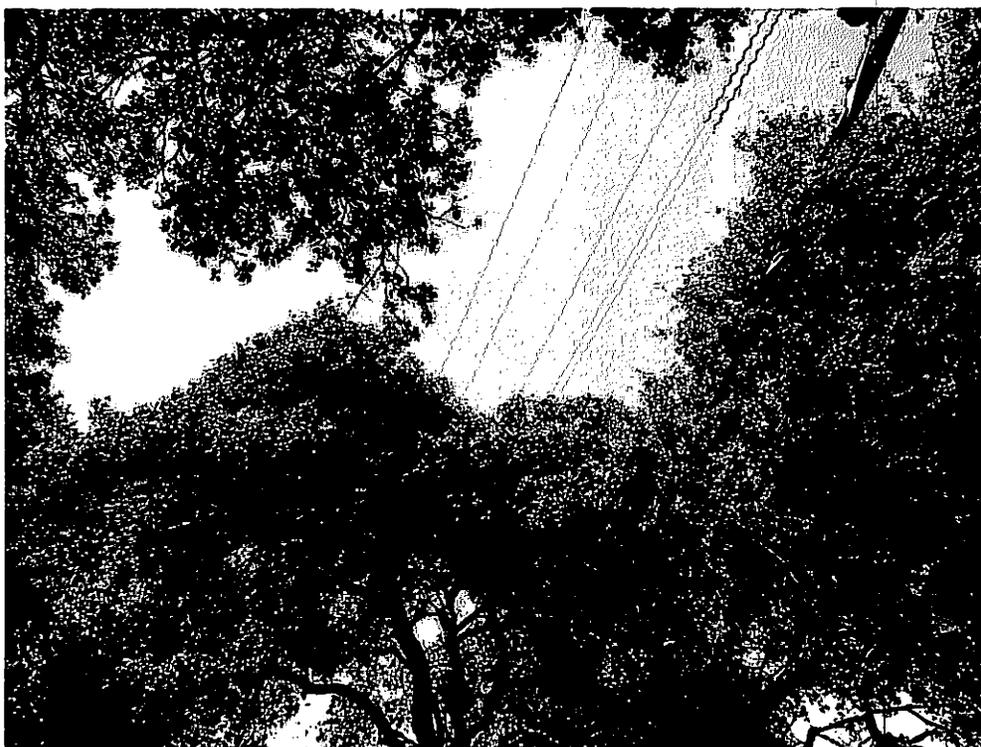
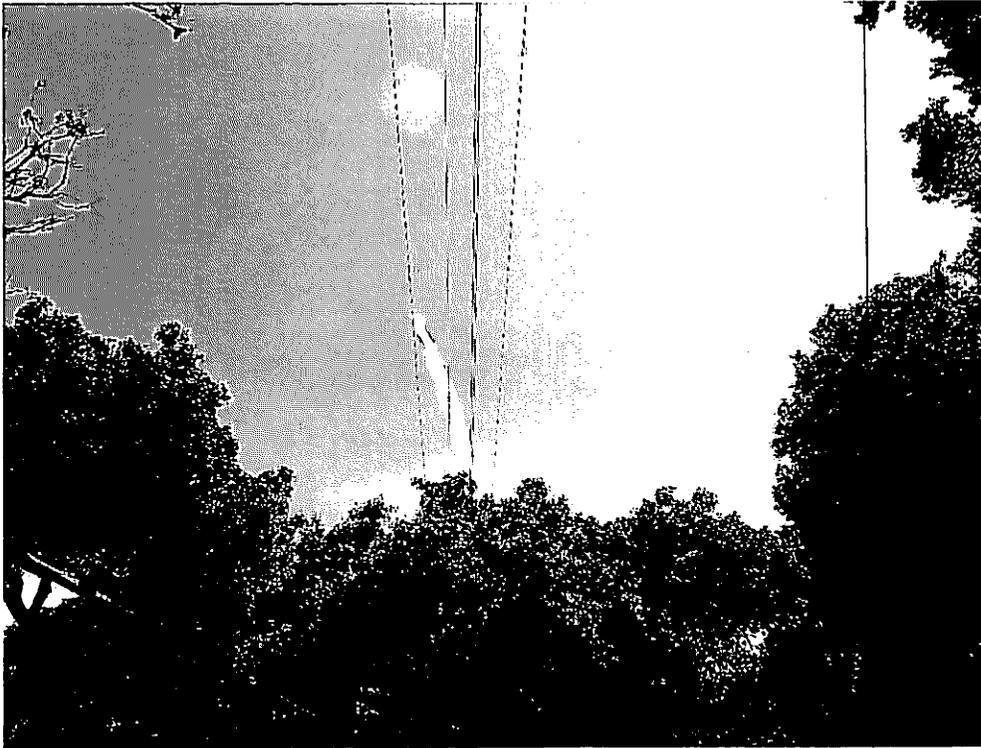
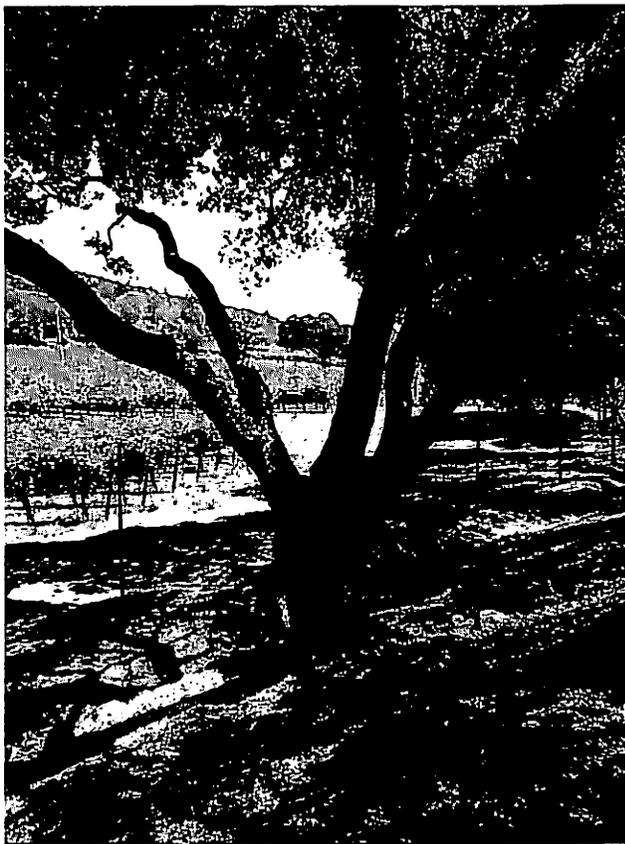
A potential radial clearance tree was found during a Monitor Inspection on June 24, 2019 of Project *PR\_002250* on Circuit *Silverado 2104*. In general terms, this circuit is located on the outskirts of the city of St. Helena, CA, running approximately 15 miles to the north of the city. This circuit is located in/near a Tier 3 fire threat area pursuant to the ArcCollector database. The approximate position of the tree is denoted as the red circle in the second graphic below.

PG&E ArcCollector Project Status	Tree Work Complete
Monitor Team Observed Tree Work in Immediate Vicinity of Subject Tree	Yes
Monitor Team Observed Recent Tree Work on Subject Tree	Yes
Tree Paint or Other Markings Observed	Yellow dot
Species	Coastal Live Oak
GPS Coordinates	38.549890, -122.472047
Approx. Distance from Primary Conductor	Trunk of tree underneath primary conductor
Approx. Height	35 feet
Veg Type	Potential Radial Clearance Tree
Monitor Arborist Comment	Vegetation with evidence of pruning observed within 12 feet of primary conductor

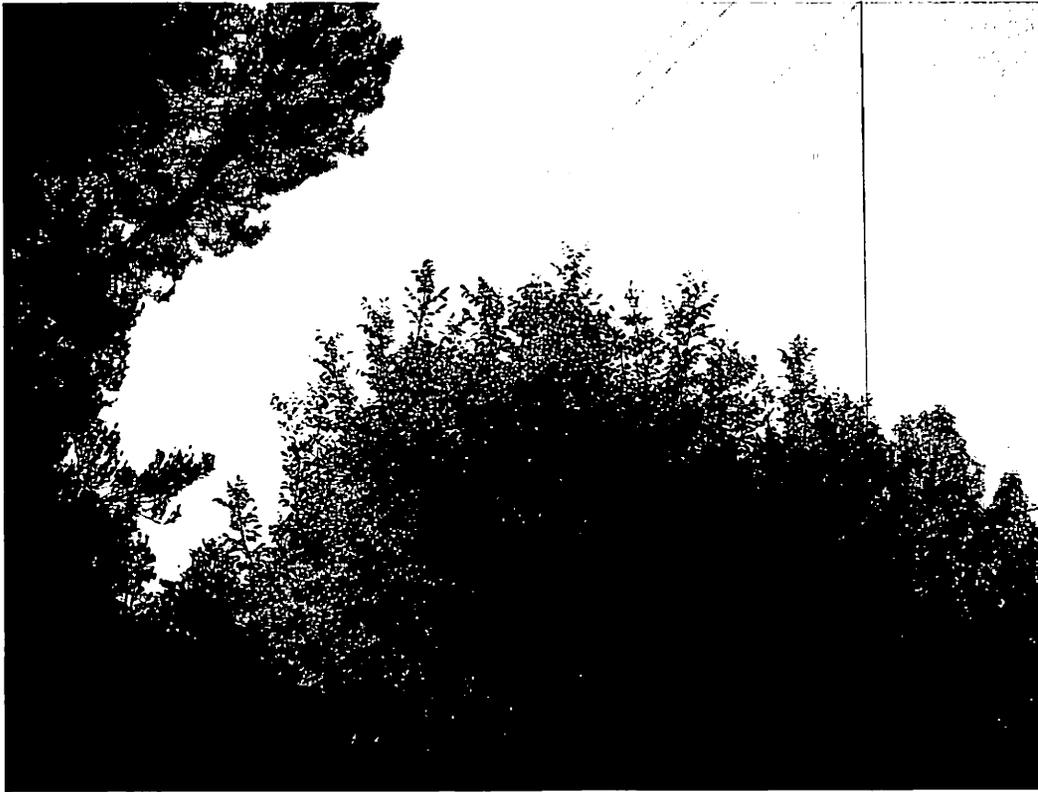
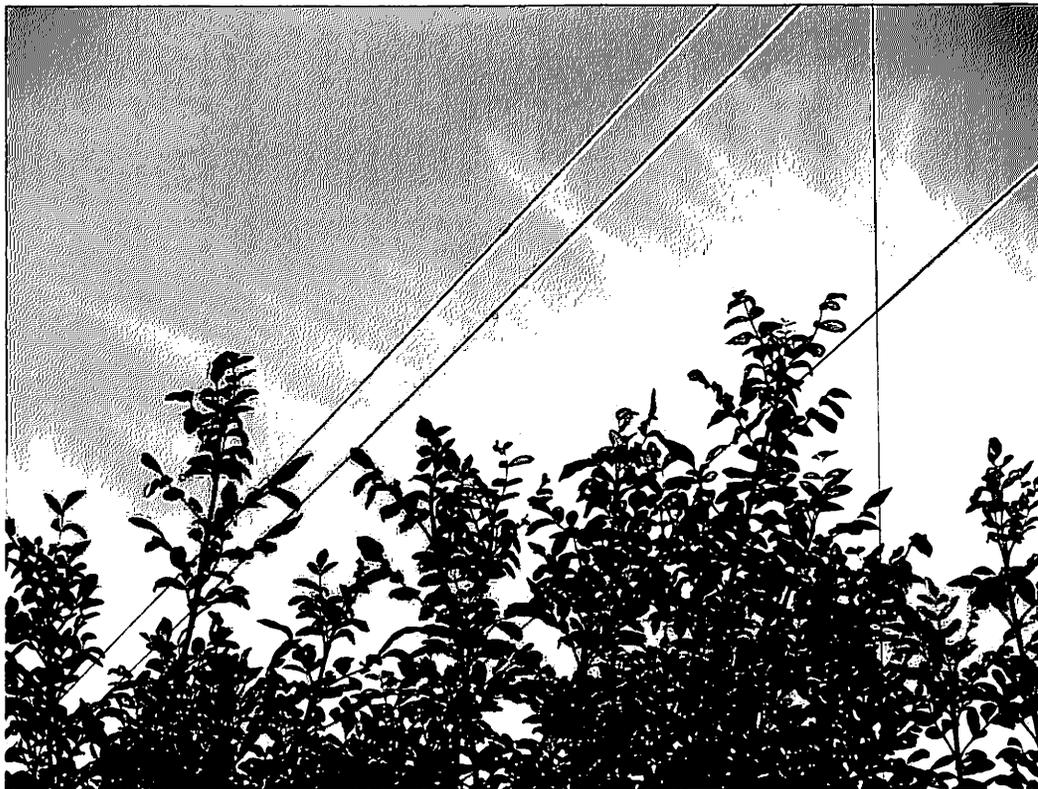
PG&E ArcCollector Project Status	Work Identified
Monitor Team Observed Tree Work in Immediate Vicinity of Subject Tree	No
Monitor Team Observed Recent Tree Work on Subject Tree	No
Tree Paint or Other Markings Observed	No paint observed
Species	Ash
GPS Coordinates	38.4517713, -122.9273266
Approx. Distance from Primary Conductor	Trunk of tree 4 feet south
Approx. Height	26 feet
Veg Type	Potential Radial Clearance Tree
Monitor Arborist Comment	Vegetation observed within 4 feet of primary conductor, and tree not visibly marked for pruning
