**KIRKLAND & ELLIS LLP**  
AND AFFILIATED PARTNERSHIPS

July 26, 2019

As you requested, this is a letter report on the vegetation management field inspections (“VM inspections”) the Monitor team is conducting pursuant to the Court’s April 3, 2019 Order (“April 3 Order”). This submission includes: (1) background information on the VM inspections; (2) an explanation of the VM inspections process; (3) the Monitor team’s preliminary observations; (4) PG&E’s feedback based on the Monitor team’s preliminary findings; (5) the Monitor team’s preliminary suggestions to PG&E, as shared with the Company on July 17, 2019; and (6) concluding thoughts.

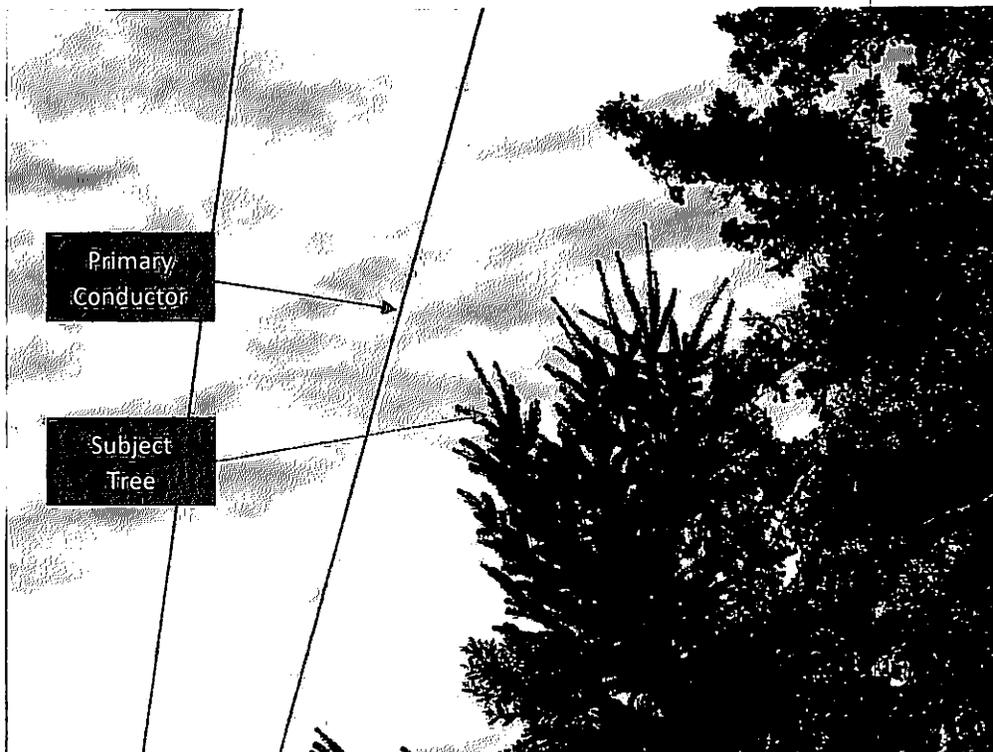
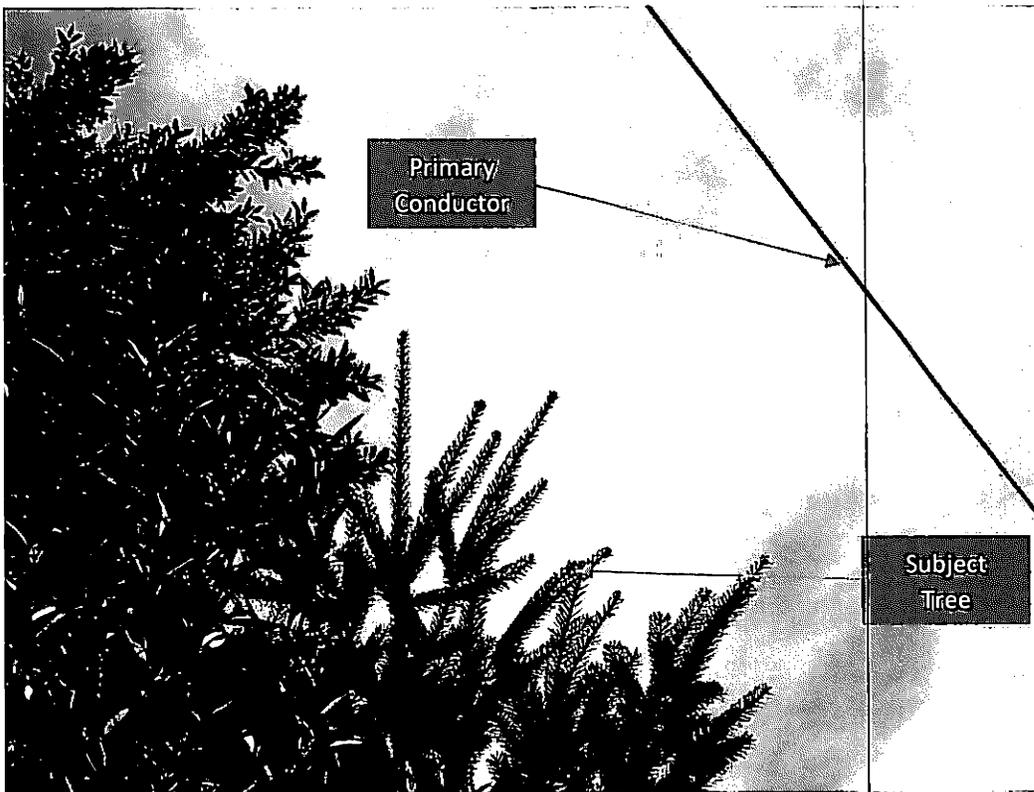
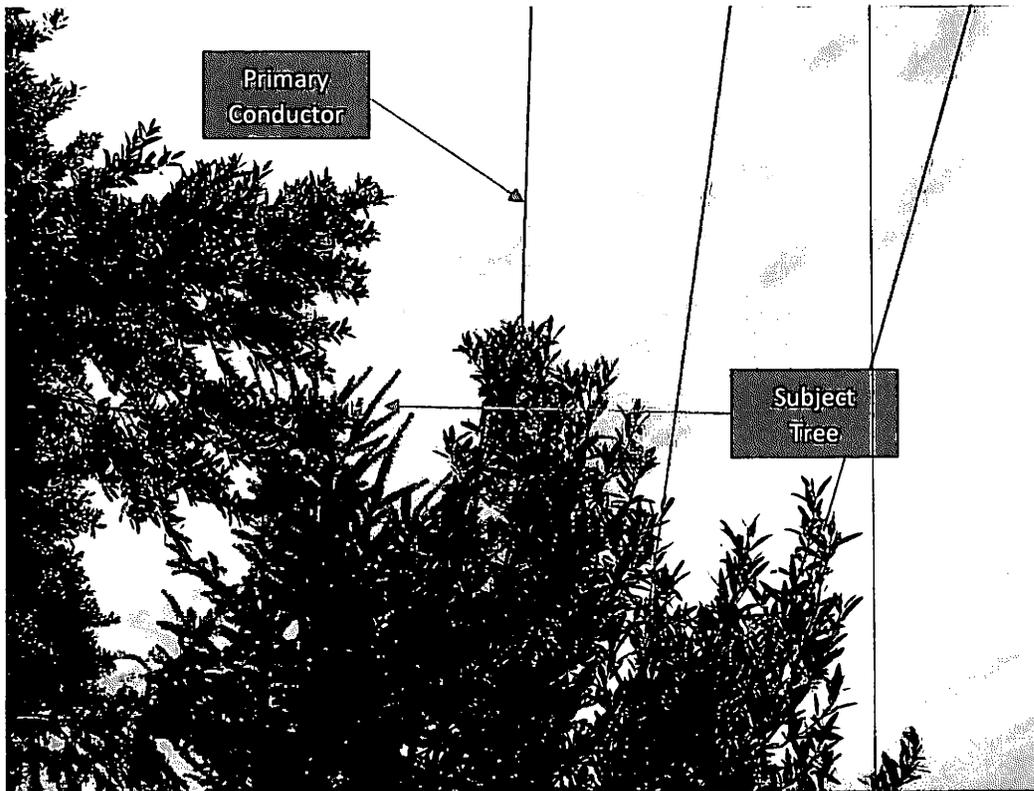
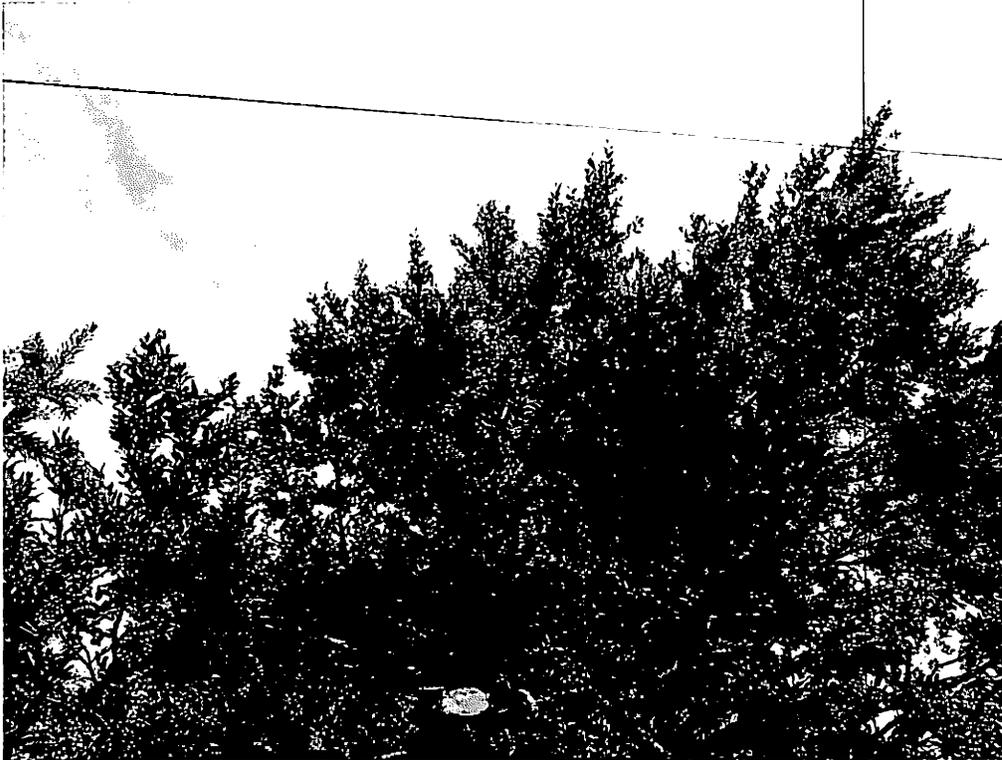
PG&E ArcCollector Project Status	Wood Mgmt Complete
Monitor Team Observed Tree Work in Immediate Vicinity of Subject Tree	Yes
Monitor Team Observed Recent Tree Work on Subject Tree	No
Tree Paint or Other Markings Observed	No paint observed
Species	Douglas Fir
GPS Coordinates	38.555299, -122.451173
Approx. Distance from Primary Conductor	Trunk of tree 2 feet north
Approx. Height	30 feet
Veg Type	Potential Radial Clearance Tree
Monitor Arborist Comment	Vegetation observed within 4 feet of primary conductor

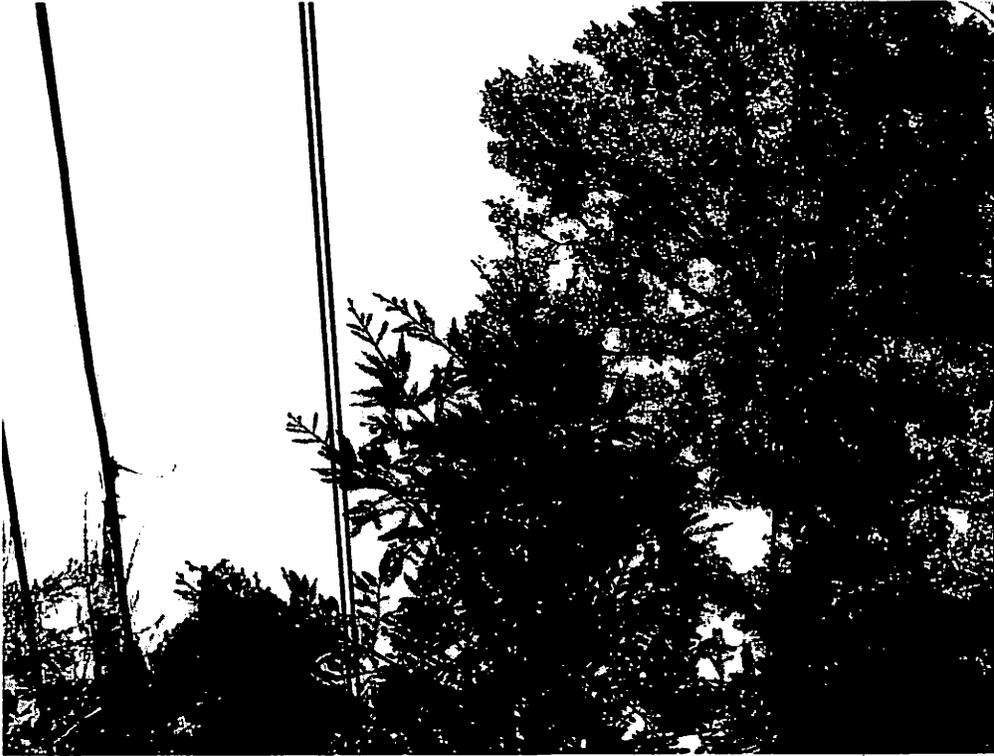
PG&E ArcCollector Project Status	Work Identified	
Monitor Team Observed Tree Work in Immediate Vicinity of Subject Tree	No	
Monitor Team Observed Recent Tree Work on Subject Tree	No	
Tree Paint or Other Markings Observed	No paint observed	
Species	Coastal Redwood	
GPS Coordinates	38.4076087, -122.9726341	
Approx. Distance from Primary Conductor	Trunk of tree 2 feet south of the primary conductor	
Approx. Height	25 feet	
Veg Type	Potential Radial Clearance Tree	
Monitor Arborist Comment	Vegetation observed within 4 feet of primary conductor, and tree not visibly marked for pruning.

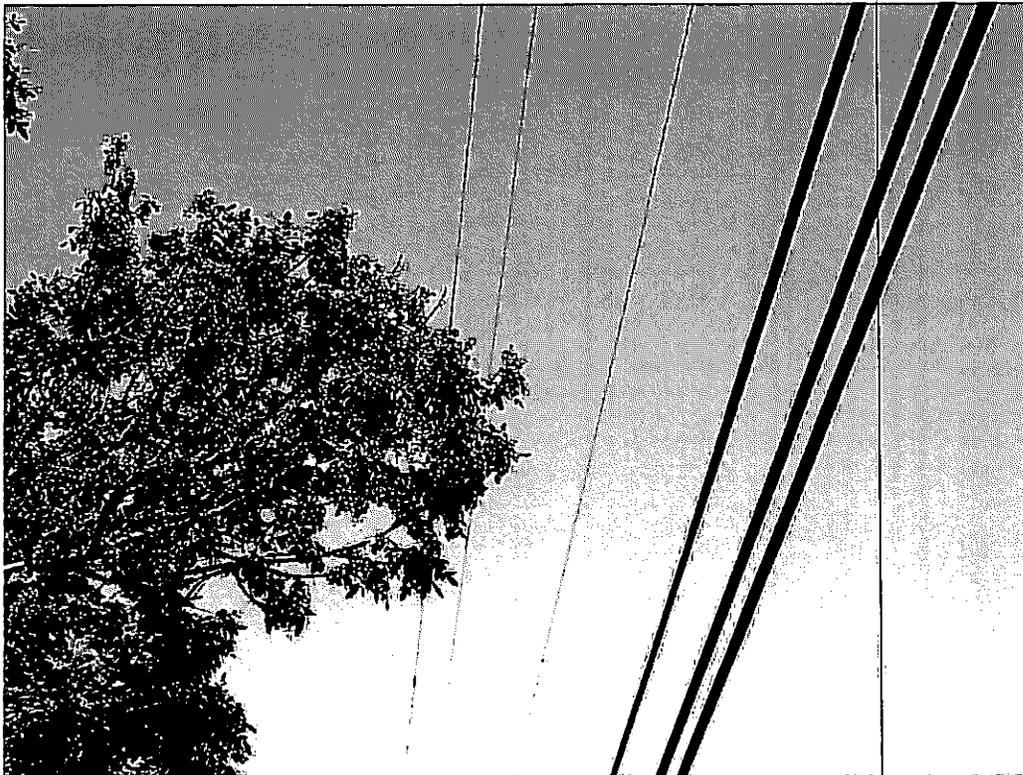
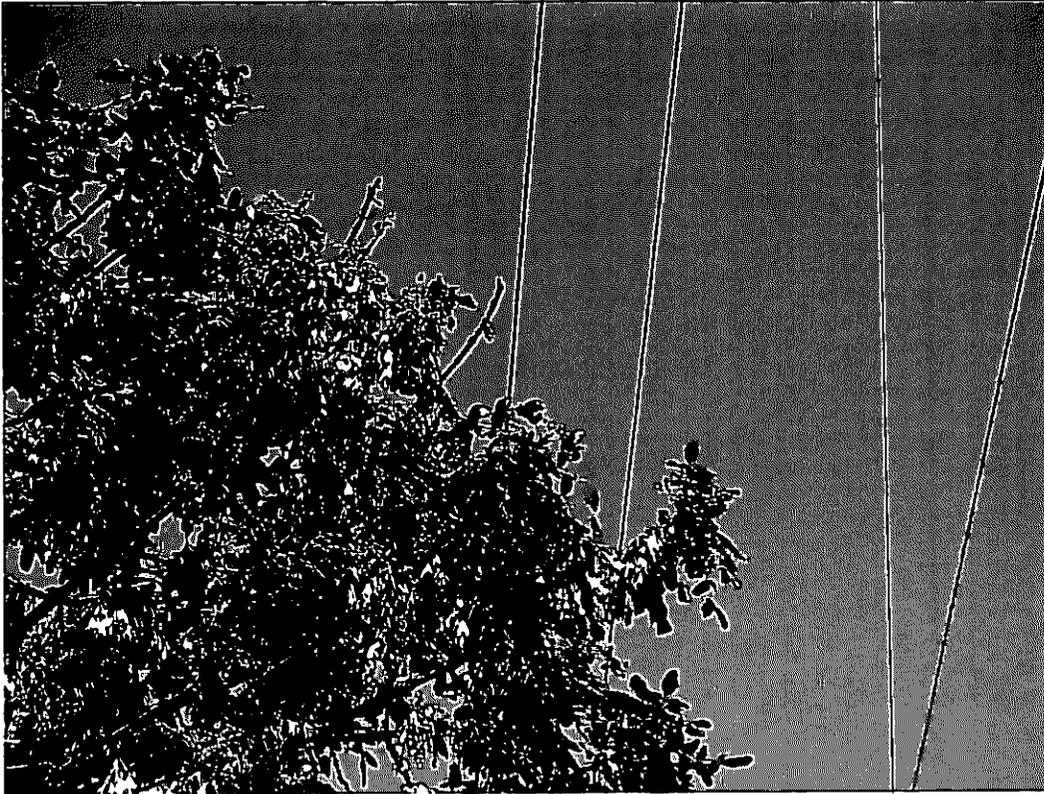
PG&E ArcCollector Project Status	Work Identified
Monitor Team Observed Tree Work in Immediate Vicinity of Subject Tree	No
Monitor Team Observed Recent Tree Work on Subject Tree	No
Tree Paint or Other Markings Observed	Flagging observed
Species	Ash
GPS Coordinates	38.380354, -122.931494
Approx. Distance from Primary Conductor	Trunk of tree 20 feet southwest
Approx. Height	32 feet
Veg Type	Potential Radial Clearance Tree
Monitor Arborist Comment	Vegetation observed within 4 feet of primary conductor, and tree has potentially been in contact with the primary conductor, as what appear to be singed branch tips can be observed from the ground.
