SUPERIOR COURT OF THE STATE OF CALIFORNIA  
COUNTY OF SANTA CRUZ

PACIFIC GAS & ELECTRIC COMPANY and  
PG&E CORPORATION,

**CLASS ACTION**

**COMPLAINT FOR  
INJUNCTIVE RELIEF**

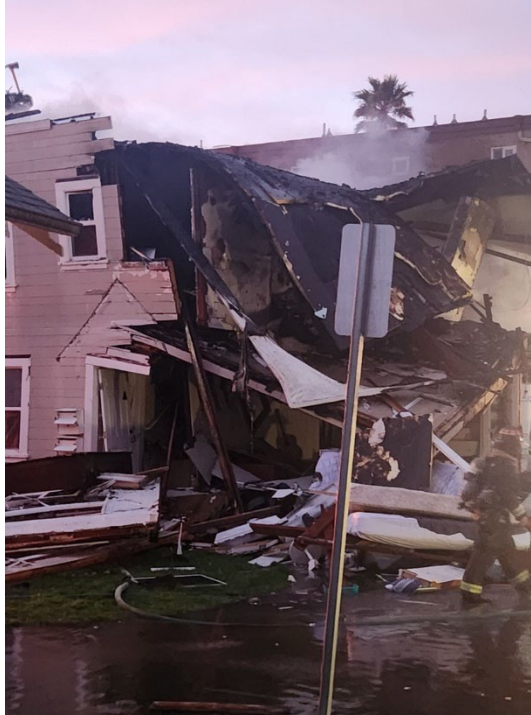
2. Early on Christmas morning of 2024, the residential property at 105 Lawn Way in Capitola exploded. The blast and resulting fire completely devastated the property, which was a two-story residential building. The west wall and the floor of the second story were entirely blown out, and the fire consumed virtually all of the fixtures and items inside.

3. The following photo shows 105 Lawn Way several hours after the explosion:

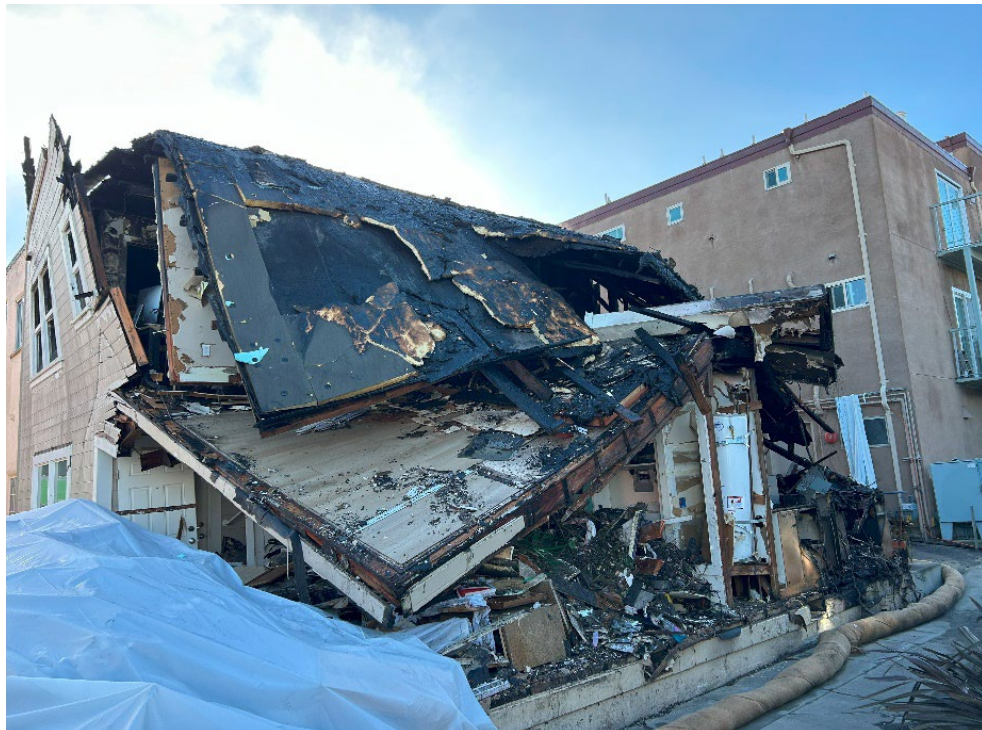
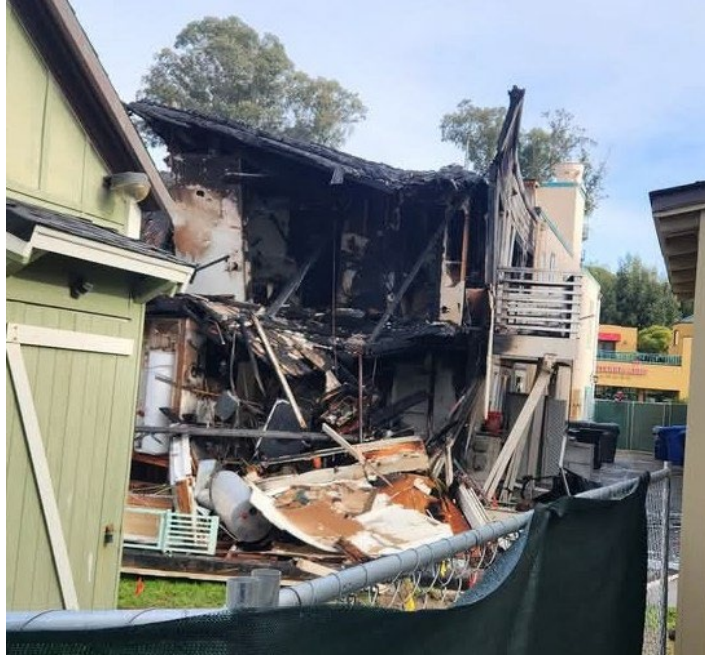
15           30.     The following photos show additional views of 105 Lawn Way in the days  
16 following the explosion:

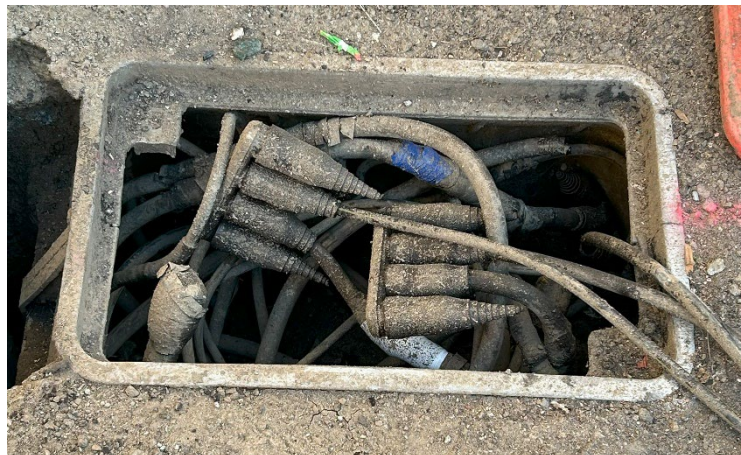
12 43. This electrical box held the splice connectors to electrical power supply lines which  
13 ran underground.

14 44. The following is a photo of the electrical supply lines in the box by 105 Lawn Way:

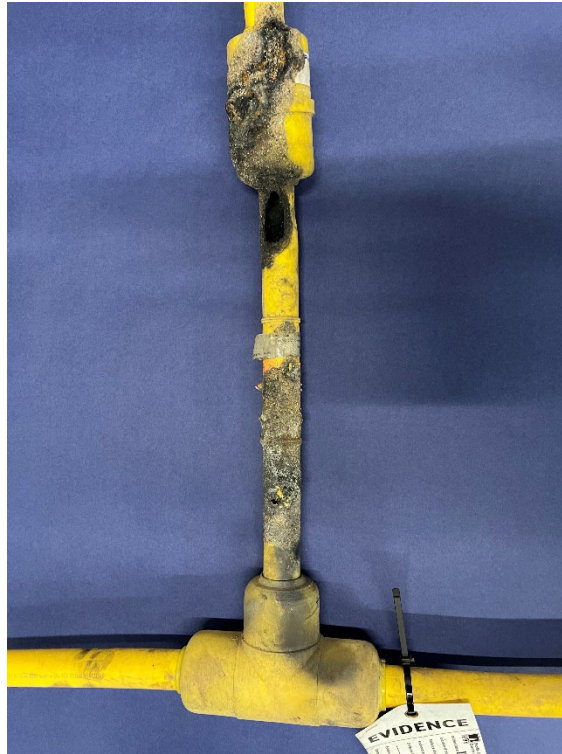
1           47.     There was a significant melted area of sand underground. Notably, the yellow gas  
2 supply line was visibly melted through in several spots, which was the source of the gas leak.

3           48.     A photo of the section of the gas supply line showing the melted spots is as follows:

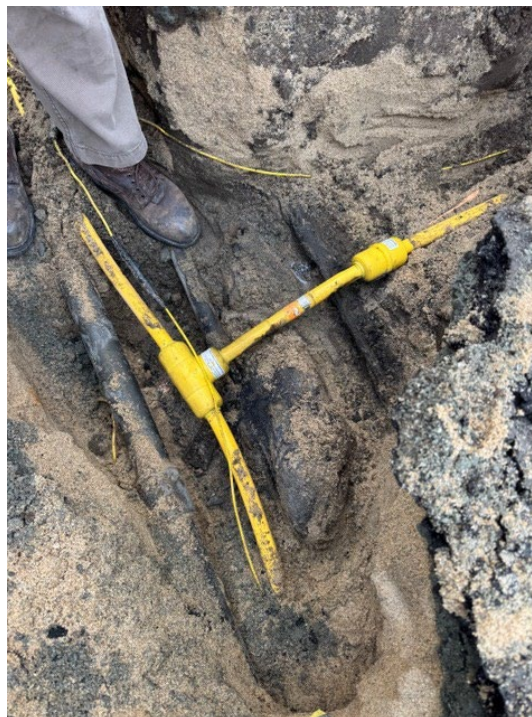
16           49.     A photo of the melted gas supply line in the ground among the other partially  
17 uncovered parallel lines is as follows:

1           50.     As digging progressed, three melted electrical supply cables were uncovered.

2           51.     Since there was no other cable in the ground carrying the necessary voltage to melt  
3 surrounding sand and nearby pipes to the degree found at this site, the electrical supply cables are  
4 the only possible cause of the electrical arcing event which was responsible for melting and  
5 penetrating the active gas line, creating holes in it.

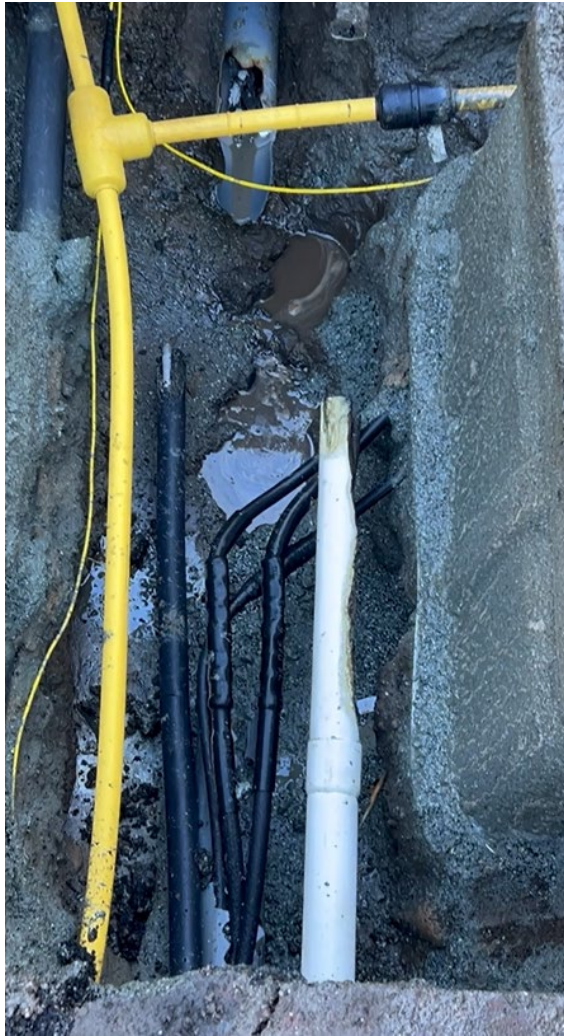
60. However, the conduit pipe ended several feet away from the electrical box on each side. This meant that the electrical cables travelled unprotected in the earth for several feet before they came up into the enclosure of the electrical box.

61. Based on the location of the melted area as it was uncovered after the explosion, the melting event likely occurred in the section of the electrical cables that were unprotected in the earth near the electrical box and perhaps surrounded by seawater or damp conditions.

62. A photo showing the conduit pipe ends at the top and bottom of the photo containing the electrical supply cables is as follows (**note** that in this photo, the melted section of gas line had already been replaced and the melted ends of the electrical cable had been cut off and removed):

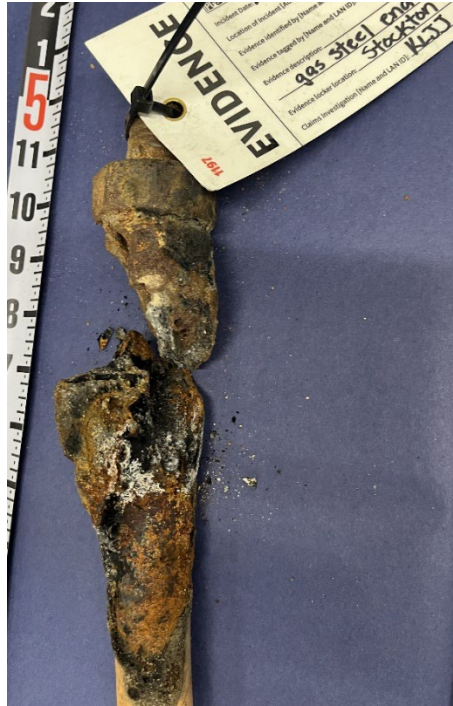
64. Notably, there was a defunct, non-operational steel gas line owned and previously operated by PG&E running parallel to the gas and electric lines in the ground. This defunct steel gas line appeared highly corroded and likely melted as well, contributing to the extreme heat event.

66. The defunct or “orphaned” steel gas line ran parallel in close proximity to the electrical supply cables and to the gas line, so when the electrical meltdown event occurred, the orphaned/defunct steel gas line would have acted as a conductor for electricity and heat, further contributing to the underground meltdown at that site.

67. The close proximity of the defunct or orphaned steel gas line to the active gas and electric lines violated CPUC General Order 112-F section 144.3 and General Order 128 section 31.4, which require active gas and electric lines to be separated from “other pipe systems or other foreign substructures” by at least 12 inches when paralleling and 6 inches when crossing.

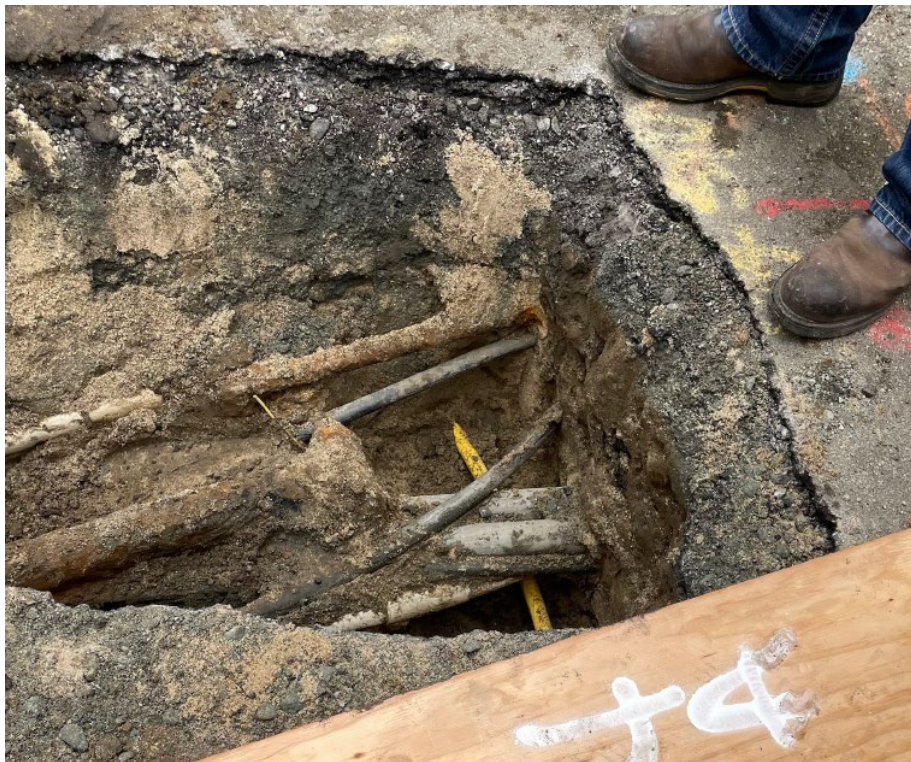
75. As one example, the following photo shows PG&E gas and electric lines in "Hole 14A" where the gas and electric lines were measured as being only 1 inch apart:

77. While all the various pipes and service lines in Hole 14A and Hole 15A have not been identified by Plaintiffs, the numerous pipes in the above photos are consistent with the defunct or “orphaned” PG&E steel gas service line being present in these locations and throughout Capitola Village.

78. Additionally, the above photos of Hole 14A and Hole 15A appear to show active electric cables running directly in the earth and not encased within a conduit pipe, which was the condition of the electric cables outside of 105 Lawn Way when the meltdown event occurred.

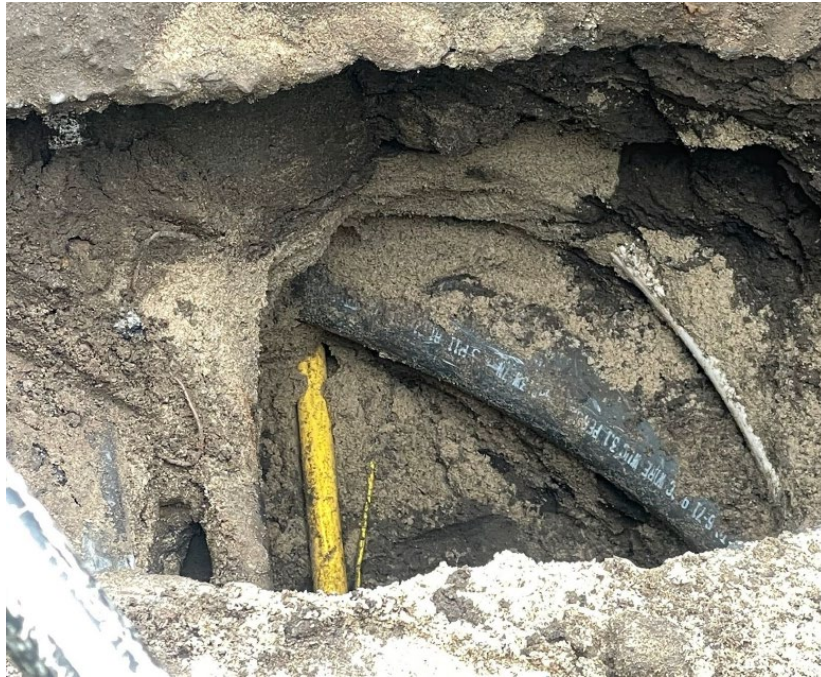
76. Another example is "Hole 15A" where the gas and electric lines were measured as being only 3.5 inches apart, as seen in the following photo:
