Analysis and Assessment of MBTA Green Line Light Rail Track System

The Commonwealth of Massachusetts
DEPARTMENT OF PUBLIC UTILITIES (DPU)
TRANSPORTATION OVERSIGHT DIVISION

November 23, 2017

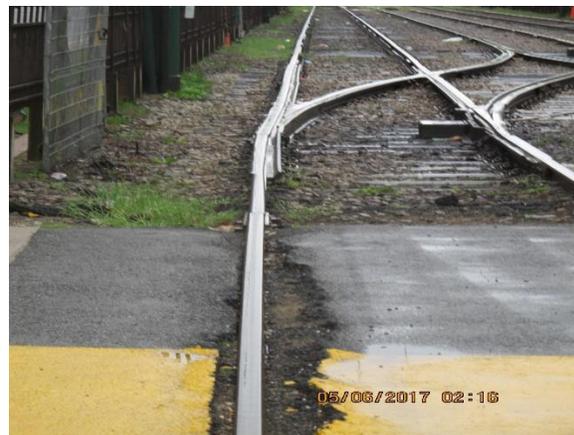
Figure 8 - Alignment Issue on Special Trackwork Near Fixed Roadway

Figures 7 and Figure 8 illustrate alignment issues at turnout locations. These two examples, although similar, are completely different from a maintenance perspective. Figure 7 shows a turnout that is located in a very small section of track between two crossings, aligning this area can be achieved by standard maintenance methodology. Figure 8 on the other hand, demonstrates the unique challenges faced by the MBTA due to legacy issues with the right-of-way alignment. To address this correctly, the agency would need to completely align the track crossing the roadway (resulting in vehicular traffic interruption) and realign all three tracks in this area. Conditions of this type present unique challenges for track maintainers who must make maintenance and

installation decisions which at times may appear to conflict with standards but are necessitated by the unique physical characteristics the Green Line legacy track system. Without significant investment and redesign, situations of this type will continue to challenge track managers to assure these areas do not deteriorate beyond the capabilities of the No. 8 vehicles. This condition also requires continuous monitoring on gauge spread as the two rails may spread apart as the stock rail is pushed out during turnout moves.

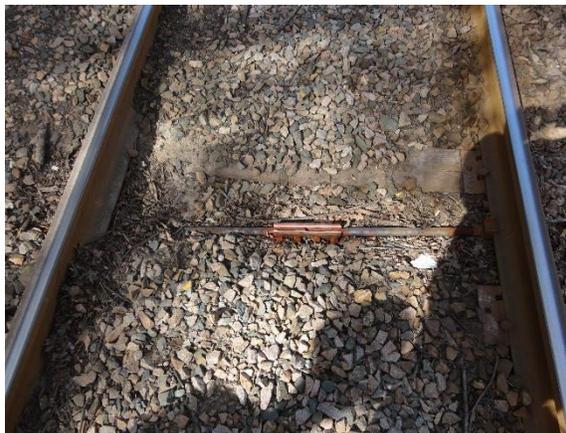
Figure 10 - Gauge Rod installed due to Wide Gauge

Gauge variations due to track alignment issues are frequently encountered on the Green Line as shown on Figure 9. These areas are easily found by observing alignment issues or installed gauge rods as shown on Figure 10. These conditions are generally the result of defective wood ties at these locations. Although not spelled out in the MBTA Track Standards Manual, gauge rods are only a temporary measure and should only be used in track for a determinate amount of time. These were several areas where during our inspections, the gauge rods that had been installed for an extended period of time and were loose and no longer performing their intended temporary function.

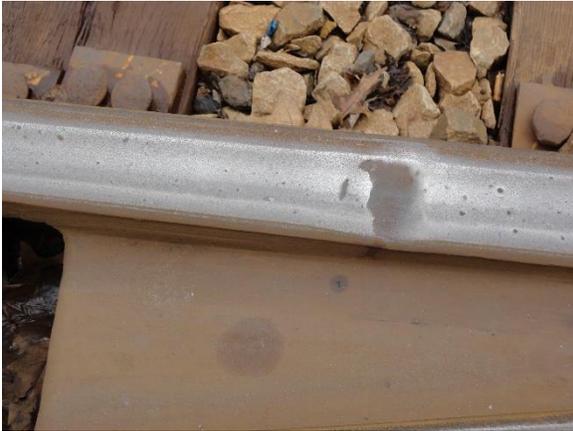
Figure 11 - Engine Burn with flattened rail head.

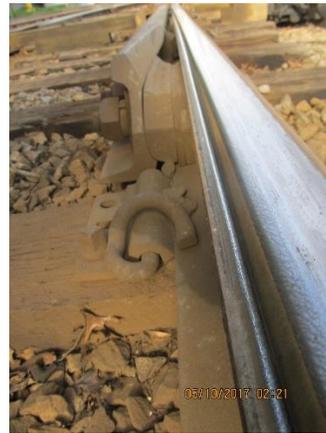
Figure 22 - Worn Rail on Gauge Face creating Shelf

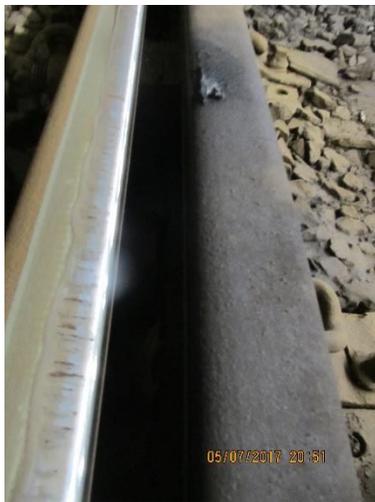
Figure 23 - Micro-Cracking on Rail Head

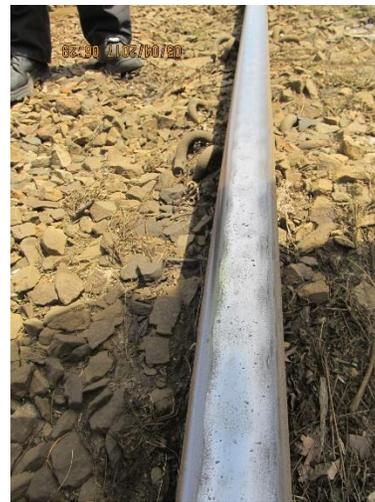
Figure 24 - Corrugation

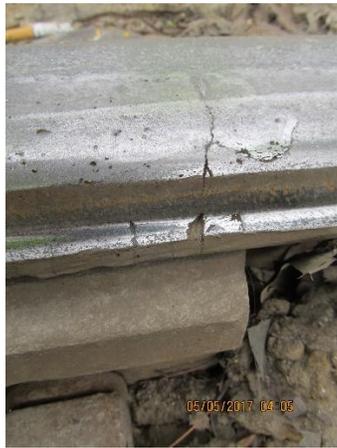
Figure 27 - Transverse Crack, Worn Rail

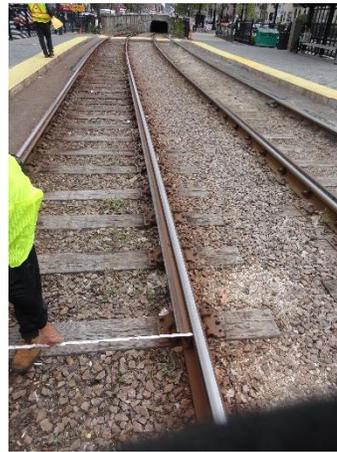
Figure 28 - Mismatched Types of Rail, Tee Rail then small section of Girder Rail

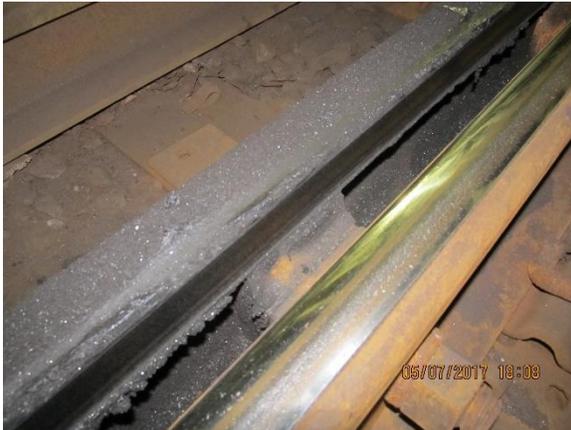
Figure 29 - Severely worn restraining rail indicating considerable contact with back of wheel flange.

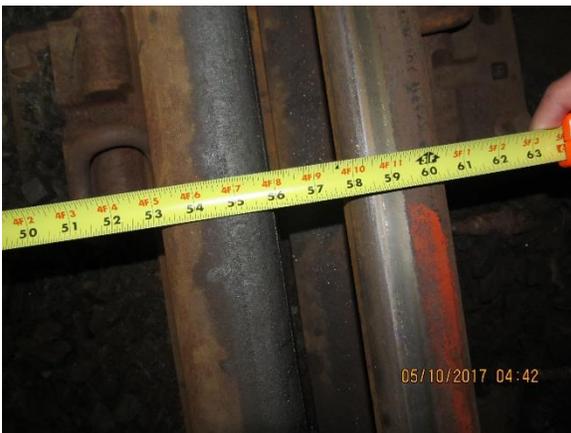
Figure 31 - 2" Flangeway of new installation. This is a Red condition per LRT213.116.

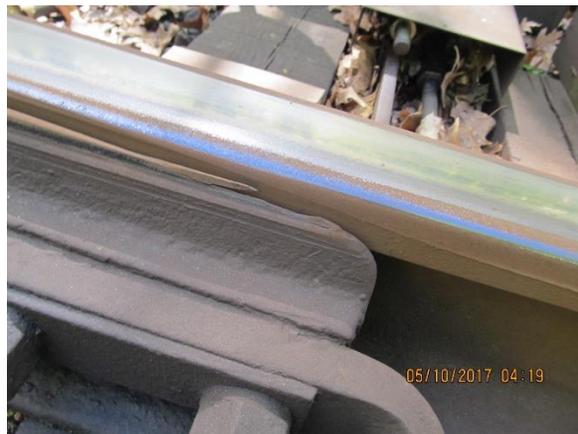
Figure 41 - Chipped Point at Undercut Location.

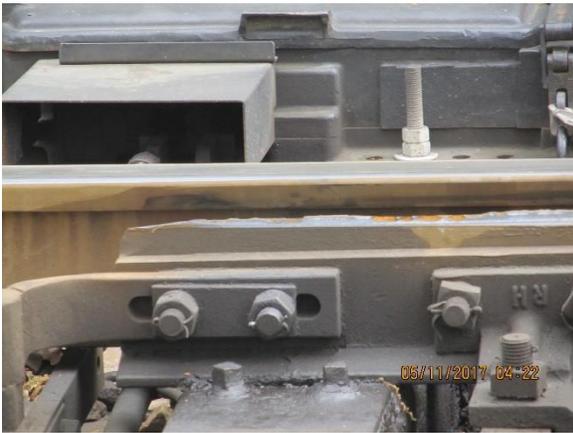
Figure 42 - Severely Chipped Switch Point

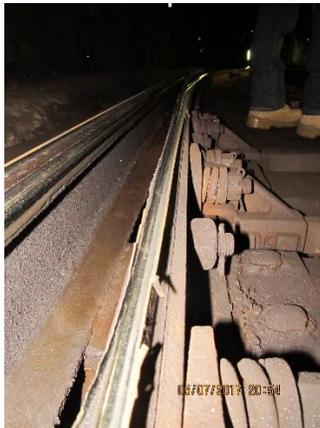
Figure 44 - Severely Worn Switch Point

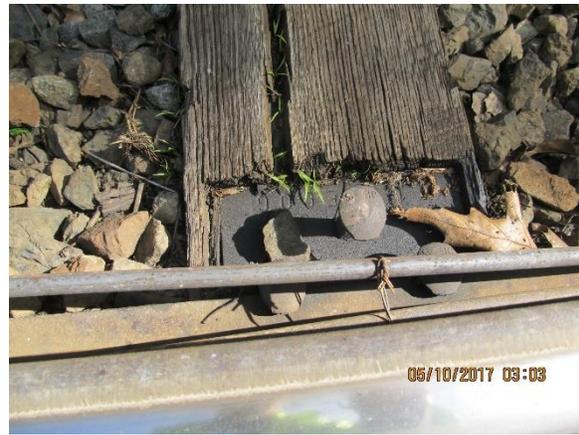
Figure 47 - Plate Cut Tie with spike kill.

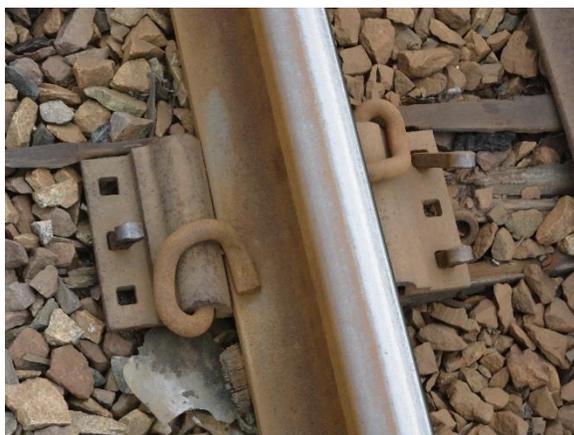
Figure 48 - Split Through, Spike Killed Tie

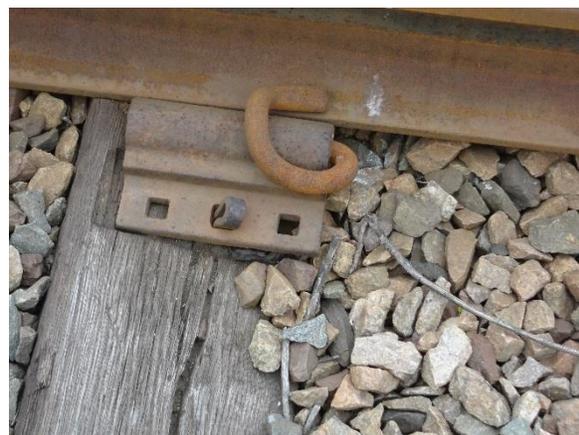
Figure 49 - Skewed Tie, Indications of movement

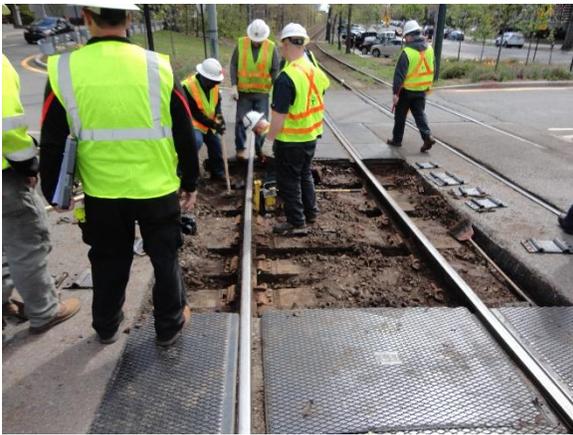
Figure 58 - Crossings Prevent Any Inspection of Ties

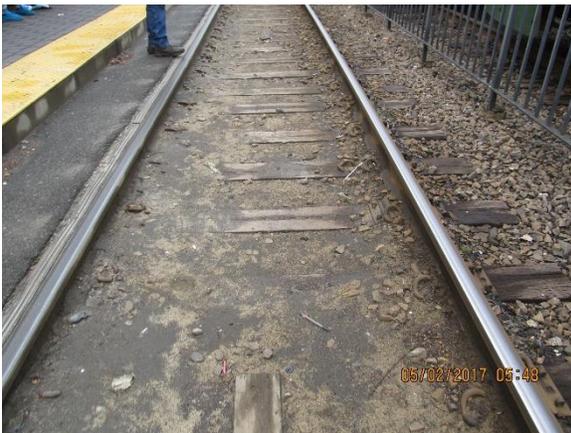
Figure 62 – Severely Fouled Ballast with Fine Soil Preventing Drainage

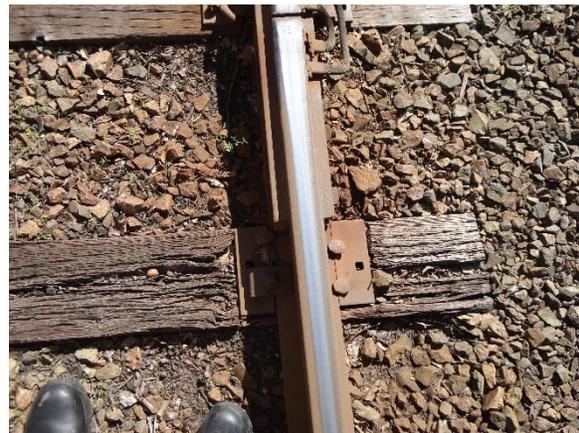
Figure 63 - Moderately Fouled Ballast.

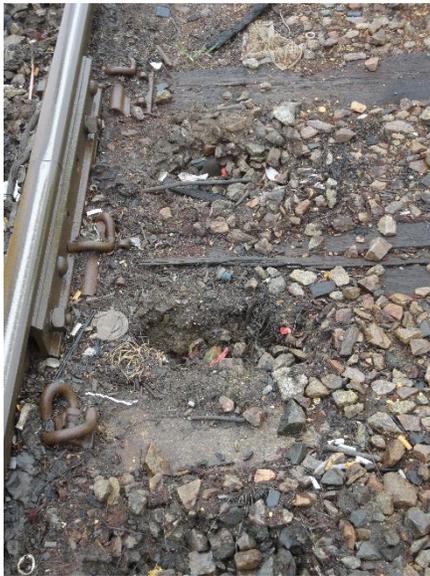
Figure 64 - Fouled Ballast at Joint. Note Unsuccessful Attempt to Tamp.

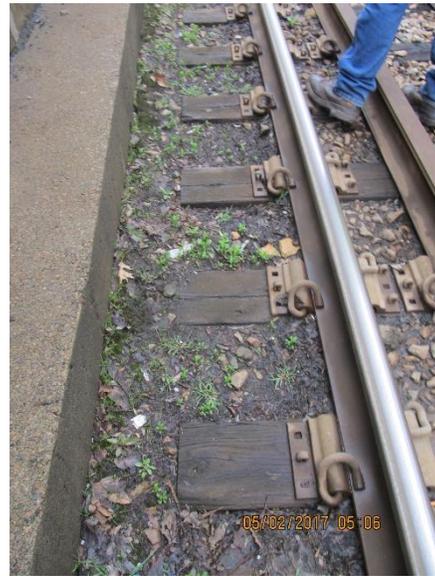
Figure 65 - Severely Fouled Ballast.

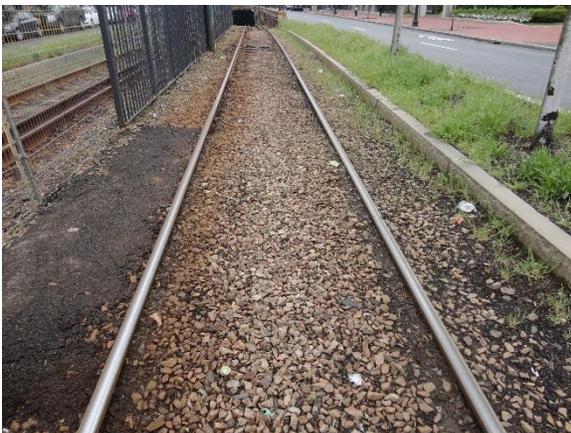
Figure 66 - Excessive Ballast in Crib and Shoulder Areas.

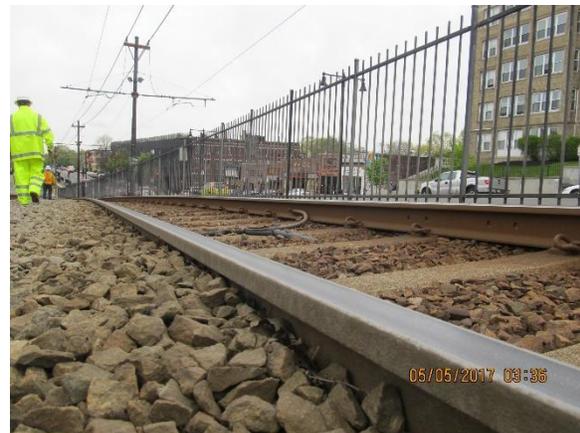
Figure 67 - Excessive Ballast in Shoulder Area.

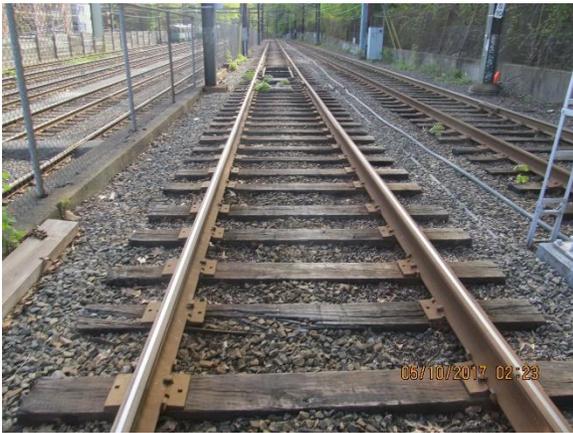
Figure 68 - Skeletonized Track - Low Ballast

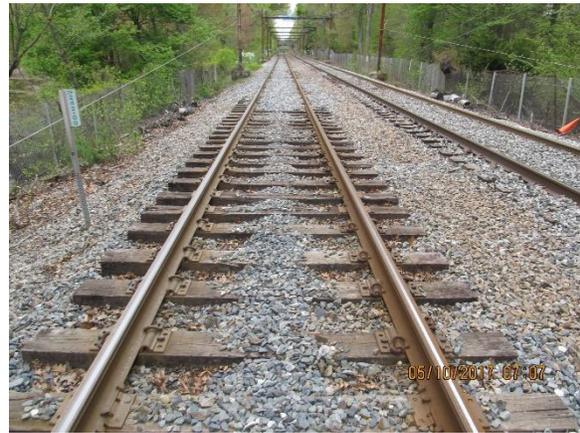
Figure 69 - Insufficient Shoulder Ballast - Buckling Potential.

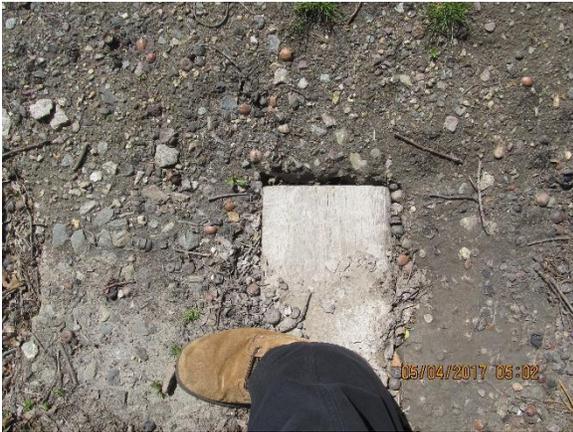
Figure 70 - Severely Fouled Ballast Indicating Lateral Movement of Track.

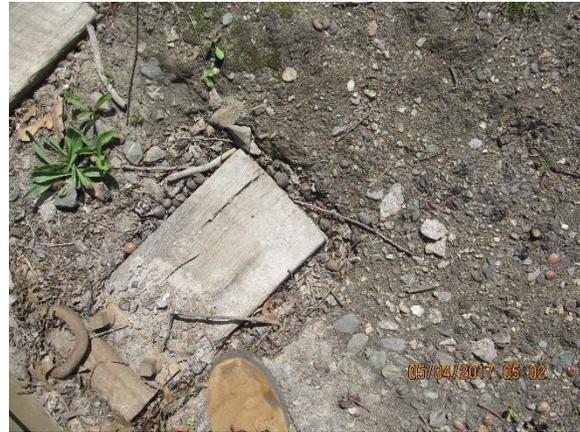
Figure 71 - Severely Fouled Ballast Indicating both Lateral and Longitudinal Movement.

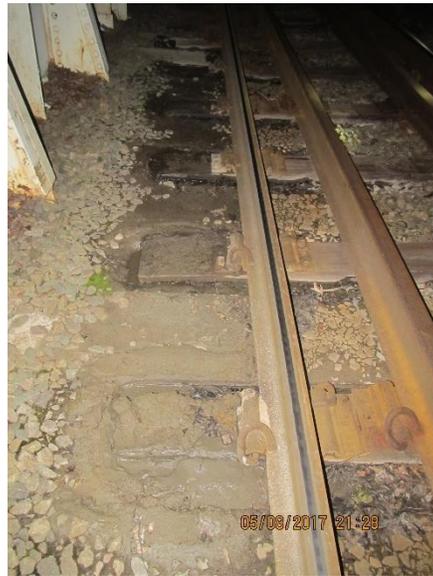
Figure 73 - Fouled Ballast, Poor Subgrade - Mud Pumping. This is on a bridge Deck.

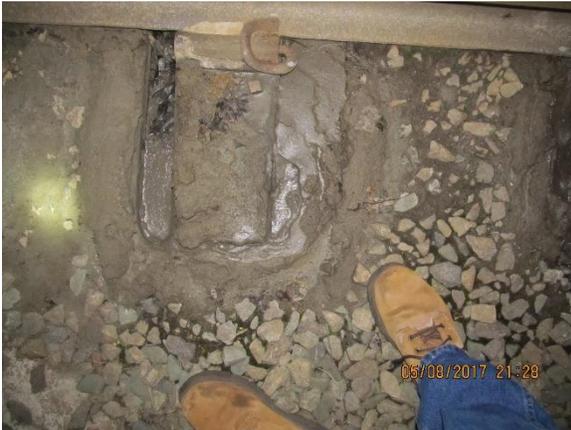
Figure 74 - Unstable Trackbed - Subgrade is liquefied. Track is pumping and moving laterally, longitudinally, and vertically.

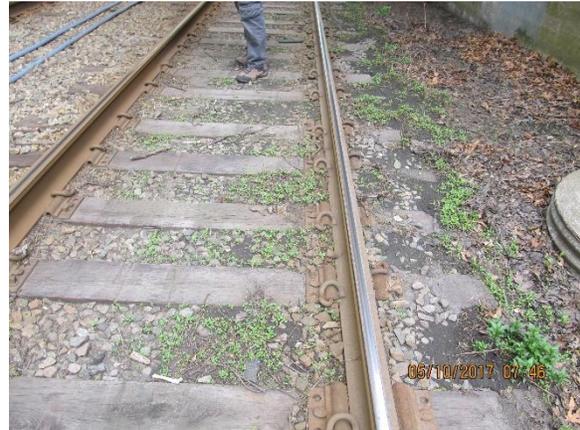
Figure 75 - Fouled Trackbed Area with dried mud. Area is subject to repeat runoff from overhead structure.

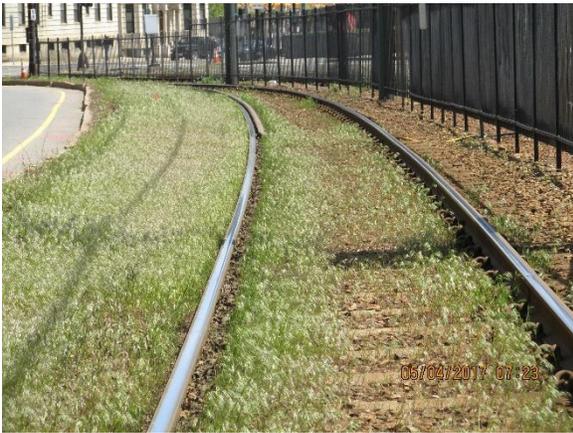
Figure 76 - Vegetation growth in fairly good ballasted area. This can be controlled by spraying.

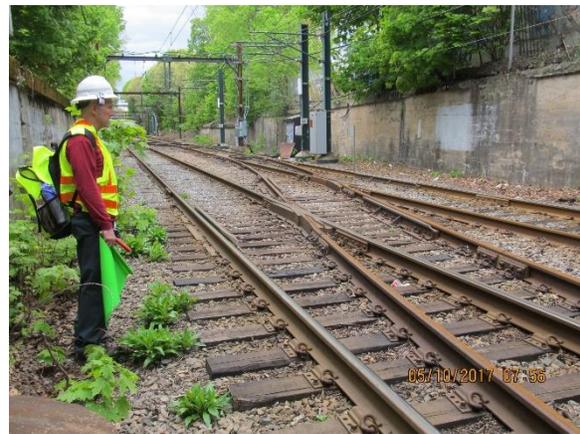
Figure 79 - Vegetation Growth Adjacent to Track which may impact sight lines for Track Workers.

Vegetation issues are abundant throughout the entire Green Line. Although the assessment team found only one area on the D-Line where safety may be impacted by vegetation growth as shown in Figure 79, this situation must be monitored to prevent a reduction in sight lines for employees and train operators. The majority of the vegetation within the dynamic envelope of the roadway is a result of the deteriorated and contaminated ballast. The Track Maintenance Group should investigate the use of a specialty contractor to apply approved herbicides to control the growth. The majority of transit systems and railroads within North America have vegetation control programs which include both pre-emergence and cutting programs.

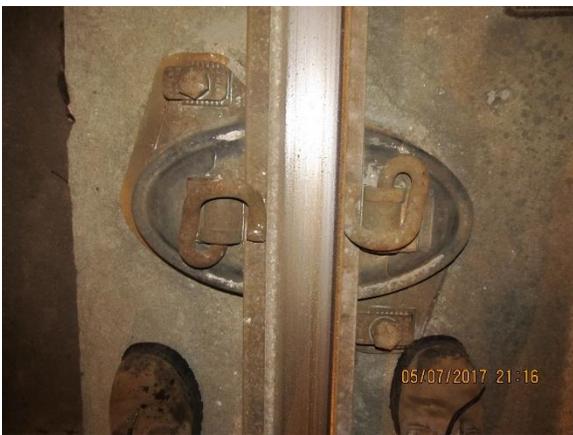
Figure 80 - Direct Fixation Fastener on Concrete Invert – No Concrete Trackbed Defects Observed.

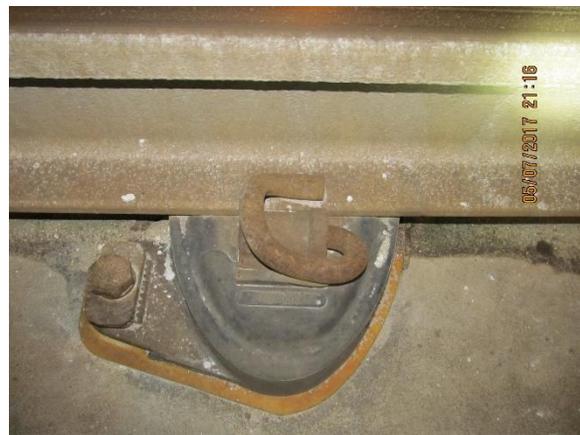
Figure 81 – Koln Egg Fastener - No Invert Defects Observed.

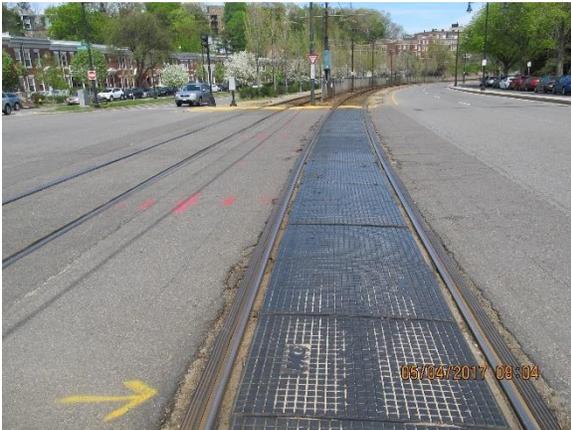
Figure 82 - Crossing with both rubber and asphalt covering.

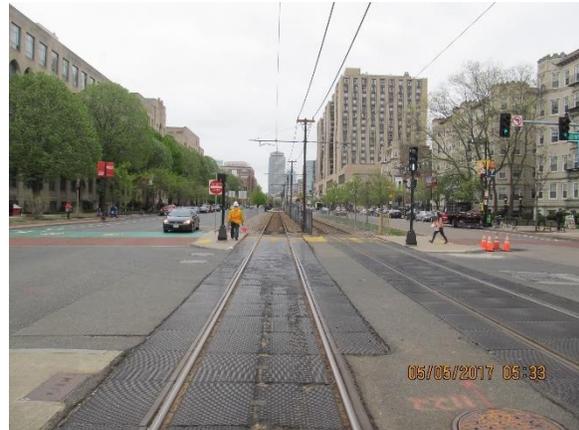
Figure 83 - Rubber Crossing.

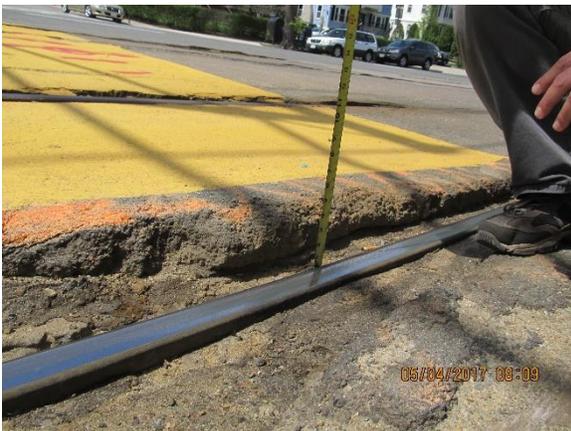
Figure 84 - Pedestrian Crossing with 4+ " of heave from Top of Rail. Tripping Hazard and impedes Track Maint and Insp.

The maintenance and inspection requirements for grade crossing areas are limited in the MBTA Green Line Track Maintenance and Safety Standards. Section LRT213.334 requires inspectors to look for signs of movement only but there is no surface inspection or crossing durability requirement. Currently, it appears that the MBTA tends to replace rubberized crossings with asphalt crossings. This restricts the ability for track maintainers to remove sections of the crossings to determine conditions underneath. It is recommended that the MBTA investigate and analyze the use of

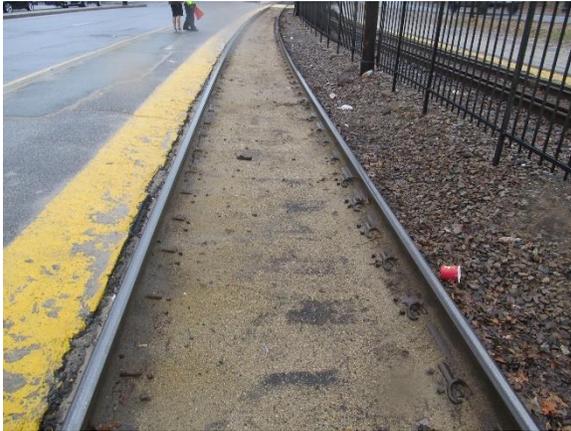
Figure 86 - Southerland Station before Clean-up

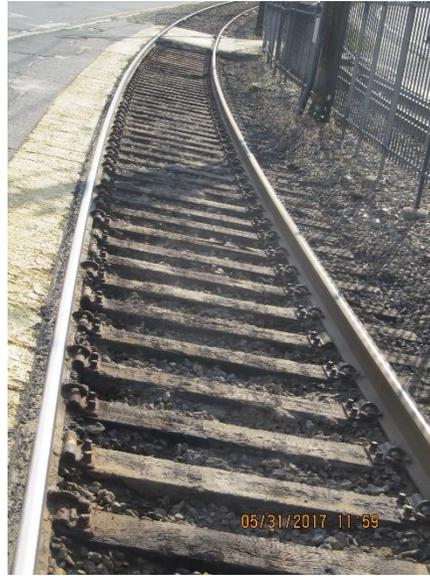
Figure 87 - Southerland Station after Clean-up.

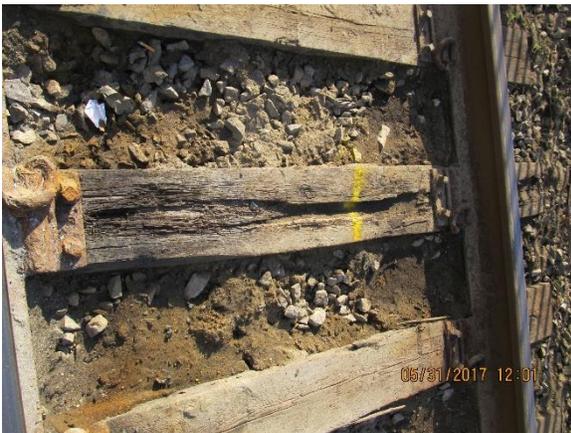
Figure 88 - Close-up view of crib area after cleaning.

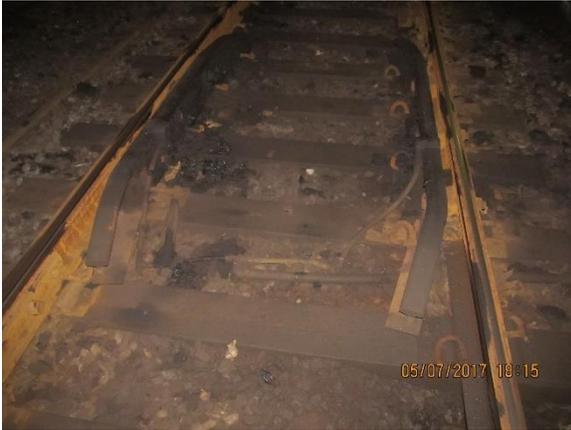
Figure 90 – Non-Functioning Rail Lubricator In Tunnel Area

Rail lubricators prevent wear which is a result of friction between the wheels and rails. Gauge side wear on the high rails of sharper curves is a common problem. Wear affects the life and performance of rails and wheels. The influential wear factors are: axle loads, lateral forces, longitudinal force, creepage, curve radius, gradient of the track, cant/superelevation, track gauge, surface conditions of the wheels and the rails, train speed, train length, frequency and type of trains, rolling stock performance, and operational and environmental issues.

Further, the assessment team recommends that all wayside lubricators be installed with double blades (lubricating both rails).

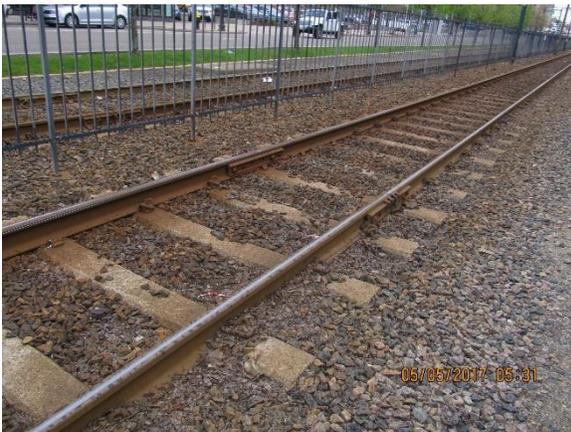
Figure 92 – Non-Staggered Joint on Concrete Tie Area

Joint stagger is especially important in areas where there is poor ballast and sub-surface conditions. As a solid axle train passes over these locations they receive the full impact of both wheel loads on the axle. This causes surface pounding and eventually surface deviations at the joint locations. There are no joint stagger requirements in the MBTA Track Maintenance and Safety Standards, section LRT213.121. It is recommended that a minimum of 2' or one tie spacing, whichever is larger, for joint stagger requirements.

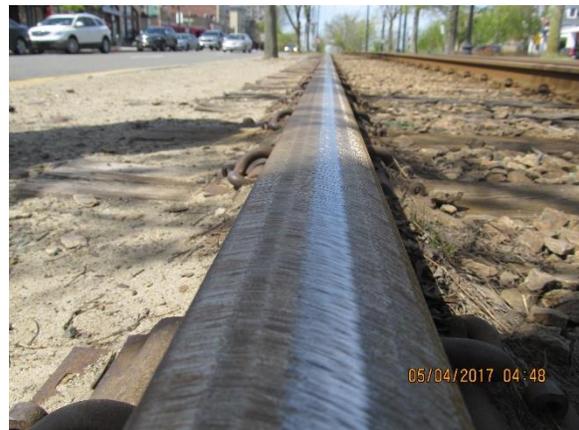
Figure 95 - Heavy Gouge Marks due to grinding.

During the grinding cycle, not only is the gauge face of the rail is being ground, but also the top of the rail head is ground to produce a profile that was recommended in the past to reduce the flattened railhead and leave a crowned railhead. This crowning of the railhead profile was determined to be a better fit with the new wheel profile to reduce detrimental wheel/rail interaction. However, in order to produce this railhead crowning profile, there is a requirement to remove a great deal of metal off the top of the rail due to “flattening” of the rail head that is prevalent on older rail. Metal removal depends on a number of factors: the power of the grinding motor, the number of motors being used by the grinder, the number of passes used by the grinder and the coarseness of the grinding stone. Unfortunately, the grinder being used by the MBTA Contractor has only 16 grinding stones (8 per rail). This leaves a very wide cut on the top of the rail for each stone and thereby wide facets are also left on the top of rail as seen in the photographs above. This multifaceted profile is detrimental to the life of both wheels and rails and should be made smoother using extra stones, more passes, or less coarse stones.

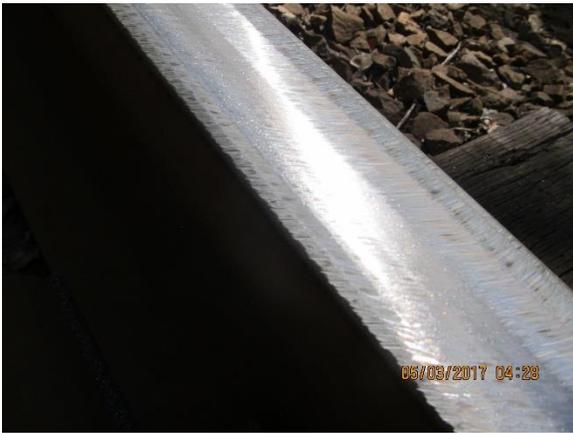
Figure 96 - New Rail Grinding showing multi-pass to re-profile rail head.

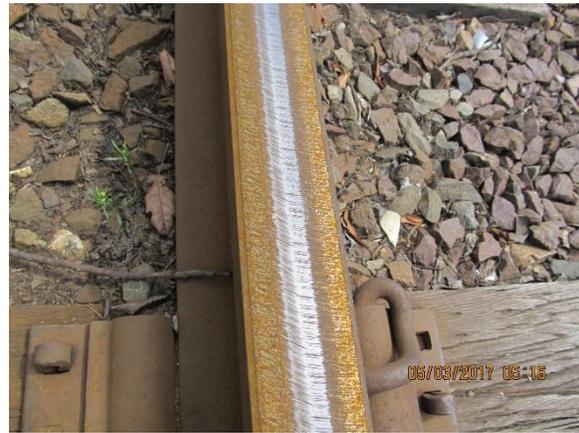
Figure 97 - Running Bead on newly profiled rail.

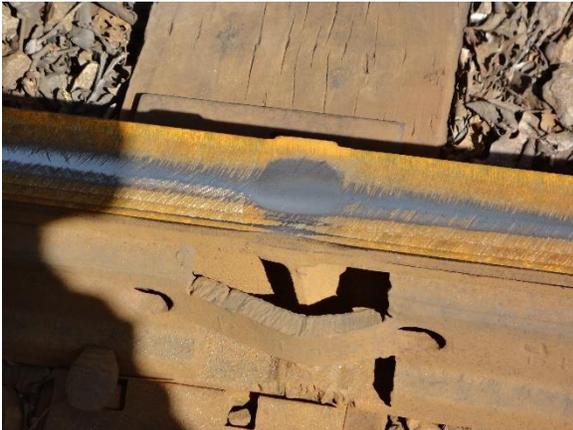
Figure 98 - Fabricated Weld-Mate Bar. Out of Standard. Used due to lack of parts.

As the MBTA makes efforts to be more efficient and to modernize their track infrastructure, it will be even more critical for maintenance inventory to be available and correctly specified. The assessment team would recommend that Maintenance team, led by MOW Engineering, determine where there are critical shortages in stock and what measures are necessary to assure that correct spare parts are available.

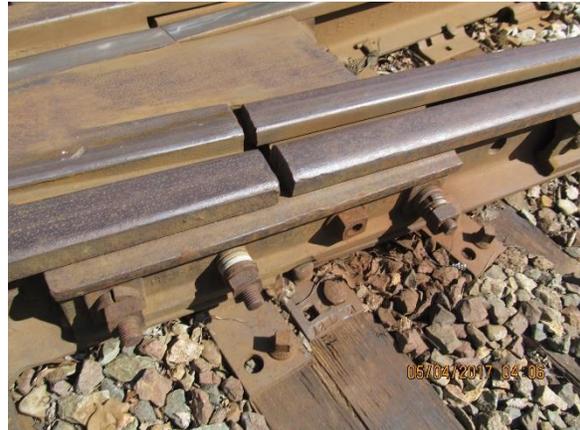
Figure 99 - Example of both too short and too long bolts being used

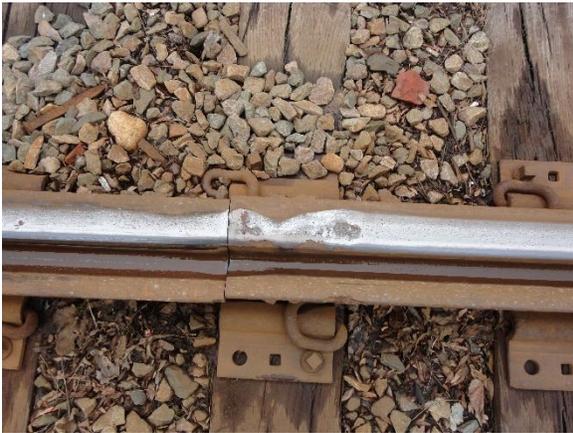
Figure 100 - Two types of Girder Rail being used leading to mismatch.
